Vermont Yankee
Cooling Tower
Update

October 14, 2008

- **August 2007: Cell 2-4 Failure**
- **July 2008: Support Saddle Failures**
- **September 2008: Distribution Header Leak**

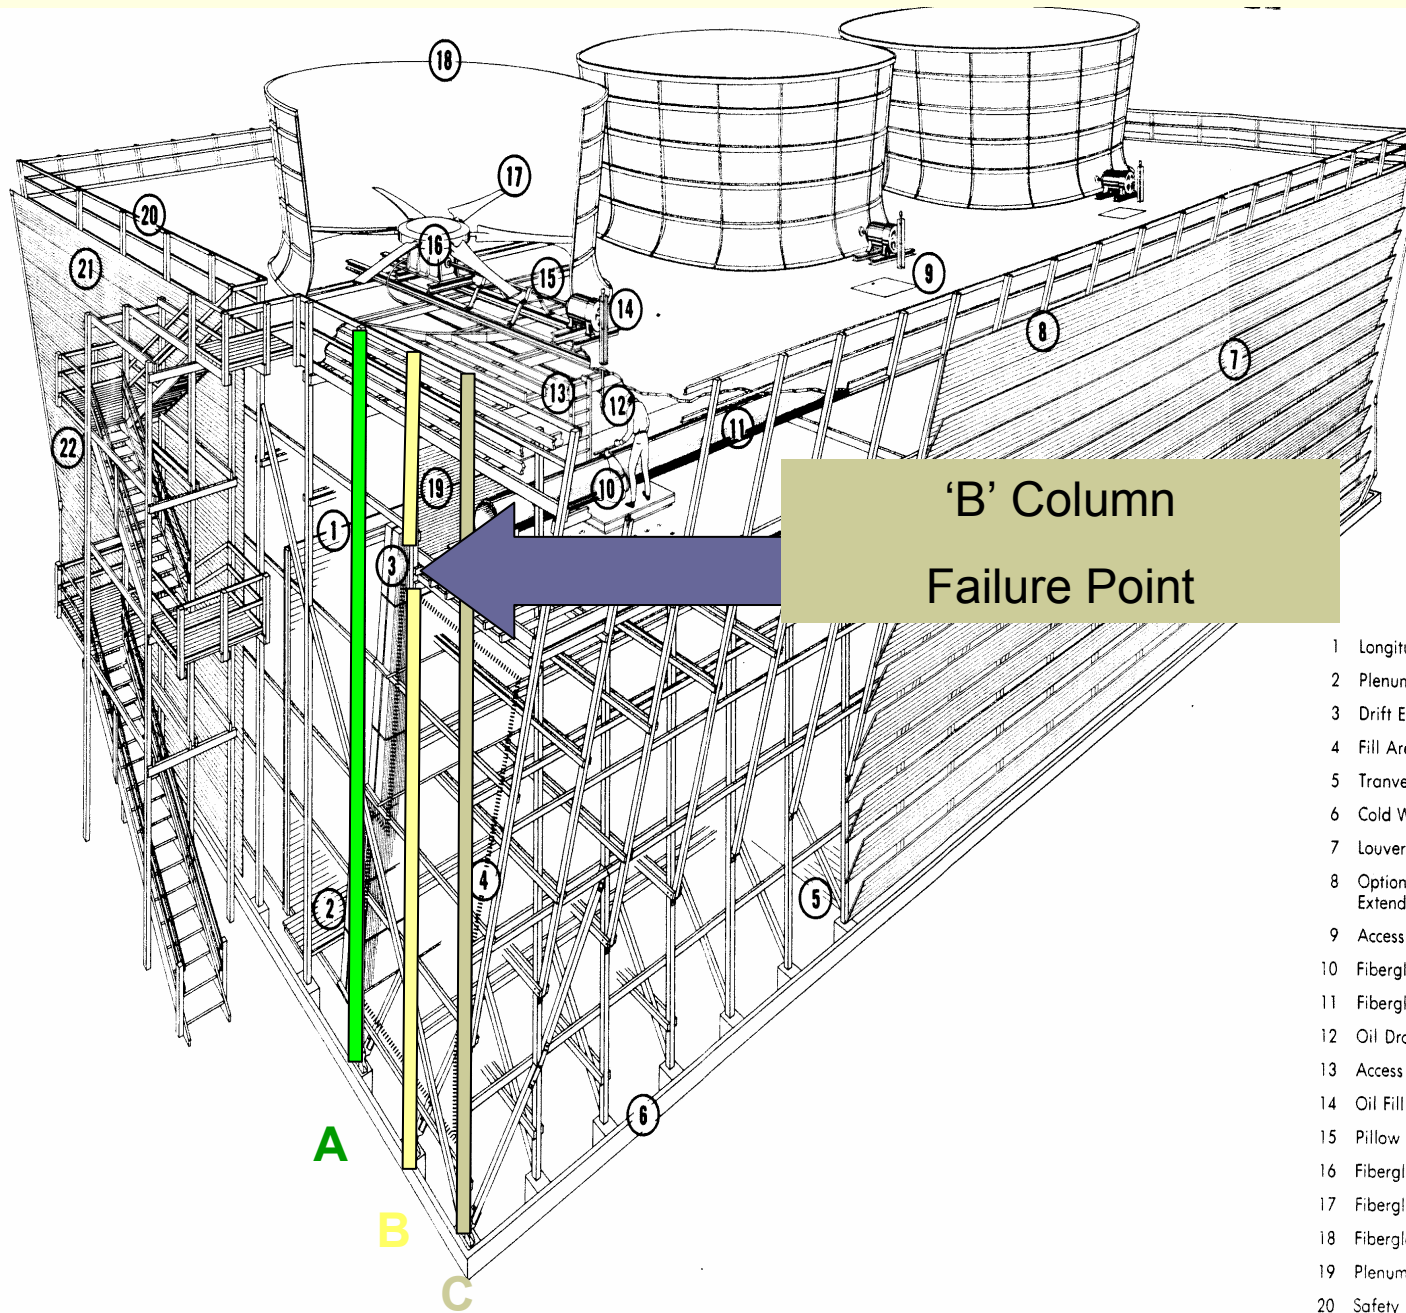
- Two support columns failed
- Failure of B Columns caused Distribution Header to sag
 - Loosened slip joints and caused large leaks
- Additional water increased weight on remaining support columns
- Other Support columns overloaded and failed
- Resulted in a partial collapse

'B' Column
Failure Point

- Support columns failed due to overload condition**

- **Rebuilt Cell 2-4**
- **Completed Extent of Condition Inspections and Repairs**
- **Fully Revised Inspection Procedures and Acceptance Criteria**
- **Established 2008 Cooling Tower Project Plan**

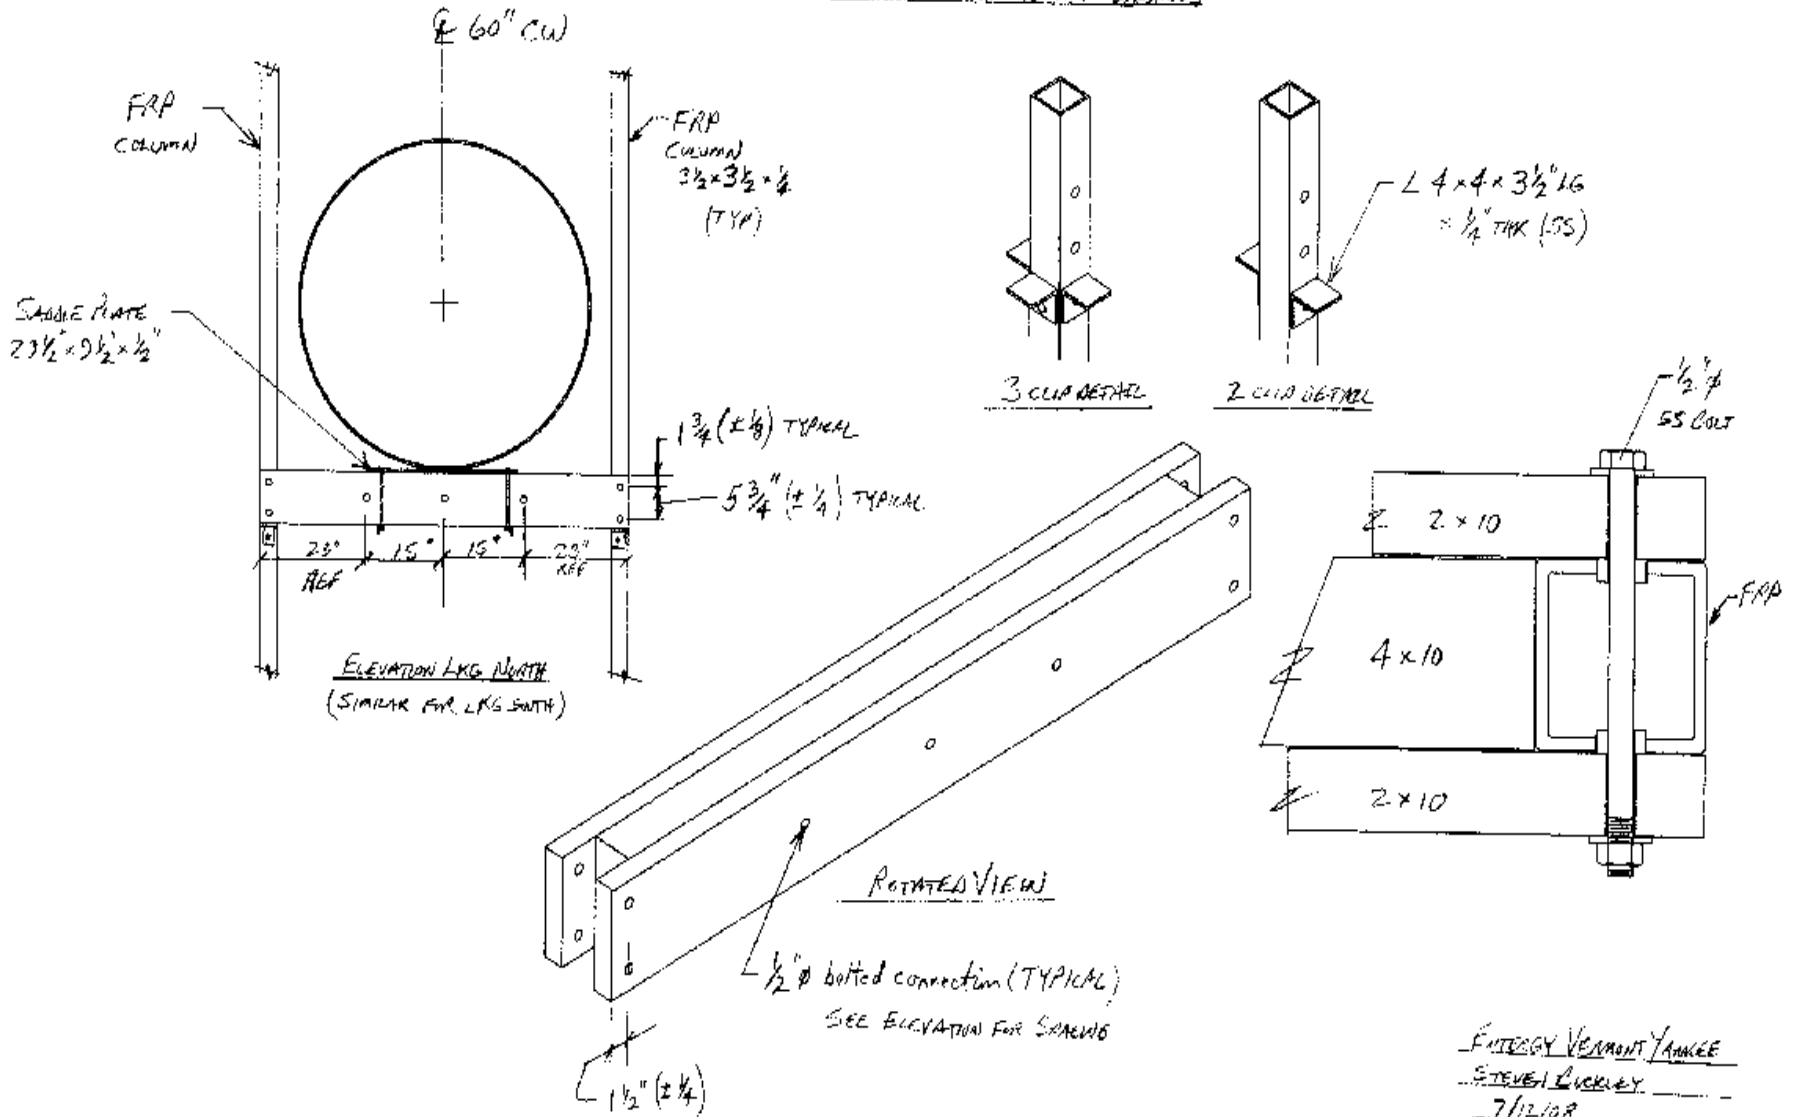
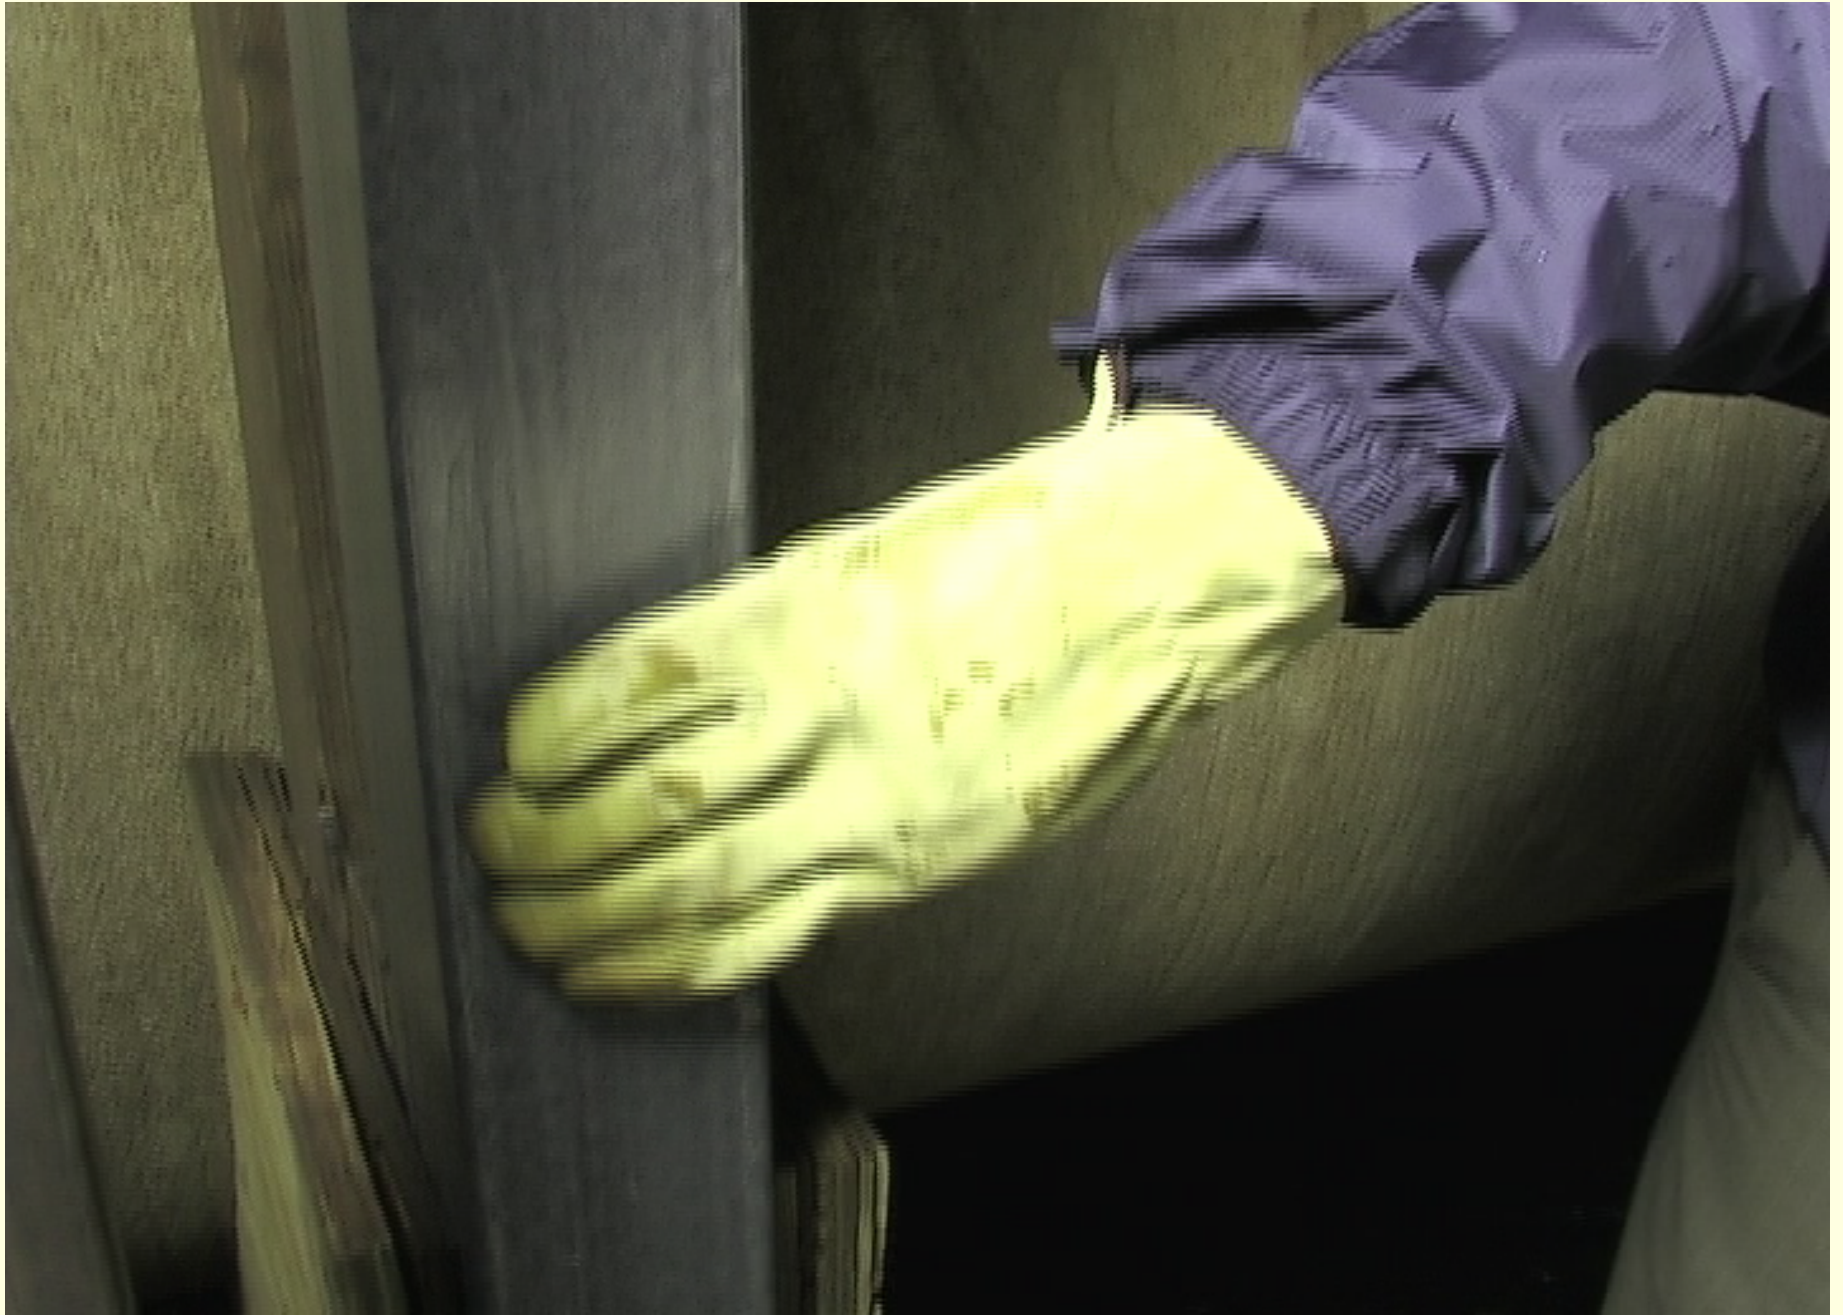
COOLING TOWER 1; CIRC. WATER SUPPORTS

- Leak in Distribution Header (Cell 1-1 East, ~60 gpm)
- Broken/Degraded Saddles (4 in tower 1, 2 in tower 2)

- Wooden Saddle to FRP Connection
- Identified by VY Design Engineering prior to placing tower in service
 - Incorrect Technical Assessment by Engineering/Vendor
 - Limited to FRP/Wood Saddles

TYPICAL DETAIL FOR CONNECTION TO FRP COLUMNS

- Full extent of condition walkdowns
- Repaired all saddles/connections
- Revised design documentation
