**UNITED STATES DEPARTMENT OF COMMERCE
National Oceanic and Atmospheric Administration
NATIONAL OCEAN SERVICE**

Center for Coastal Fisheries and Habitat Research
101 Pivers Island Road
Beaufort, North Carolina 28516-9722

Re. Control No.: 142793

Subject: POST DECONTAMINATION SURVEY DATA FOR ROOM 112

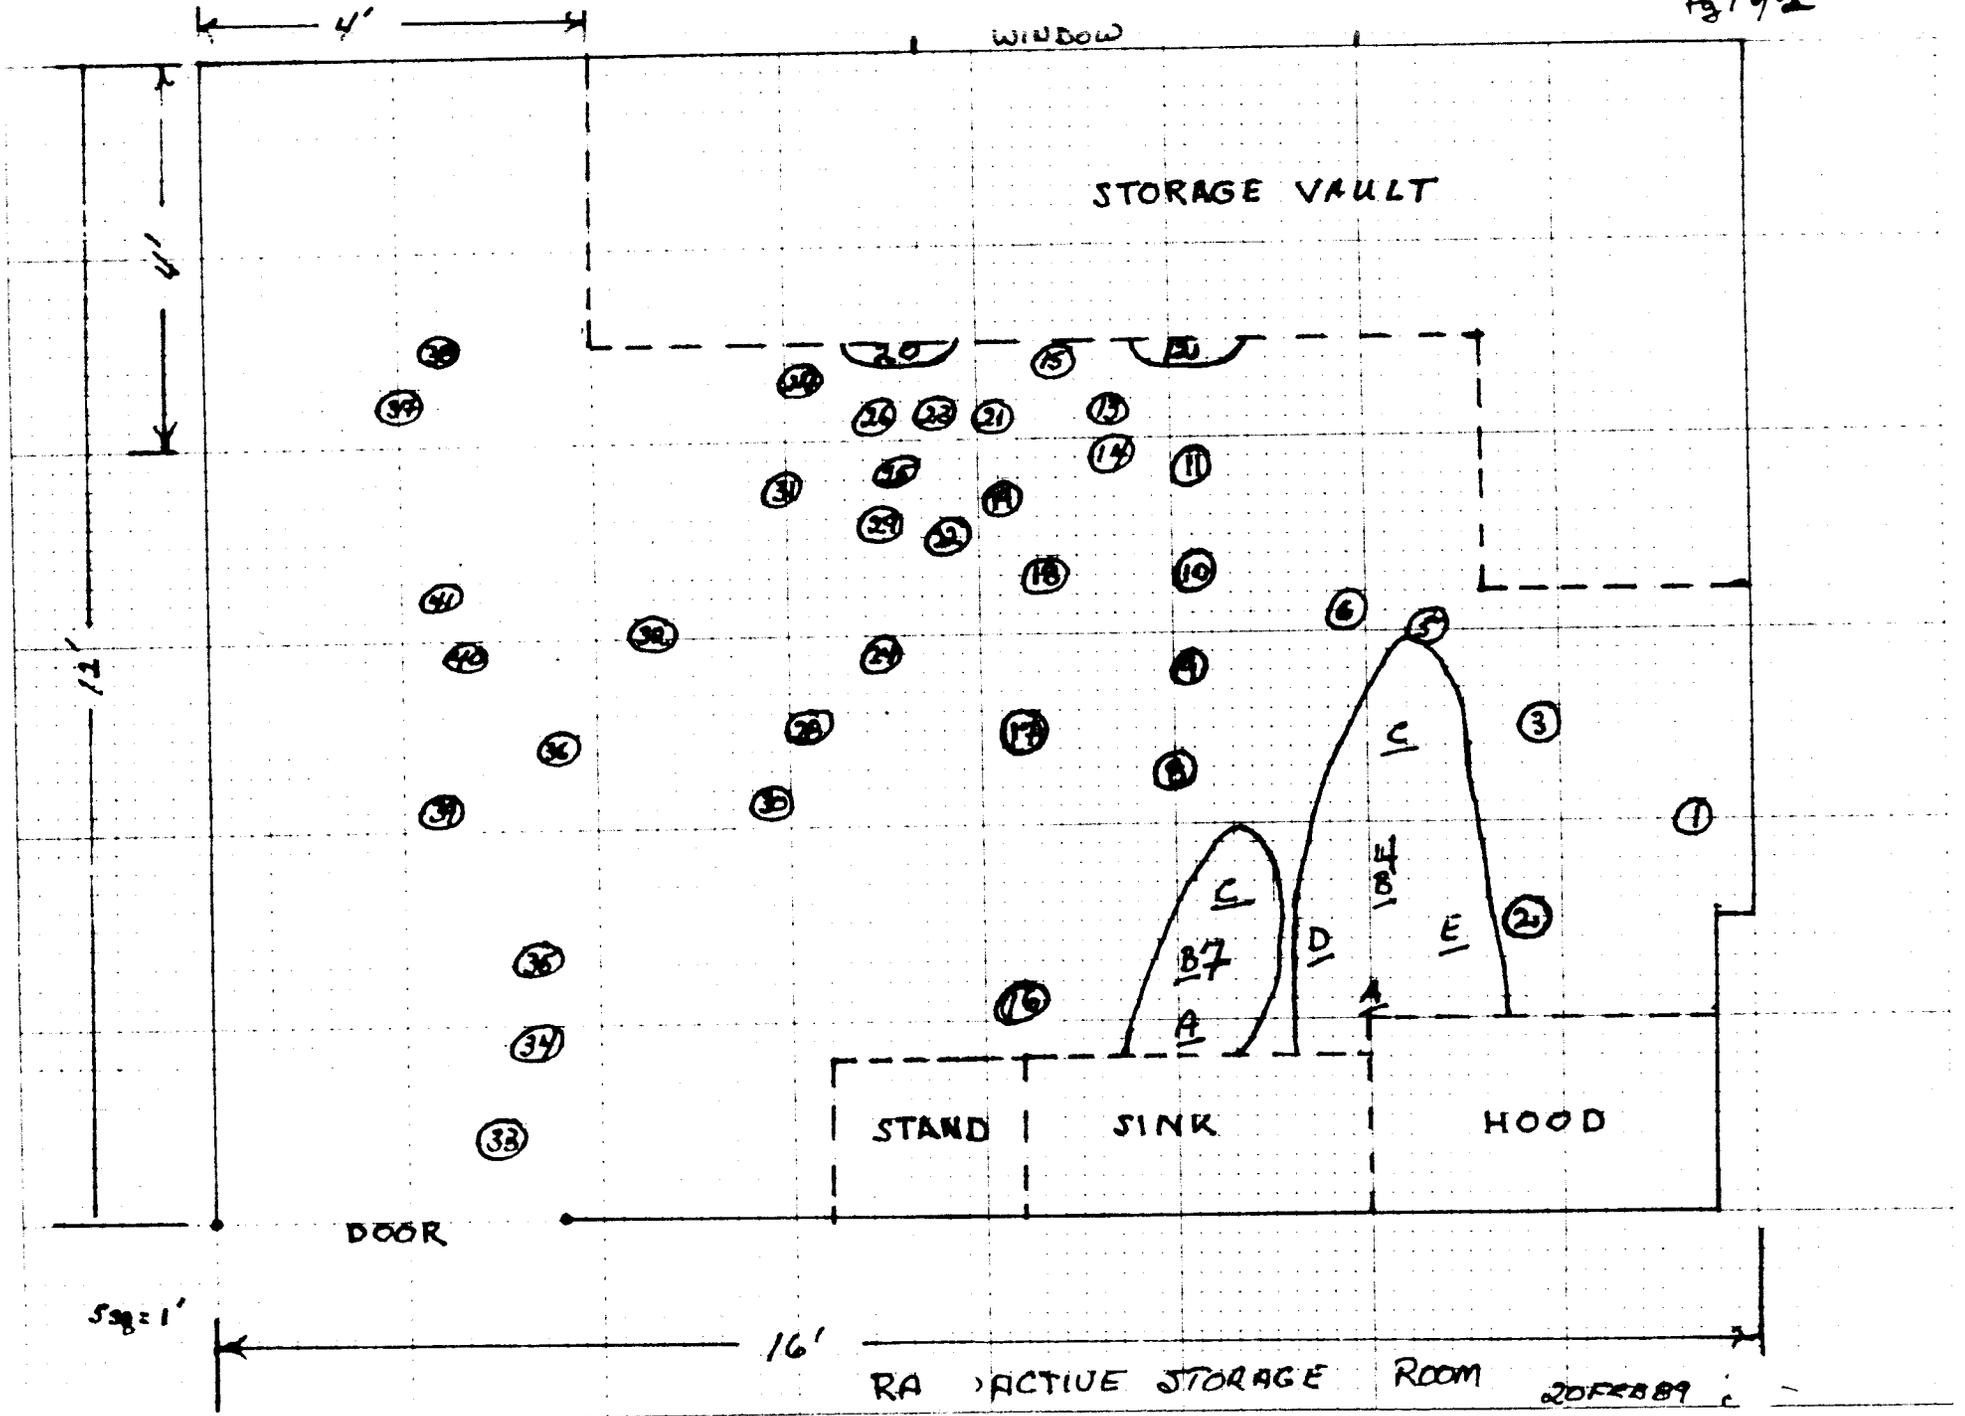
Enclosed is a drawing of the radioactive spots on the floor of the room where the isotope vault was previously located. Also, the readings obtained with a GSM-10 survey meter are included. As we discussed on the phone, I have secured the room and will wait until I hear from you to proceed with the decontamination procedure.

SPOT number	mrb at 1cm	mrb at 1 meter	SPOT number	mrb at 1cm	mrb at 1 meter
1	0.8	13 kg	20	0.7	0.
2	0.6	13 kg	21	14.0	0.
3	2.0	13 kg	22	0.5	0.
4 A	6.0	13 kg	23	1.3	0.
B	0.3	0.03	24	0.8	0.
C	4.0	0.03	25	4.0	0.
D	0.08	0.07	26	0.8	0.
E	0.4	0.04	27	0.3	0.
5	0.11	0.02	28	2.0	0.
6	0.4	0.04	29	1.1	0.
7 A	0.15	0.04	30	0.6	0.
B	0.3	0.05	31	1.4	0.
C	0.07	0.04	32	4.0	0.
8	0.4	0.05	33	0.5	0.
9	18.0	0.04	34	4.0	0.
10	1.0	0.03	35	1.0	0.
11	0.14	0.02	36	1.3	0.
12	0.12	0.04	37	0.1	0.
13	0.2	0.02	38	1.5	0.
14	3.0	0.02	39	6.0	0.
15	0.6	0.03	40	3.0	0.
16	2.0	0.03	41	2.0	0.
17	8.0	0.04			
18	0.3	0.03			
19	0.3	0.03

Measurements with GSU-1
 Survey meter by Constant
 and Bowen 2/22/89

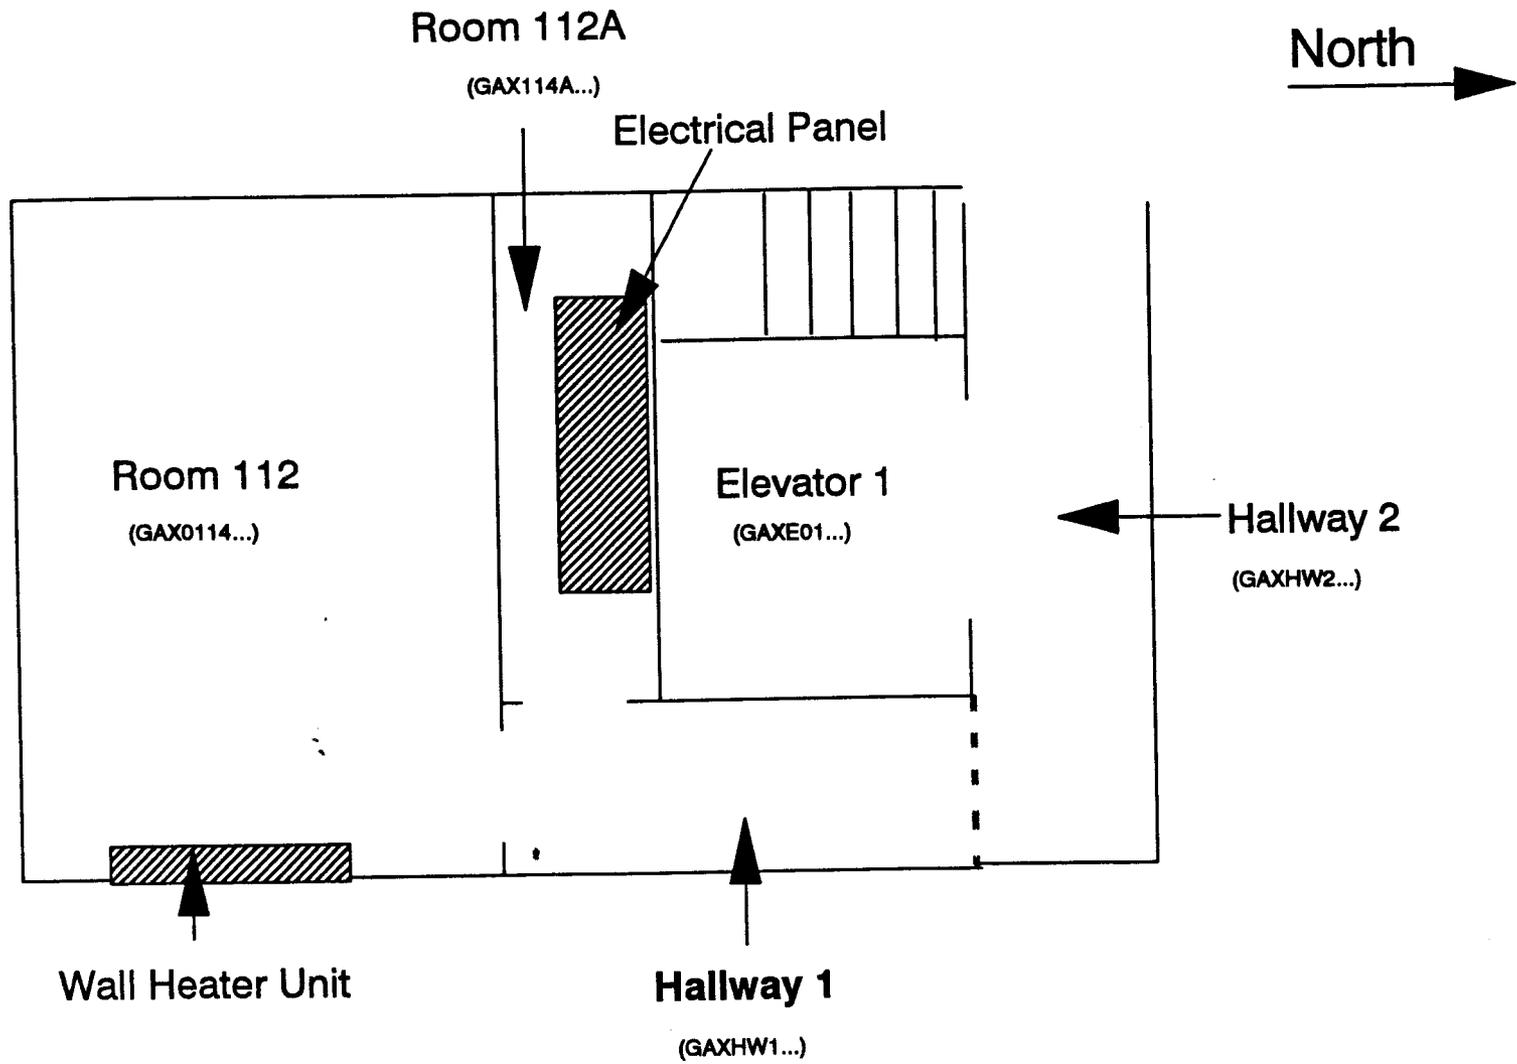
Ecology Wing Room 112 Characterization Areas

A characterization survey was performed for room 112 and surrounding areas. Results of the room 112 survey showed direct survey results of <MDA to 210,000 dpm/100cm² and removable survey results of <MDA to 2,275 dpm/100cm². The surrounding area showed direct survey results of <MDA to 31,591 dpm/100cm² and removable survey results <MDA.

There is a small spot in the hall that gave a reading of 31,590dpm/100cm², about twice the acceptable level of unremovable contamination. This spot is less than 2 inches across, (i.e., is completely covered by the GM pancake detector), and has no removable activity. It is located just outside the door of room 112, near the wall. The SEG team said they did not have time to remove it and stay within the agreed time to complete their contract (which specified only the floor of room 112). Since this spot is in a hall that is used only for access to room 112, and furthermore, is not in a heavily trafficked portion of the floor, I'm wondering if we could allow it to remain? If not, what are the guidelines for removing it ourselves?
