SRNL-ESB-2008-00017

Re: Video Survey of Saltstone Vault 4, Cell G

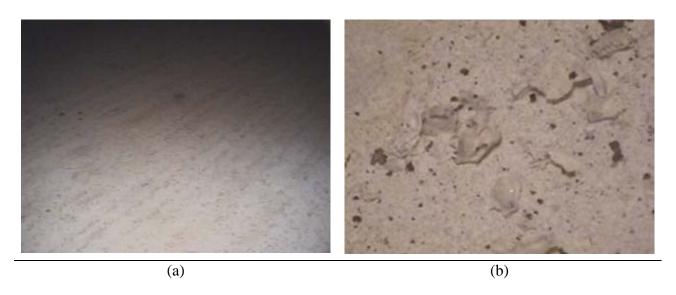
A five minute long video was made of the interior of Vault #4, Cell G. From this video, several still images were captured and are presented in Figures 3 through 5. These images provide a basis to qualitatively assess the surface condition of the saltstone waste including any observed cracking. Figure 3a provides a general view of the saltstone waste surface as seen from the north corner of Cell G. Figure 3b provides a close-up view of the saltstone waste surface. The surface of the saltstone waste appears to be relatively free of large scale cracking. Figure 4a shows a large aperture crack emanating from the north corner of Cell G. This crack propagates out from the corner at approximately a 45 degree angle and appears to extend entirely across the cell. The smaller aperture crack in Figure 4b is oriented perpendicular to the crack in Figure 4a and appears to extend a short distance from the main crack. Figure 5a shows the north corner of Cell G. This image shows that the crack observed in Figure 4a extends to the corner of the cell. The north wall of Cell G is shown in Figure 5b. There is no obvious separation between the vault wall and saltstone associated with shrinkage of the saltstone grout (Figure 5a and b).

Figure 3. General view (a) and close-up view (b) of saltstone waste surface as seen from the north corner of Cell G.

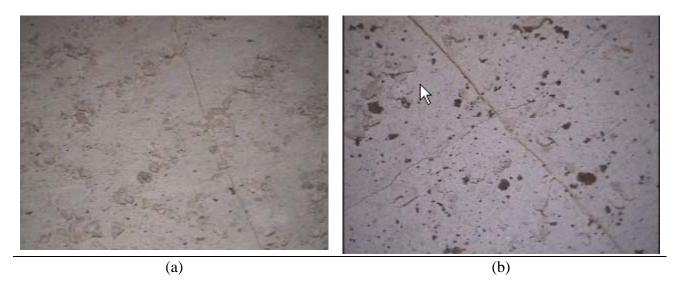
The results of the video survey show that there is some cracking in the saltstone grout, but it is not considered to be extensive. The survey was limited by the zoom capability of the PTZ camera and the view accessible from the north corner of Cell G. It is possible to obtain better quality video and still images over a larger area by using a remote controlled vehicle equipped with a high resolution camera. The surface of the saltstone grout appears to be smooth enough to accommodate a rubber tracked vehicle for this type of survey. Access to the saltstone waste surface could be obtained via an access point similar to the one shown in Figure 6. It should be noted that any vehicle placed on the surface of the saltstone grout would be considered contaminated and would not be released for general non-radioactive use.

Figure 4. Crack in saltstone waste surface emanating from the north corner of Cell G (a) and smaller aperture crack oriented perpendicular to it (b). The larger aperture crack propagates out from the corner at approximately a 45 degree angle and appears to extend entirely across the cell. The smaller aperture crack appears to only extend a short distance from the main crack.

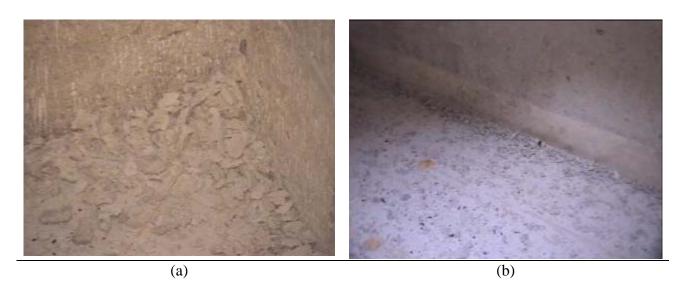
Figure 5. Close-up view of the north corner (a) and east wall of Cell G (b). There appears to be no separation of the saltstone from the vault wall along the edge of the walls in Cell G.

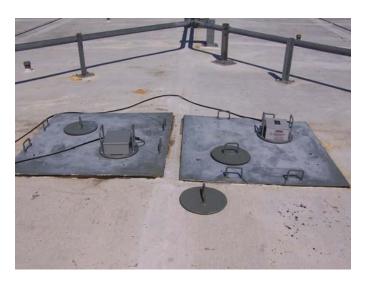
Figure 6. Access ports that could be used to lower a remote controlled vehicle for closer inspection of cracking in the saltstone surface.
