**UNITED STATES
NUCLEAR REGULATORY COMMISSION**
REGION I
475 ALLENDALE ROAD
KING OF PRUSSIA, PA 19406-1415

January 21, 2009

**SUBJECT: OYSTER CREEK GENERATING STATION - NRC LICENSE RENEWAL
FOLLOW-UP INSPECTION REPORT 05000219/2008007**

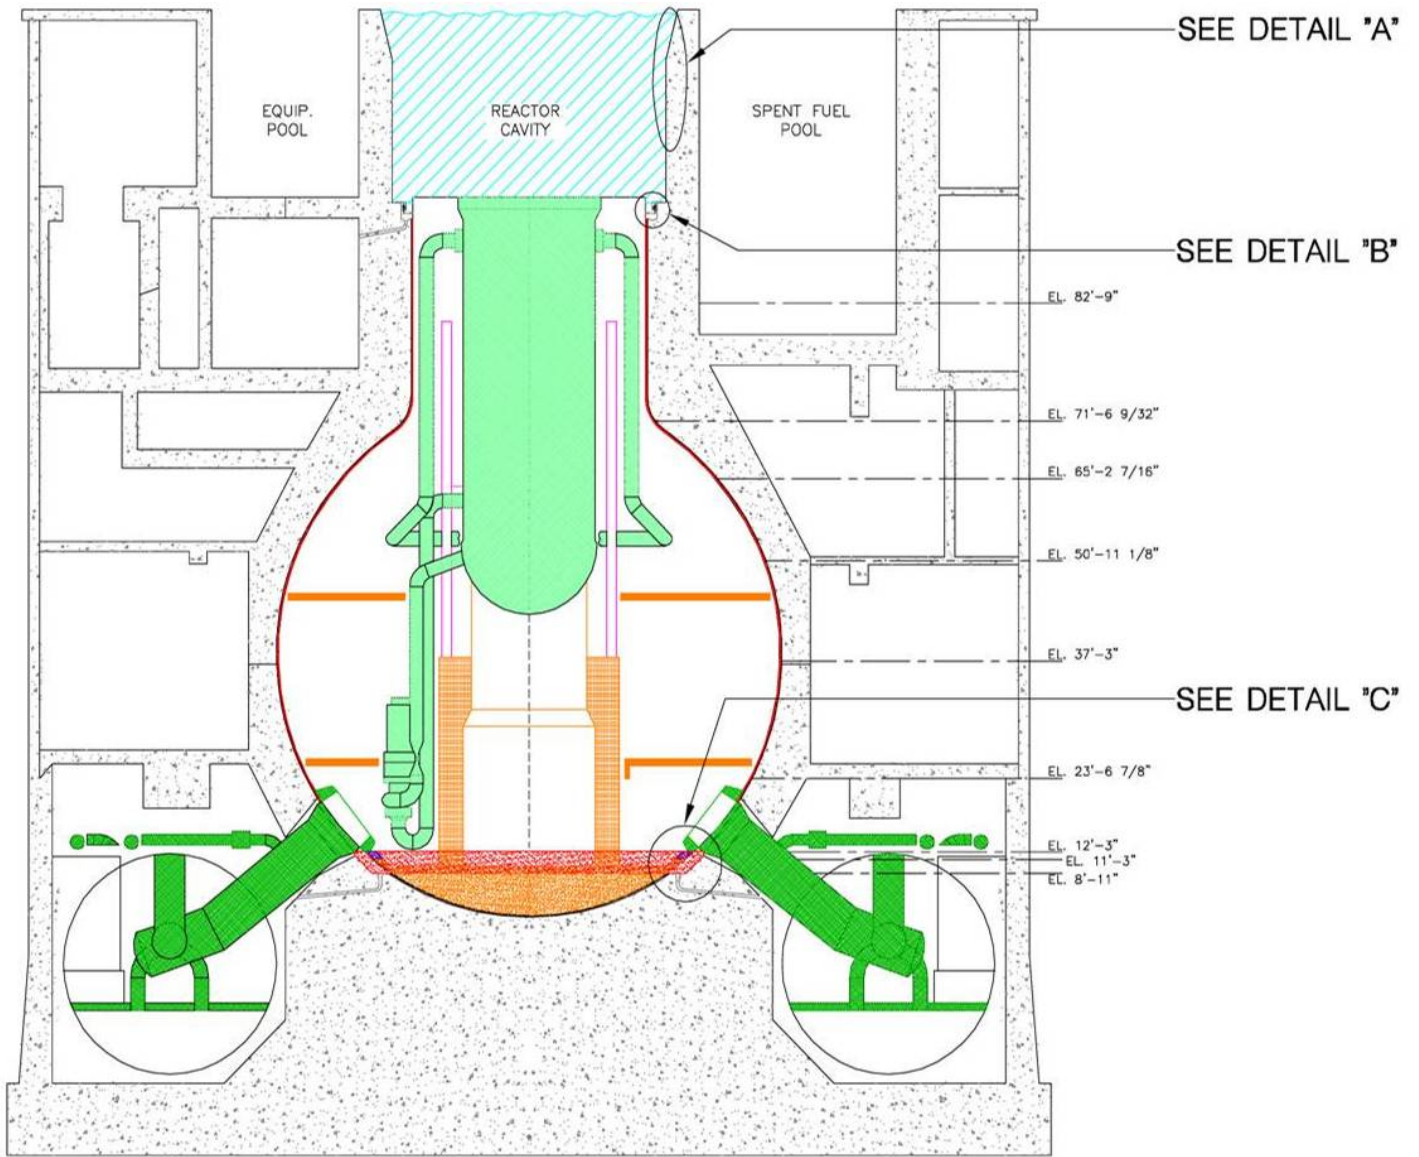
Figure A-1, Cross Section of the Oyster Creek Drywell

The strippable coating is applied to the reactor cavity liner before the cavity is filled with water to minimize the likelihood of cavity seal leakage into the cavity concrete trough. This action is taken to prevent water intrusion into the gap (Figure A-3) between the drywell steel shell and the concrete shield wall. (see Figure A-1 for general arrangement)

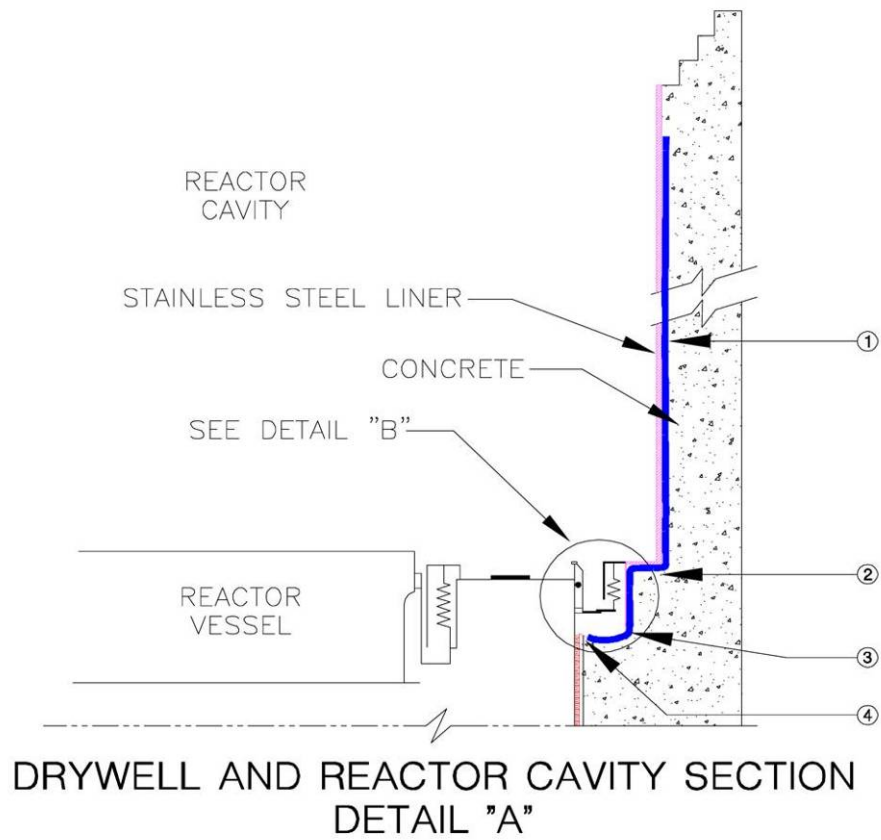
Figure A-2, Oyster Creek Reactor Cavity Seal Detail

Exelon monitored reactor refuel cavity seal leakage by checking and recording the flow in a two inch drain line from the cavity concrete trough to a plant radwaste system drain funnel which, in turn, drained to the reactor building equipment drain tank. (See Figures A-1 thru A-3)

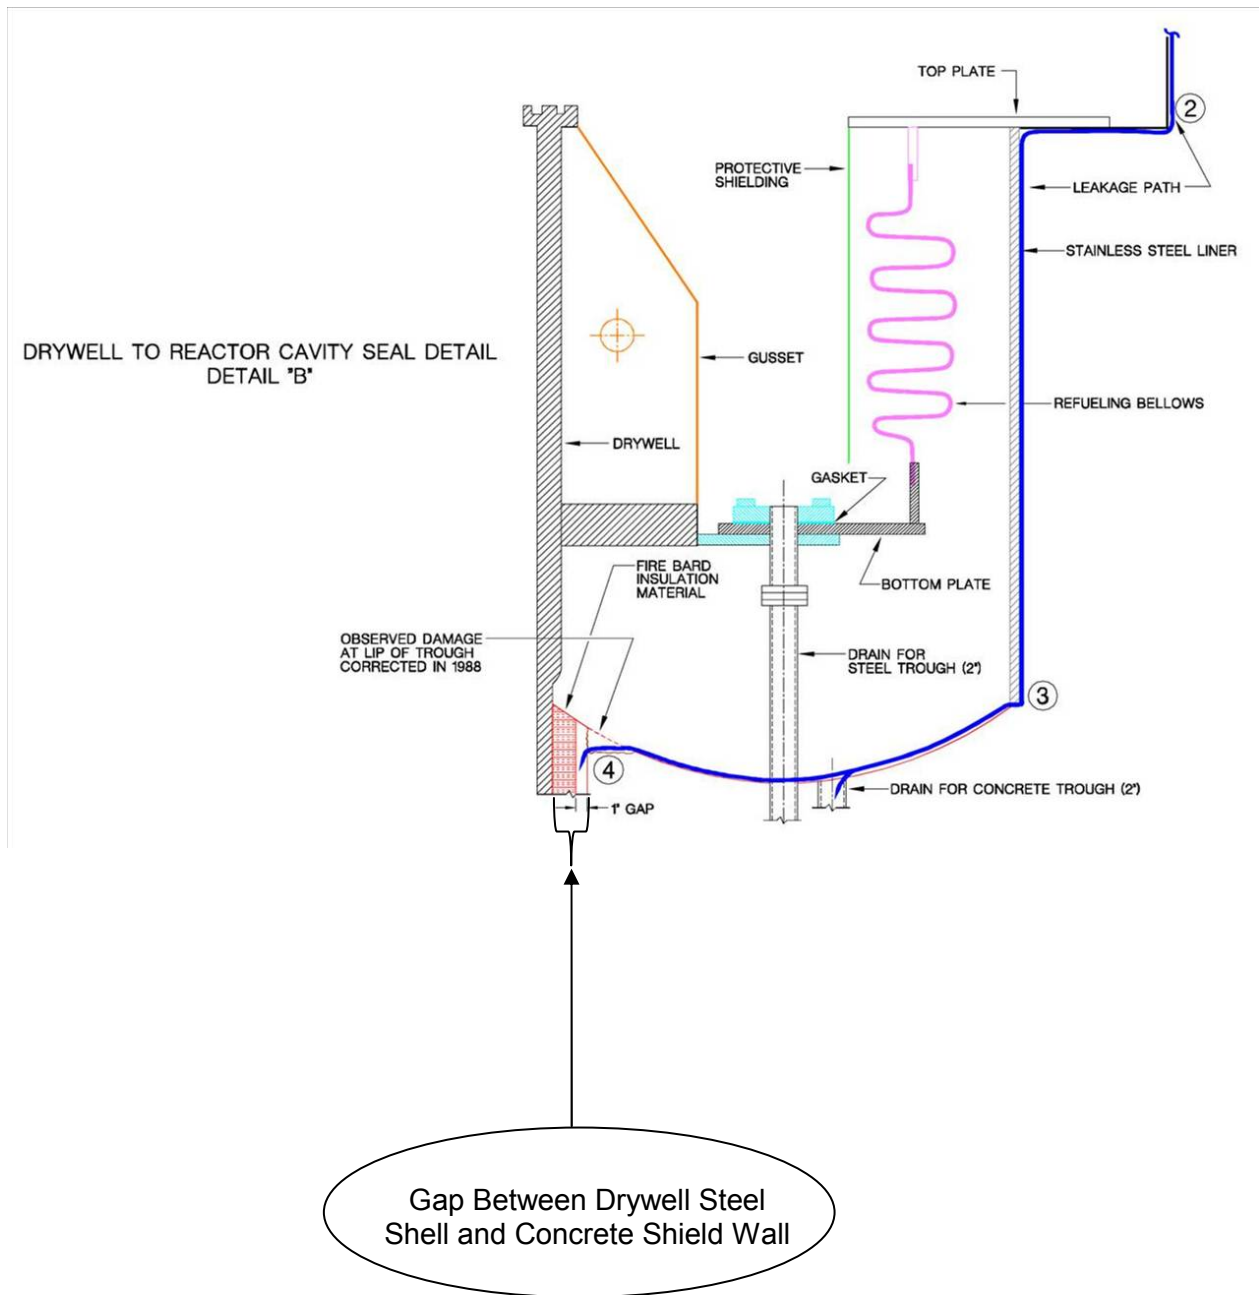
Figure A-3, Reactor Cavity Trough Drain Detail

For the reactor cavity seal leakage, Exelon established an administrative limit of 12 gpm flow in the cavity trough drain, based on a calculation which indicated that cavity trough drain flow of less than 60 gpm would not result in trough overflow into the gap between the drywell concrete shield wall and the drywell steel shell. (see Figures A-1 thru A-5)
