January 20, 2009

DOMINION NUCLEAR CONNECTICUT, INC.
MILLSTONE POWER STATION UNIT 2
10 CFR 50.55a RELIEF REQUEST RR-89-65 and 89-66; TEMPORARY NON-CODE
REPAIR, CLASS 3 SERVICE WATER SYSTEM EMERGENCY DIESEL
GENERATOR JACKET WATER HEAT EXCHANGER X-45A AND AIR COOLER
HEAT EXCHANGER X-83B

RELIEF REQUEST RR-89-65, TEMPORARY NON-CODE REPAIR
CLASS 3 SERVICE WATER SYSTEM EMERGENCY DIESEL GENERATOR
JACKET WATER HEAT EXCHANGER X-45A

**RELIEF REQUEST RR-89-66, TEMPORARY NON-CODE REPAIR
CLASS 3 SERVICE WATER SYSTEM EMERGENCY DIESEL GENERATOR AIR
COOLER HEAT EXCHANGER X-83B**

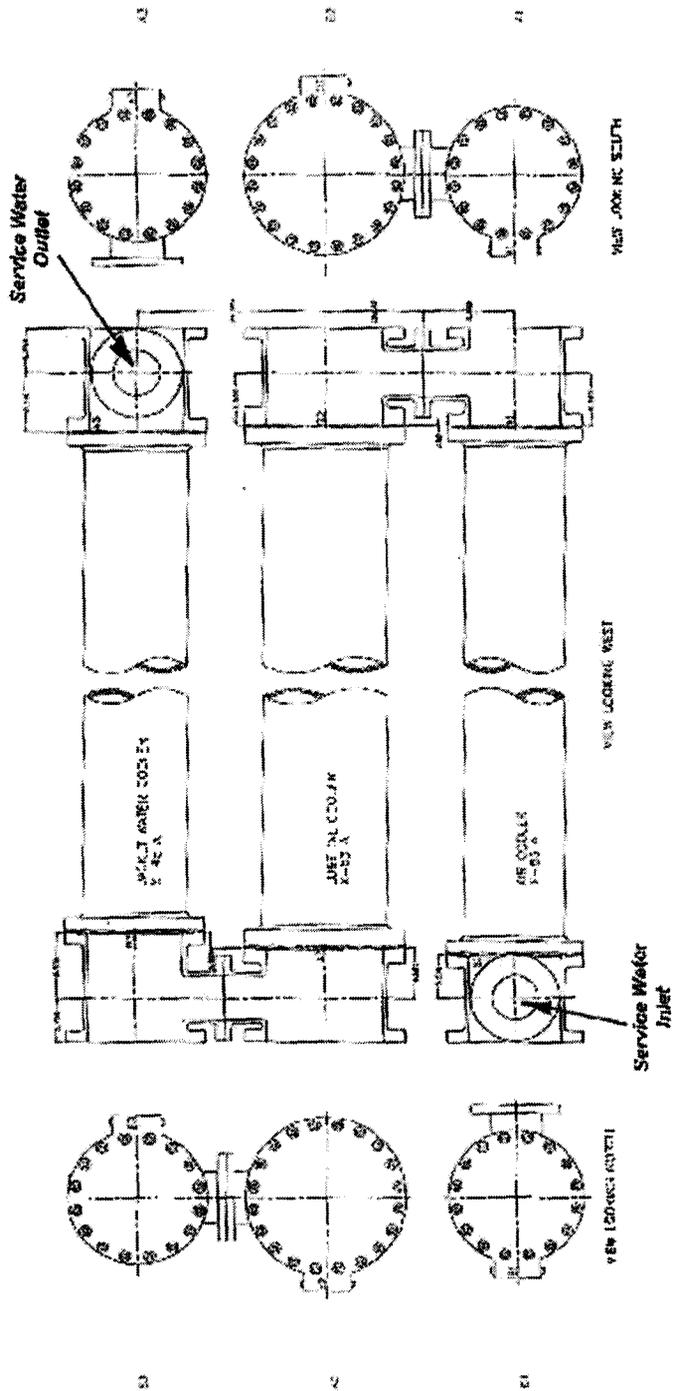
SKETCH 1

Millstone Unit 2
'A' EDG Heat Exchanger Arrangement

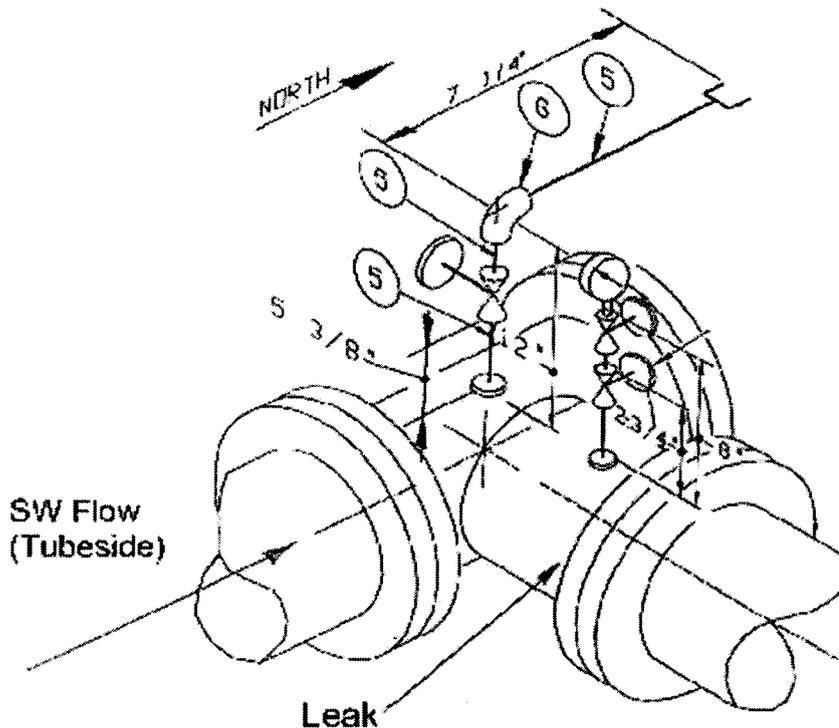
SKETCH 2

On November 6, 2008, Operations personnel identified a corrosion product buildup on the ASME Class 3 Service Water (SW) outlet channel head of the Millstone Power Station Unit 2 (MPS2) "A" Emergency Diesel Generator (EDG) Jacket Water Heat Exchanger, X-45A. Following removal of the buildup, normal system pressure was applied. One localized area (<1" in diameter) was observed to have wetness, with an estimated leakage rate at 1 drop per 15 minutes. Visual observation did not identify any specific external defect in this localized area. The wetness was observed on the neck of the 6" diameter flanged outlet nozzle connected to the outlet piping.

Based on the results of Ultrasonic Test (UT) and Radiographic Test (RT) examinations, and external surface direct visual examinations as described above, the leak is assessed to be associated with a small casting defect indicated by the presence of a rounded indication (< 1/16" diameter). Additionally, assessment indicates this rounded indication (<1/16" diameter) and other minor casting imperfections allowed sea water to migrate along a tortuous path to the outside surface of the channel head. The channel head is made from an aluminum bronze sand casting fabricated per ASTM B148 alloy C95400 that has been temper annealed. Temper annealing of aluminum bronze castings has been shown to reduce the susceptibility of aluminum bronzes to dealloying in seawater environments. In this application, the dealloying of the aluminum bronze casting is being managed by heat treatment.

Enclosure 1 contains a typical sketch of the EDG channel head and observed flaw area.

Based on the results of the above inspections, the leak is most likely the result of several small pores (including the 1/16 inch indication) that linked to create a leak path from the inside to outside surface. The maximum estimated defect diameter is <1/16 inch, but for fluid leakage evaluations (see below) it has been assumed to be 1/4 inch diameter. For structural evaluation purposes, the defect is conservatively assumed to be a one inch diameter through wall defect surrounded by sound material. This larger assumed defect was chosen to provide additional assurance of the structural integrity.

Millstone Unit 2
'A' EDG Jacket Water Heat Exchanger X-45A
Outlet Channel Head

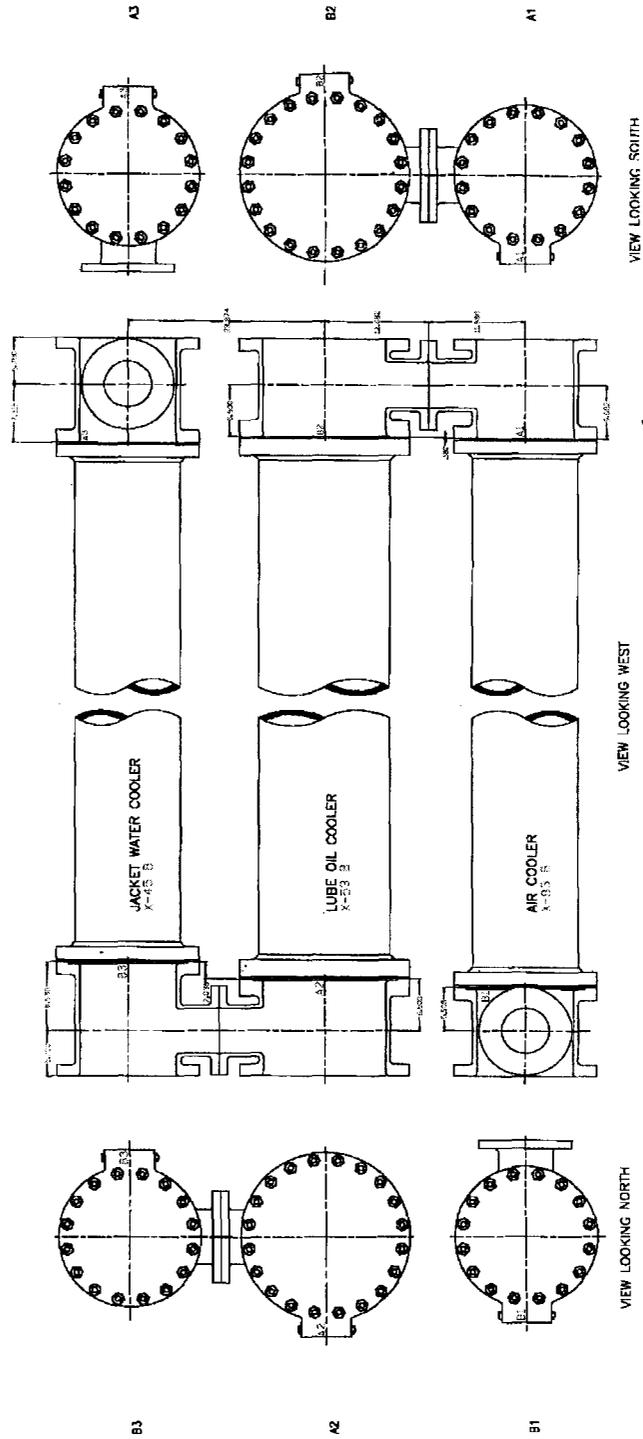
SKETCH 1

Millstone Unit 2
'B' EDG Heat Exchanger Arrangement

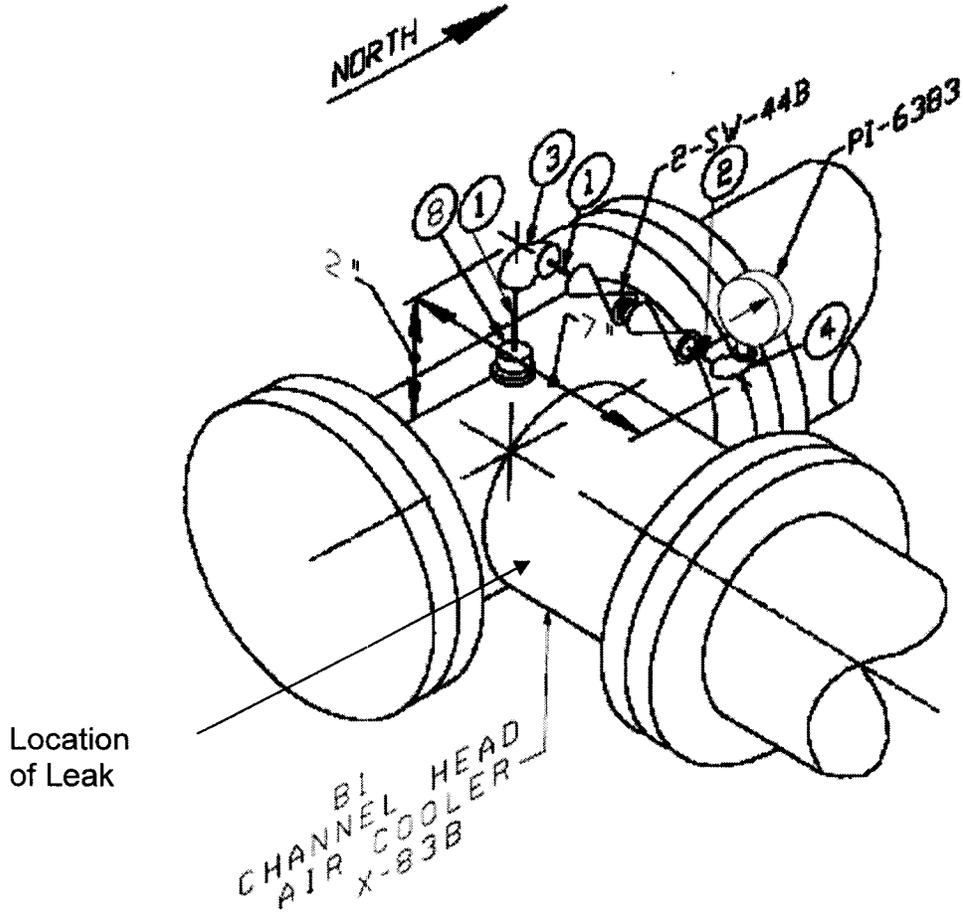
SKETCH 2

On November 25, 2008, Operations personnel identified a corrosion product buildup on the ASME Class 3 Service Water (SW) inlet channel head of the Millstone Power Station Unit 2 (MPS2) "B" Emergency Diesel Generator (EDG) Air Cooler Heat Exchanger, X-83B. One localized area was observed to have wetness, with an estimated leakage rate at less than 1 drop per 15 minutes. Visual observation did not identify any specific external defect in this localized area. The wetness was observed on the neck of the 6" diameter flanged inlet nozzle connected to the inlet piping. This condition was discovered during an augmented inspection of all 12 EDG heat exchanger channel heads for similar leakage initiated upon discovery of leakage in the X-45A jacket water cooler on the "A" EDG (See Attachment 1 of this letter). No other conditions have been identified.

Based on the results of Ultrasonic Test (UT) and Radiographic Test (RT) examinations, direct visual internal and external surface examinations, and hardness testing as described below, the leak is most likely associated with a small casting defect indicated by the presence of a shrinkage indication (about 1/2" diameter). The casting imperfection, which meets the acceptance criteria of the Construction Code, is likely part of the leak path to the outside surface of the channel head. The channel head is made from an aluminum bronze sand casting fabricated per ASTM B148 alloy C95400 that has been temper annealed. Temper annealing of aluminum bronze castings has been shown to reduce the susceptibility of aluminum bronzes to dealloying in seawater environments. Thus for the Millstone Power Station channel heads, the potential for dealloying of the aluminum bronze casting is managed by the heat treatment.

Enclosure 1 contains a typical sketch of the EDG channel head and observed flaw area.

Based on the results of the above inspections, the leak is most likely the result of several small pores which linked to create a leak path from the inside to the outside surface. It is likely the leak path includes the shrinkage area, which has an estimated size of about 1/2 inch in the plane of the casting but is not surface breaking so there is no surface defect that would permit leakage of more than a few drops per minute. The leakage is thus limited by the size of the interconnected pores. Based on the negligible actual leakage and the periodic leakage monitoring initiated, fluid leakage evaluations (see below) are based on an assumed through-wall defect of 1/4 inch diameter. For structural evaluation purposes, the defect is conservatively assumed to be a one inch diameter through-wall defect surrounded by sound material. This larger assumed defect was chosen to provide additional assurance of the structural integrity.

Millstone Unit 2
'B' EDG Heat Exchanger Arrangement
