**SUBJECT: COMANCHE PEAK STEAM ELECTRIC STATION  
DOCKET NO. 50-445  
UNIT 1 THIRTEENTH REFUELING OUTAGE (1RF13) STEAM GENERATOR  
180 DAY REPORT**

**Comanche Peak Unit 1  
Steam Generator Cycle 13 Condition Monitoring and  
Cycles 14, 15, and 16 Operational Assessment**

**Comanche Peak Unit 1 (CPNPP)  
Steam Generator Cycle 13 Condition Monitoring and  
Cycles 14, 15, and 16 Operational Assessment**

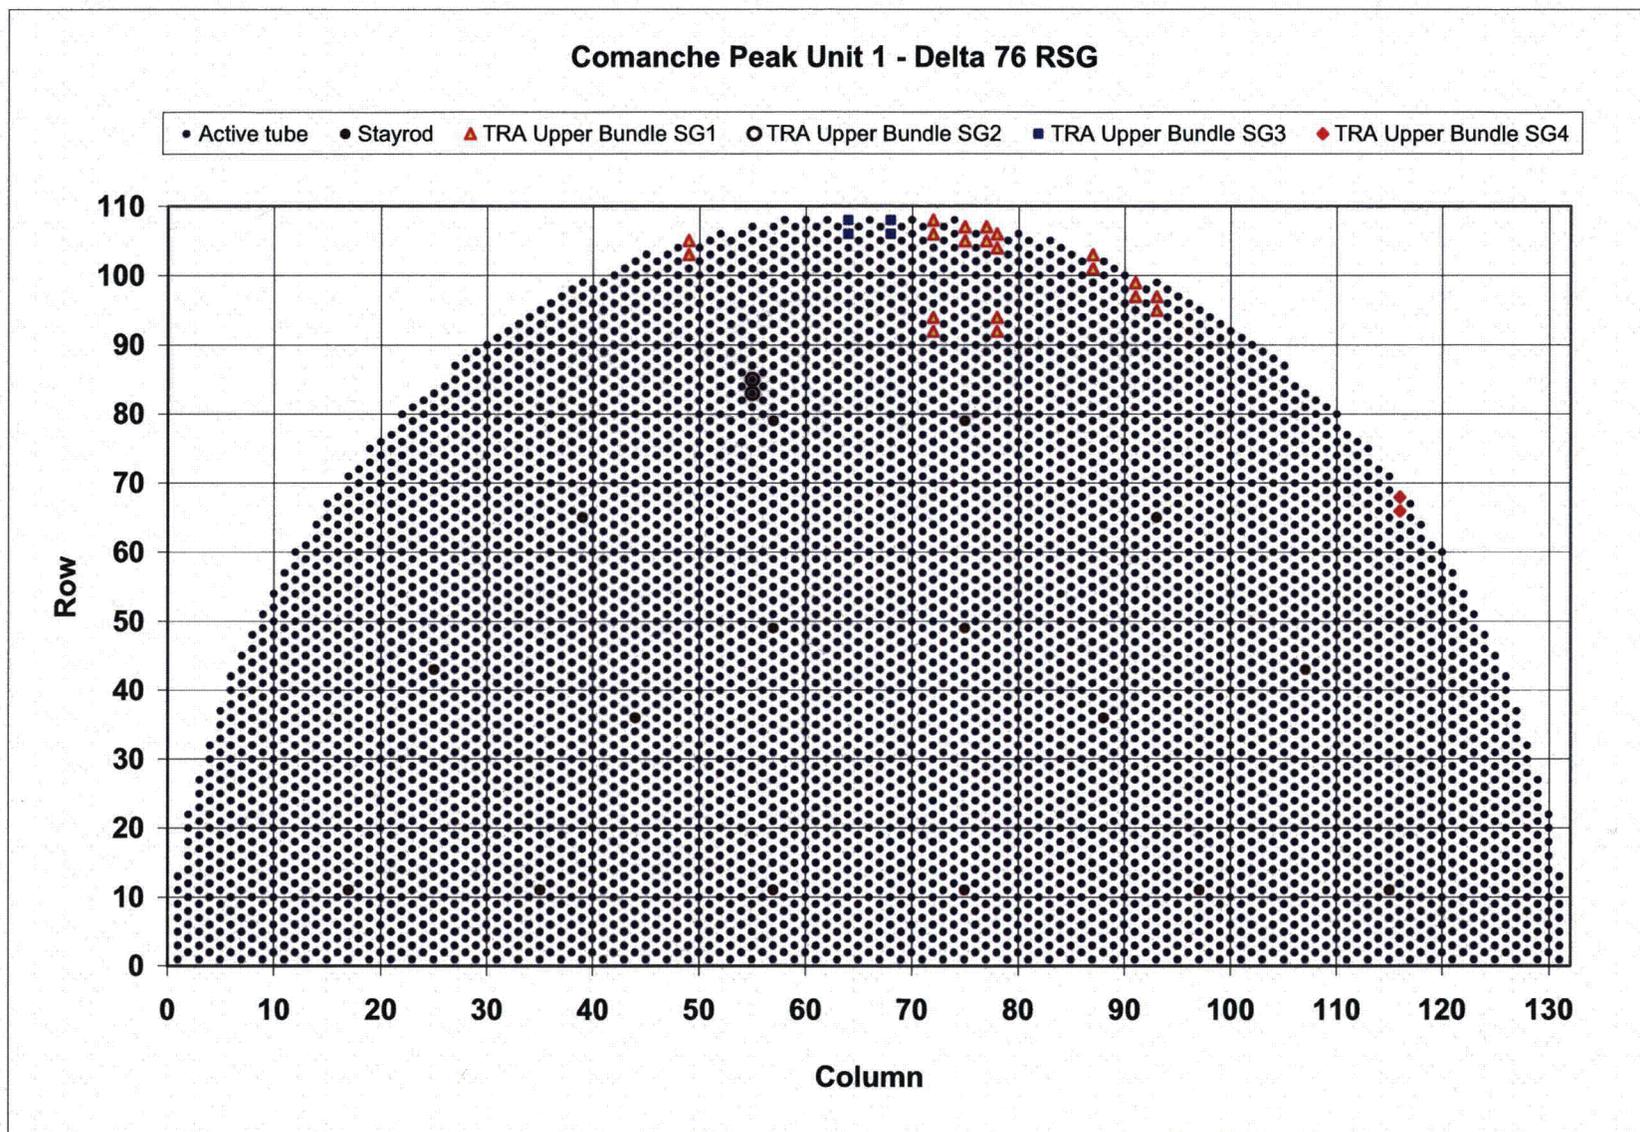
The pre-service inspection (PSI) identified a condition suggestive of reduced tube-to-tube clearance in the U-bend region. These locations were identified with a bobbin TRA code. Such indications are reported from the  $\frac{1}{4}$  prime absolute channel. None of the TRA signals at 1RF13 contained bobbin signals suggestive of degradation, i.e., tube-to-tube contact wear. All TRA signals at 1RF13 were examined using the +Pt coil; none were reported to contain volumetric degradation.

An evaluation was performed for a similar plant. This evaluation concluded that signal amplitude of 3.50 volts in the  $\frac{1}{4}$  prime absolute channel represents a contact condition. The largest TRA bobbin amplitude reported at 1RF13 was 1.87 volts in channel 6. The voltage normalization process applied at 1RF13 varied slightly from the voltage normalization used in the other program. A comparison of the normalization processes was performed and concluded that the 1RF13 amplitudes need to be increased by a factor of 1.25 to be consistent with the other data. Thus the largest TRA signal amplitude is adjusted to 2.34 volts for comparison with the 3.50 volt contact threshold. At 2.34 volts the gap is estimated at 0.026 inch. Twenty such tubes were identified in SG1; two in SG2, four in SG3, and two in SG4. Figure 1 presents a plot of the upper bundle TRA signals for all SGs.
