***Oconee Nuclear Station
Regulatory Conference***

***Unanticipated Reduction in Unit 1
RCS Inventory During Shutdown
Conditions***

***NRC Region II Office
Atlanta, Georgia
January 22, 2009***

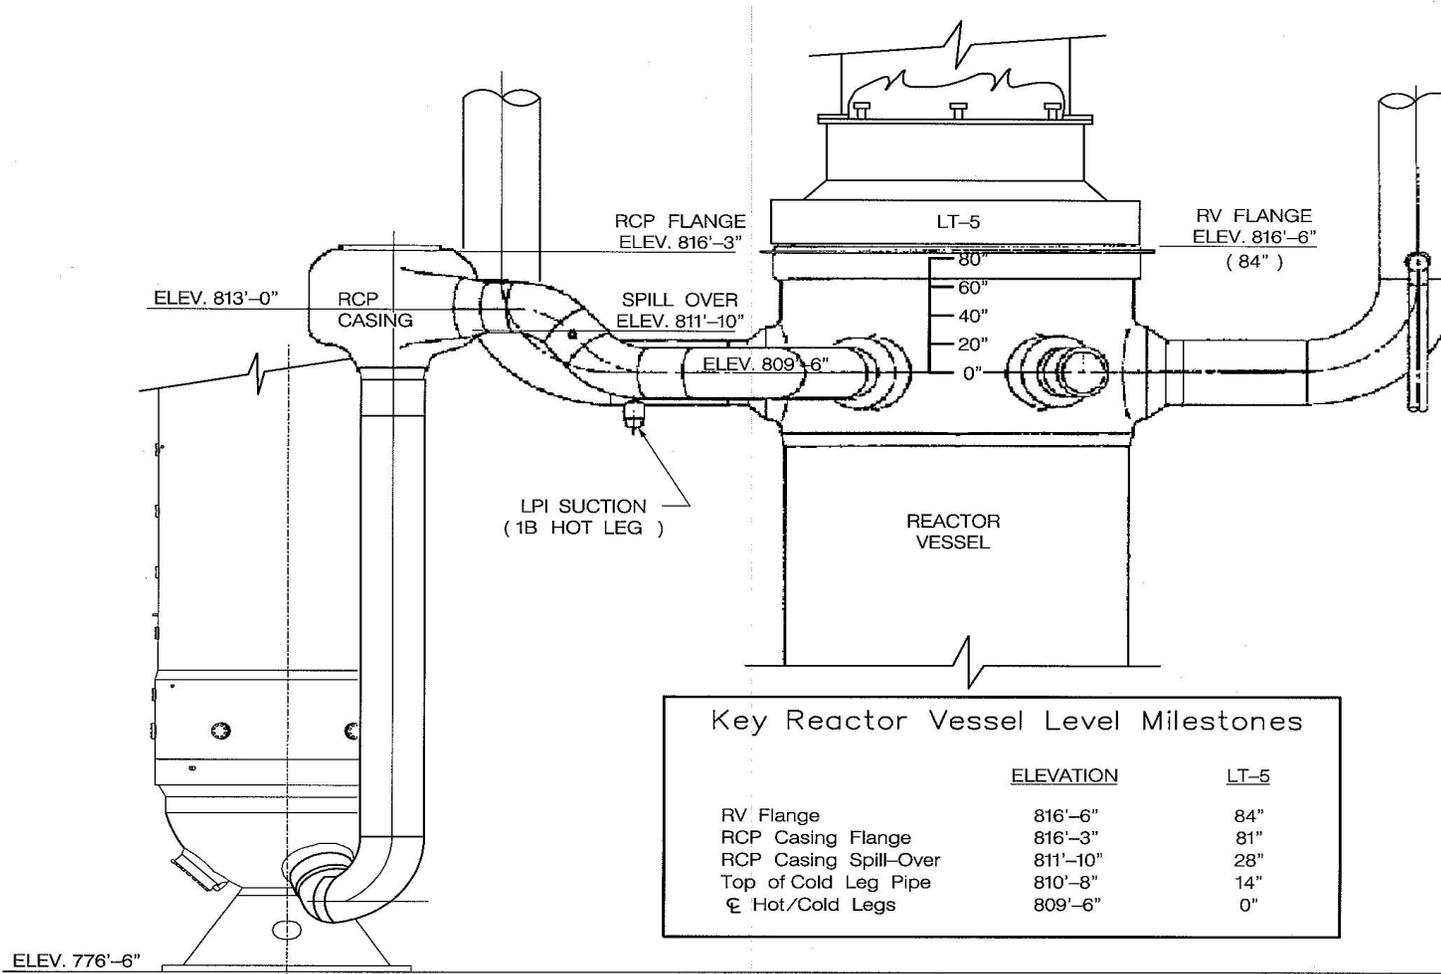
PRA Discussion

- Refer to drawing and timeline
- Time to midloop is significantly longer than assumed in the initial evaluations by Duke and NRC
- Operators have 100 minutes instead of the assumed 70 minutes
- This should be classified as “expansive” time, changing the multiplier by a factor of 10 (0.1 to 0.01)
- Considering this credit alone, revised CCDP would be 4.9E-06

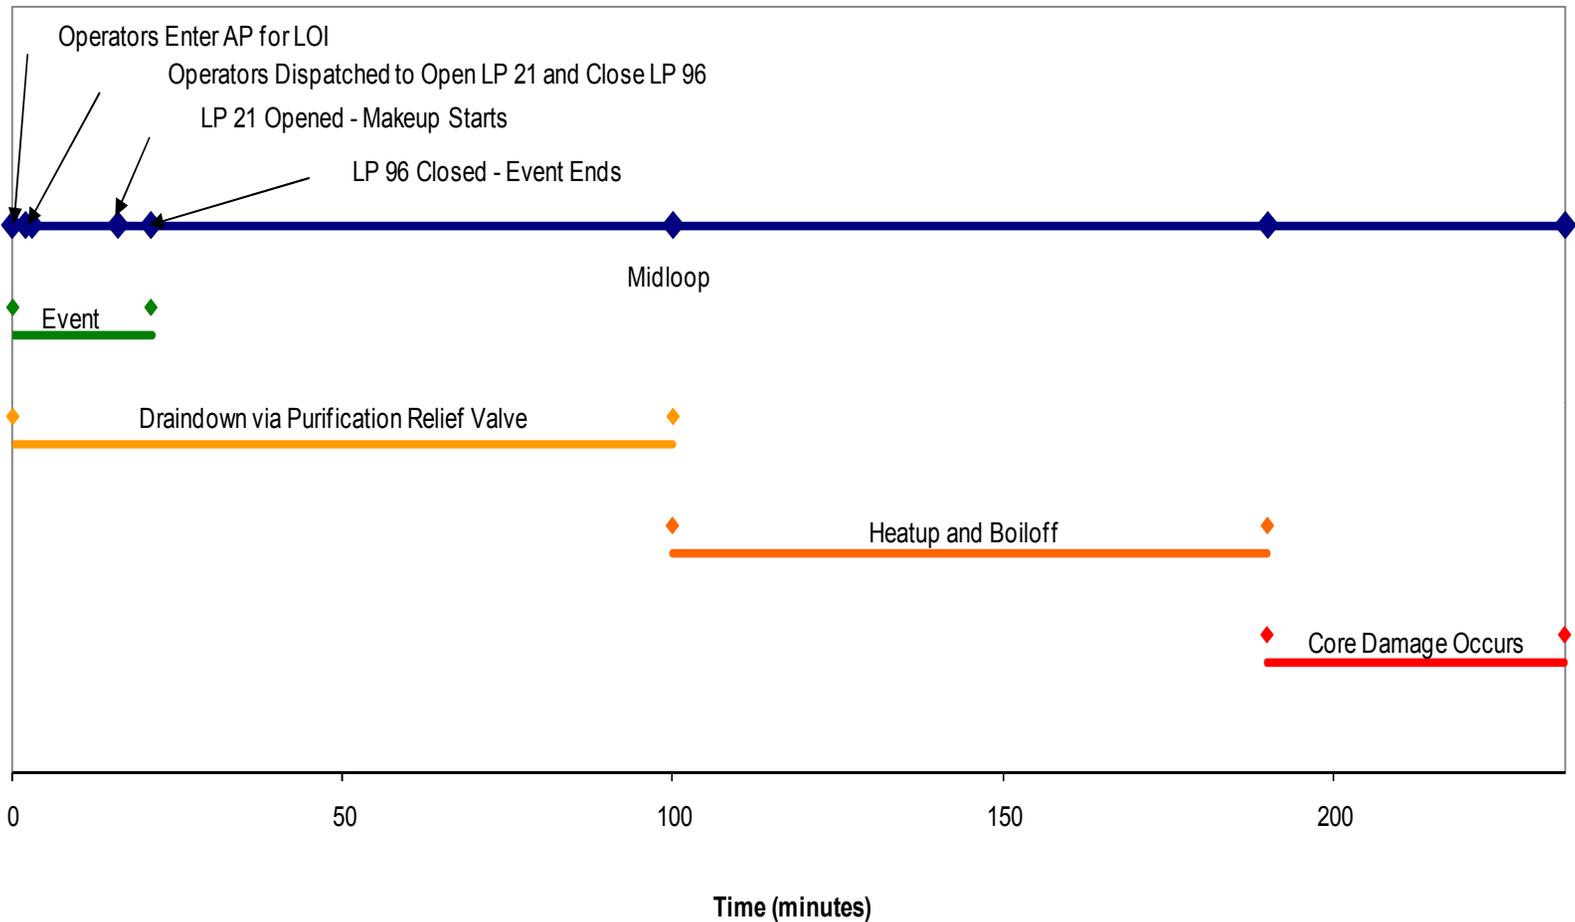
ONS LOI Event Timeline

- 1323 – Unit 1 momentary interruption of power (~ 2 seconds)
- 1324 – Operators immediately check LPI status, review activated Statalarms, silence alarms, determine RV level decreasing from computer trend
- 1325 – AP/1/A/1700/026 (Loss of DHR) entered due to decreasing RCS level
- 1326 – Operators determine normal makeup lost and dispatch NEOs to open 1LP-21 (BWST Supply to LPI)
 - Operator dispatched to close 1LP-96 (Purification Isolation)
- 1338 – RCS level at ~ 54.5” on LT-5 (lowest level observed)
 - 1LP-21 throttled open
- 1340 – RCS Level at ~ 72” on LT-5 (level restored)
- 1344 – 1LP-21 closed. 1LP-96 closed to isolate purification to stop loss of RCS inventory. Approximately 2000 gallons of RCS transferred to MWHUT

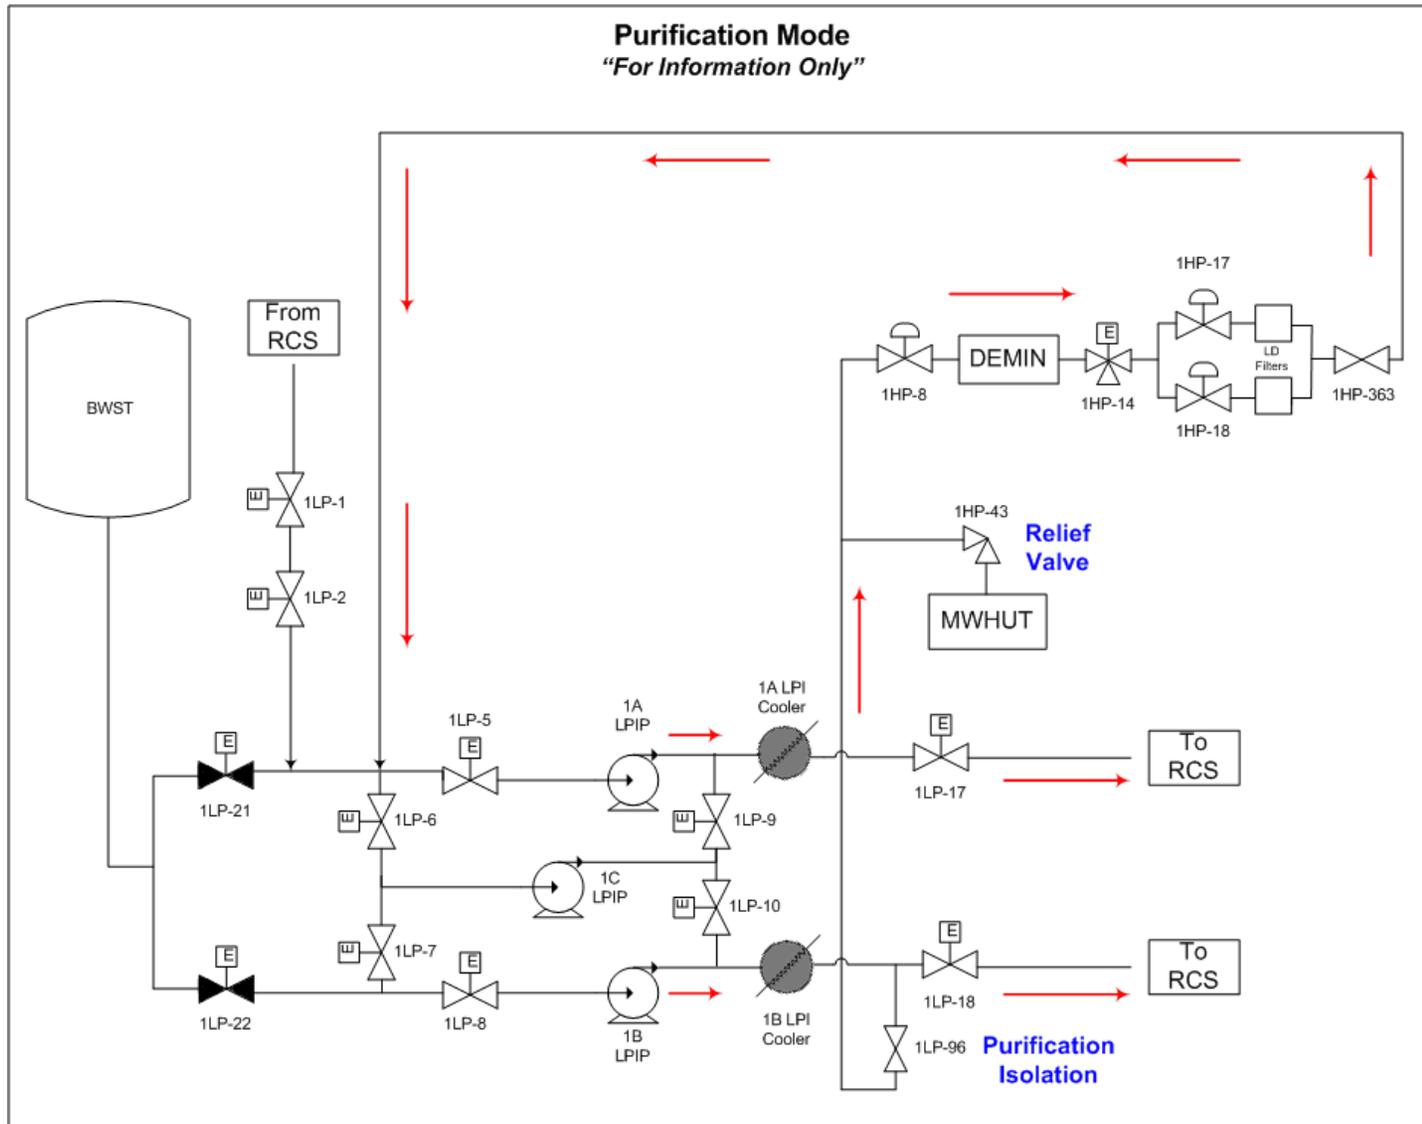
Simplified LPI Purification Diagram

- Interruption and restoration of control power to AVR actuated the K31 relay that caused Main Generator Lockout
- As designed, a slow transfer of auxiliary power to startup transformer restored Decay Heat Removal (DHR) in ~ 2 seconds
- MCC-1XP failed to re-energize as expected
- Certain Air Operated Valves on the purification loop failed closed due to loss of solenoid power from 1XP
 - Purification valves repositioning caused LPI Pump discharge pressure to lift purification relief valve
