Hairline Crack in IPEC Unit 2 Spent Fuel Pool South Wall

Revision 4, 9/15/05

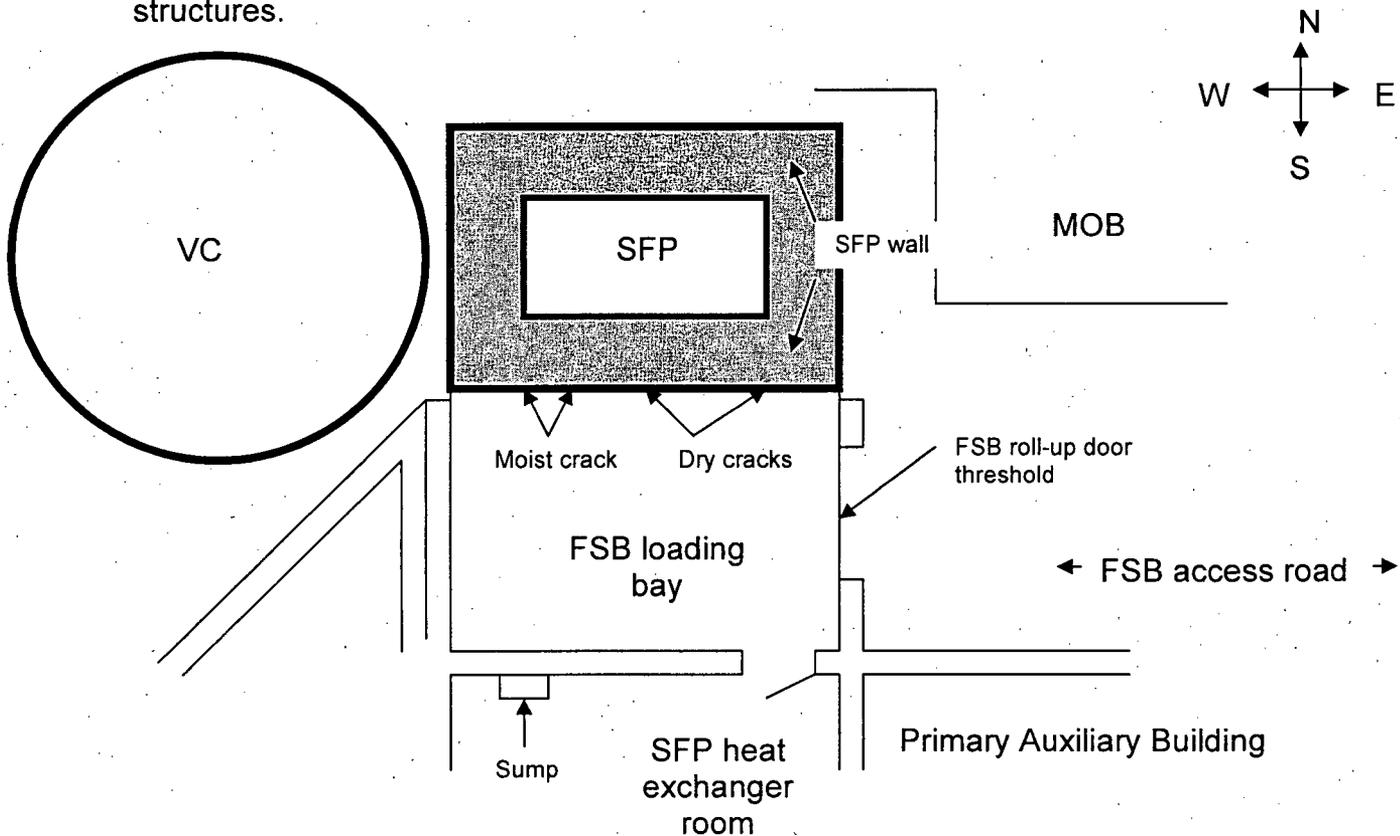
Plan View Sketch
Not to Scale

This paper discusses hairline concrete cracks, one of which is moist, discovered in the south wall of the IPEC Unit 2 Spent Fuel Pool (SFP), at an elevation of approximately 65 feet and above. The SFP is a seismically designed structure adjacent to Unit 2 Vapor Containment (VC) (to the west of the SFP), the Maintenance Outage Building (MOB) (to the north and east of the SFP), and the Fuel Storage Building (FSB) loading bay (to the south of the SFP). In order to meet seismic design requirements, the SFP is not supported by adjacent structures.

The top of the SFP base slab is at an elevation of 54 feet 7 inches. The SFP has a horizontal construction joint at elevation 75 feet, and the top of the pool wall is

at elevation of 95 feet. In addition to the above sketch, an elevation sketch and photograph of the moist crack are attached as separate documents.

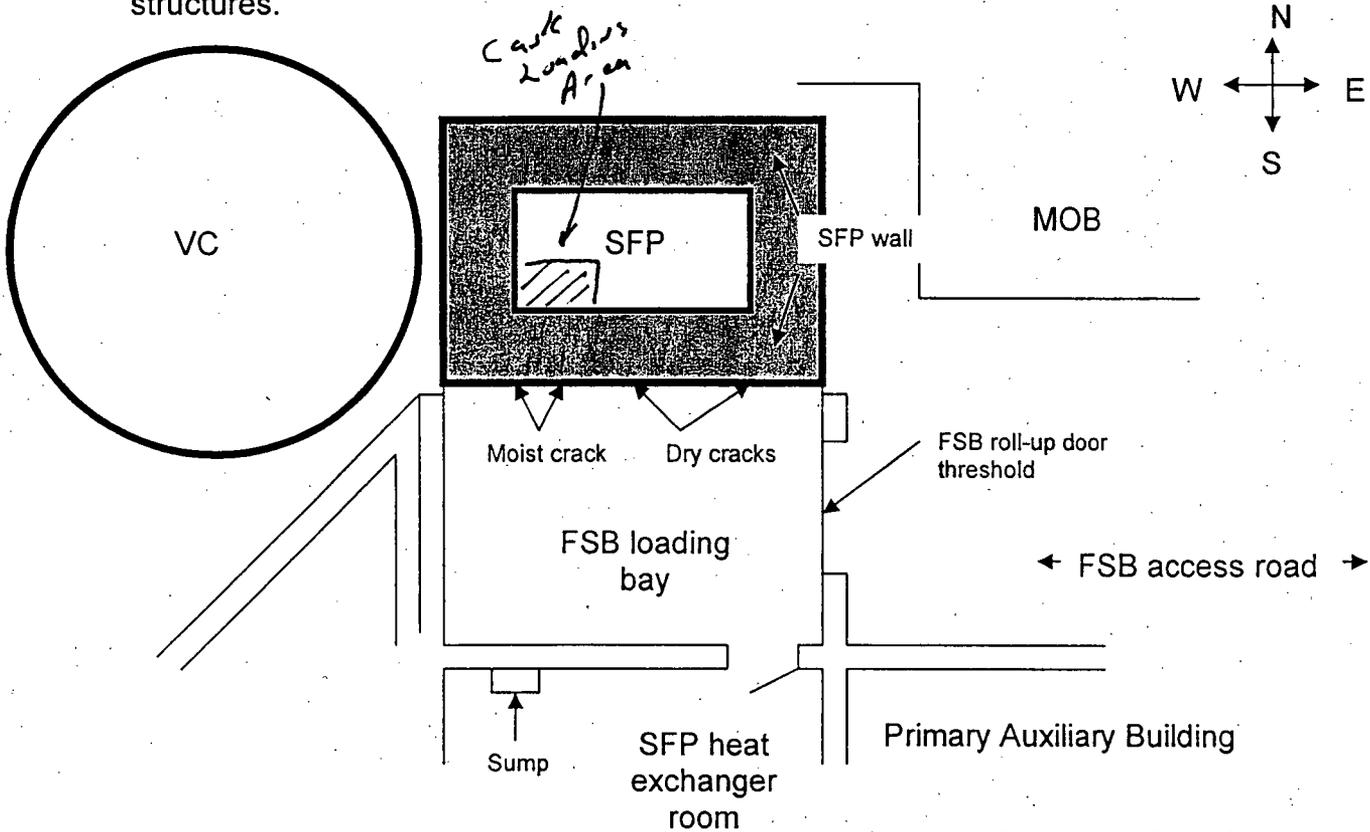
Plan View Sketch
Not to Scale

This paper discusses hairline concrete cracks, one of which is moist, discovered in the south wall of the IPEC Unit 2 Spent Fuel Pool (SFP), at an elevation of approximately 65 feet and above. The SFP is a seismically designed structure adjacent to Unit 2 Vapor Containment (VC) (to the west of the SFP), the Maintenance Outage Building (MOB) (to the north and east of the SFP), and the Fuel Storage Building (FSB) loading bay (to the south of the SFP). In order to meet seismic design requirements, the SFP is not supported by adjacent structures.

The top of the SFP base slab is at an elevation of 54 feet 7 inches. The SFP has a horizontal construction joint at elevation 75 feet, and the top of the pool wall is at elevation of 95 feet. In addition to the above sketch, an elevation sketch and photograph of the moist crack are attached as separate documents.
