Entergy Nuclear Operations, Inc.
Pilgrim Nuclear Power Station
600 Rocky Hill Road
Plymouth, MA 02360

Licensee Event Report 2008-007-00

4. TITLE
Momentary Loss of all 345kv Off-Site Power to the Startup Transformer from Switchyard Breaker Fault

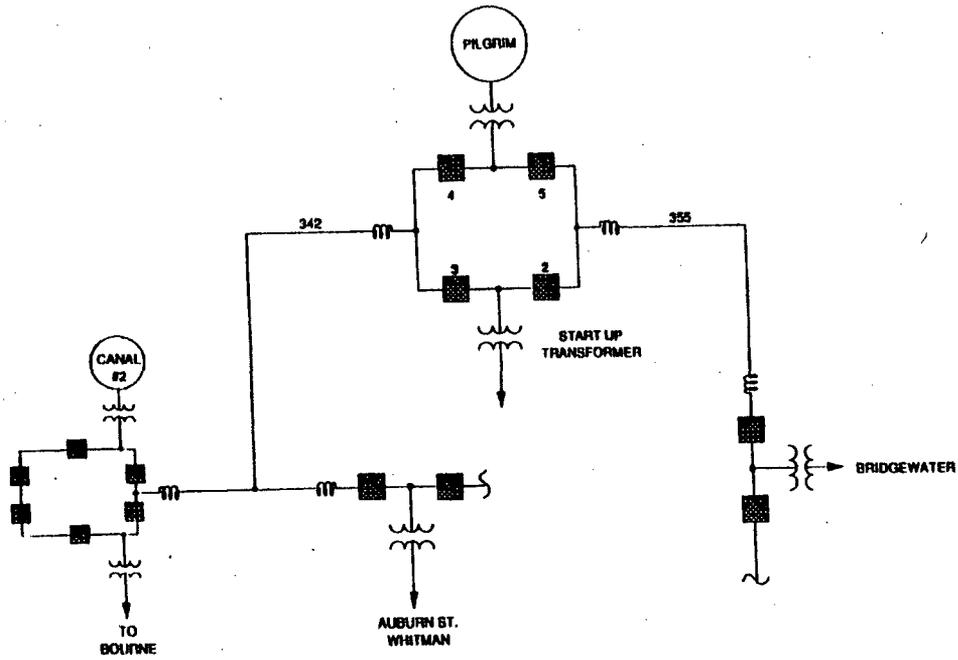
Line 355 is a two terminal line which connects Pilgrim to NGRID's Bridgewater Station and is connected to ACB-102 and ACB-105. Line 342 is a three terminal line, which connects Pilgrim to the Canal Power Plant's Switchyard in Sandwich, MA and to Auburn Street Station Switchyard in Whitman, MA. The Canal Switchyard is owned and operated by NSTAR and Auburn Street Station Switchyard is owned and operated by NGRID. Pilgrim's ACB-103 and ACB-104 connect Line 342 to the plant's switchyard. The 345kv system is the Pilgrim Station output power connection and also is the preferred off-site source via the SUT. See attached sketch for switchyard breaker arrangement. (The ACB's are identified by their last digit only).

On December 20, 2008 at 1045 hours, a flashover of a phase B arc horn on the Line 355 bus section occurred due to accumulated snow falling from the overhead bus and bridging the gap to the arc horn. (This is the Direct Cause of this event.) In response to this, ACB-102 opened per design, but ACB-103 opened in response to a transfer trip signal from the Auburn Street Station, which is associated with Line 342. Since the fault was not on Line 342, Auburn Street Station should not have sent this transfer trip signal. The tripping of the ACB-102 and ACB-103 resulted in a loss of the SUT supply and transferring of Pilgrim's safety busses to the EDGs. Subsequently, Lines 342 and 355 re-energized, ACB-102 and ACB-103 auto reclosed, and remained closed per design.

The root cause of this event was an inadequate DGOR setting on the Auburn Street Station Line 342. This relay initiated a Line 342 transfer trip signal to open ACB-103 which resulted in the momentary loss of the SUT. The initiating event was a flashover of a Phase B arc horn on the Line 355 bus section due to accumulated snow falling from the overhead bus and bridging the gap to the arc horn, causing ACB-102 to trip per design; ACB-103 opened shortly after in response to a transfer trip signal from the Auburn Street Station. The tripping of the ACB-102 and ACB-103 resulted in a loss of the SUT supply and transferring of Pilgrim's safety busses to the EDGs.

Additional corrective action taken by the Auburn Street Station facility owner was to reset the DGOR based on the actual fault current seen at Auburn Street Station during the December 20, 2009 disturbance plus margin. The Auburn Street Station facility owner also validated the calibration of the Digital Fault Recorder, which was reported to be accurate.
