## ENGINEERING DESIGN FILE (EDF)

EDF Number: 338884-EDF-011

Project: PEC COLA

**Title:** Geomatrix Field Documentation.

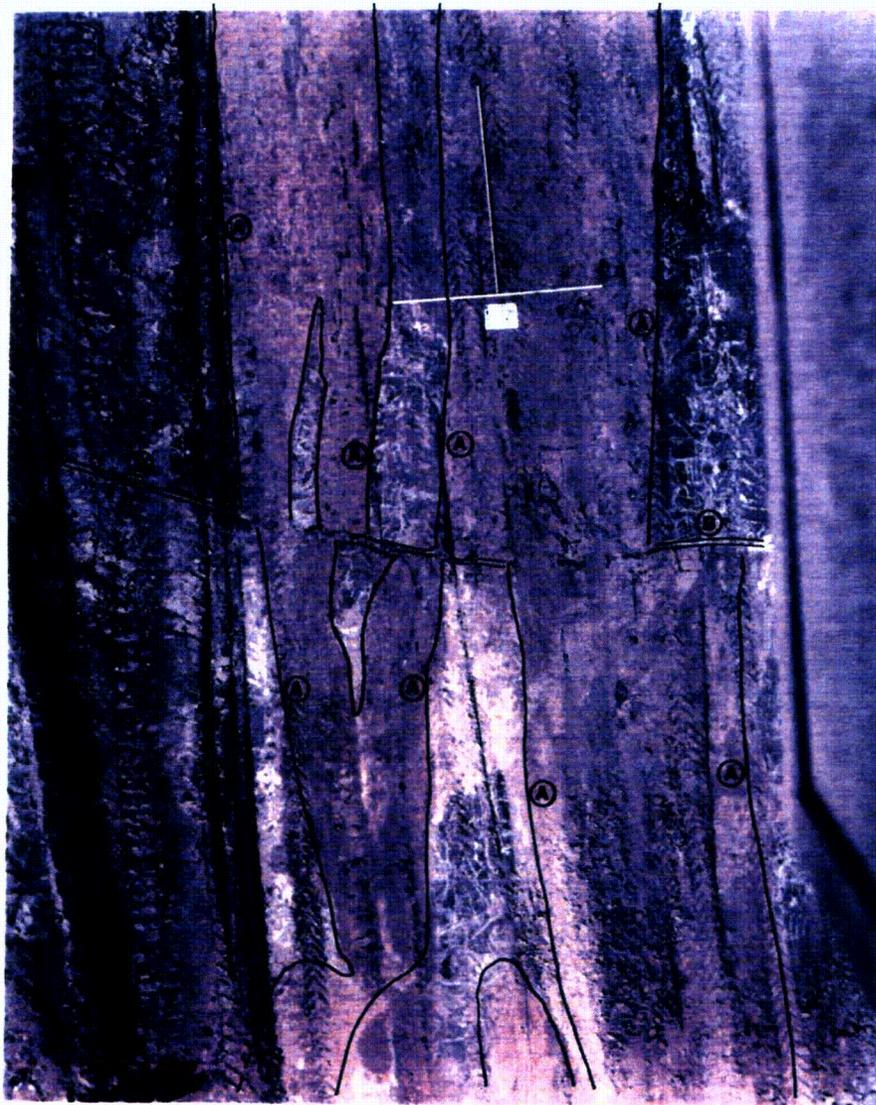
Photograph of Ebasco (1975)  
Harris Fault Excavation Along East Dike 2  
RAI 2.5.1-25 FIGURE 1

View north along East Dike 2 at intersection with the fault at elevation 2.2 feet below beginning elevation 247. Line segments (A) represent limits of segments of diabase. Line segments (B) represent shearing along the trace of the fault. Note that the horizontal component of displacement is greatest in the eastern diabase segment and least in the western segment. This is consistent in photos taken at greater depth and forms part of the basis for our interpretation that the dikes were intruded during movement on the fault, since the westernmost diabase segment is paleomagnetically the youngest.

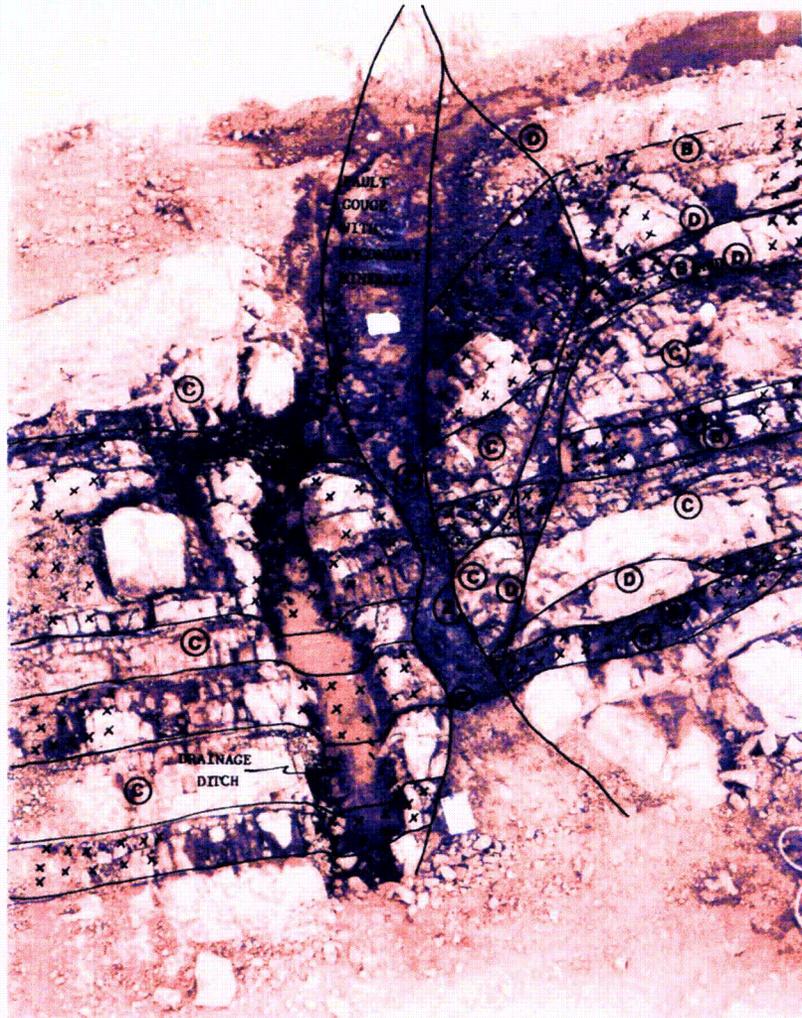
View eastward along fault at the intersection with East Dike 2 at reference elevation 210. The primary trace of the fault is enclosed between the line segments outside of the small areas identified as "Z". The "Z" locations are those from which zeolite mineral samples were taken from the fault gouge. Line segments (B) represent the limits of the three diabase segments making up this composite dike. Areas around the letter (C) are hornfels. Line segments (D) represent secondary fractures associated with the commonly observed drag folding in material immediately south of the fault. This view represents the deepest excavation at the fault intersection with East Dike 2. Samples of coal and pyrite were taken in the fault gouge at the extreme top of the photo. Barite was sampled at approximate elevation 214, above the level of this photo at approximately the location of the sheet and arrow in the upper center of this photo. Paleomagnetic dating indicates that the thinner diabase segment nearest the viewer in the lower part of the photo is the youngest and that the other two are of about the same age and are older. Photo (H) following is another view at this location.
