Event # 44896

PART 21 NOTIFICATION - DEFECTIVE HK AND K-LINE CIRCUIT BREAKER TENSION SPRINGS

Subject: 10 C.F.R. Part 21 Notification of Deviation re. P/N 716359A00 Tension Springs

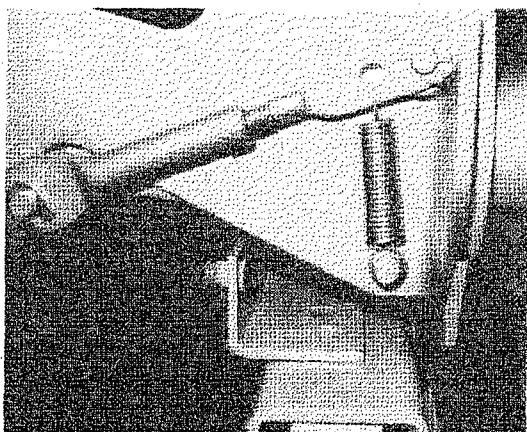
HK Racking Mechanism Latch

The identification of the Subject component is as follows: ABB P/N 716359A00 Tension Spring. These springs are used in both HK (Medium Voltage) and K-Line (Low Voltage) circuit breakers. In the HK breaker, the spring is used on the racking mechanism to position the racking mechanism interlock latch. In the K-Line circuit breaker, the spring resets the prop latch mechanism following a circuit breaker trip. See photos below:

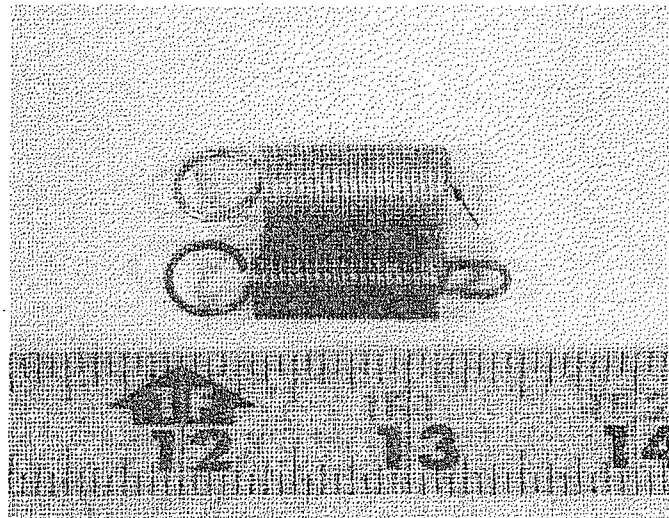
Metallurgical analysis of a failed spring concluded that the failure originated in pre-existing cracks in the bend area at the base of the fully formed round hook. Subsequent investigation at the vendor site determined that a production run in April 2008 was manufactured using a different method than prior production runs, in that the fully formed round end of the spring was made using a manual press instead of an automatic hydraulic/pneumatic press. The manual press forming cycle was significantly faster, in that the loop was formed in approximately one second, versus six seconds for the automatic press. Additionally, the manual forming operation was done after tempering and stress-relieving the spring, while the automatic forming occurred prior to tempering and stress relief.

An additional issue was identified during the investigation in that the opposite end rectangular hook had tool marks from the forming operation that could result in premature spring failure. One spring failed after 6000 cycles in the concave bend area at this end. See photo below:

- c. Worked with our vendor, Ace Wire, to determine how future incidents can be prevented and developed quality assurance means to minimize the possibility of a recurrence. As of March 9, 2009, tooling has been polished to minimize tooling marks, and the fully formed hook will be made using the automatic forming machine on future orders.
