BWVRVIP-1 38NP, Revision 1: BWR Vessel and Internals Project

Updated Jet Pump Beam Inspection and Flaw Evaluation Guidelines

1016574NP

Final Report, January 2009

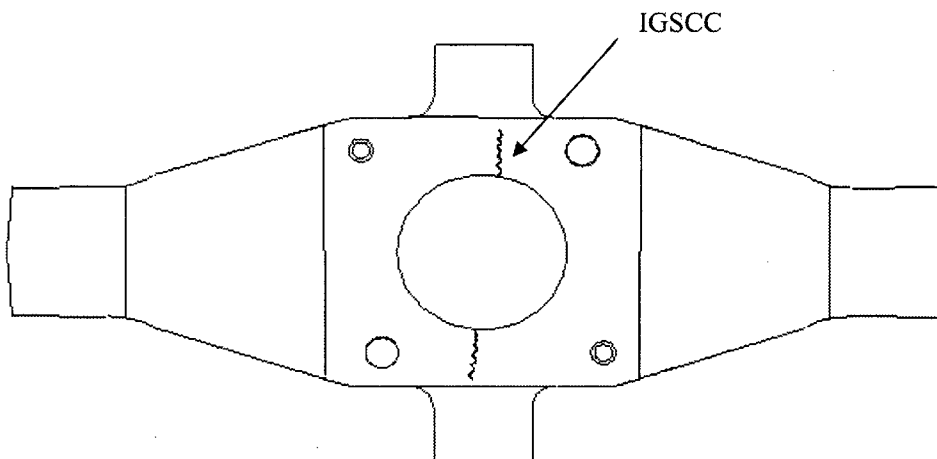
The first two jet pump beam failures occurred in 1979 and 1980 [1, 5]. Both occurred at GE BWR/3s (which had the longest operating time) and resulted in partial ejections of the inlet mixers. The beams were of the BWR/3 design and in the equalized and aged (EQA) condition. Intergranular stress corrosion cracking (IGSCC) was determined to be the failure mechanism. Subsequent inspections at other plants revealed crack indications in additional jet pump beams. The observed IGSCC cracks initiated in the thread region and then propagated across the beam, basically following the high stress trajectory (perpendicular to the beam axis). The cracking occurred on both sides of the beam bolt hole. Figure 3-1 schematically depicts the cracking orientation found in one beam. Other observations have shown that at least one of the two cracks propagated perpendicular to the centerline of the beam for its entire path. The other crack at least started from the thread with an initial path, also perpendicular.

Figure 3-1
Schematic of the Typical Cracking in a BWR/3 Jet Pump Beam at the Bolt Hole Region.
Cracking was Detected with UT and Confirmed Metallographically

In June 1980, GE issued the SIL No. 330 which established recommendations for utility actions including ultrasonic examinations (UT) during the next scheduled refueling outages, replacement of beams with detected indications and jet pump performance monitoring to avoid ejections without warning.

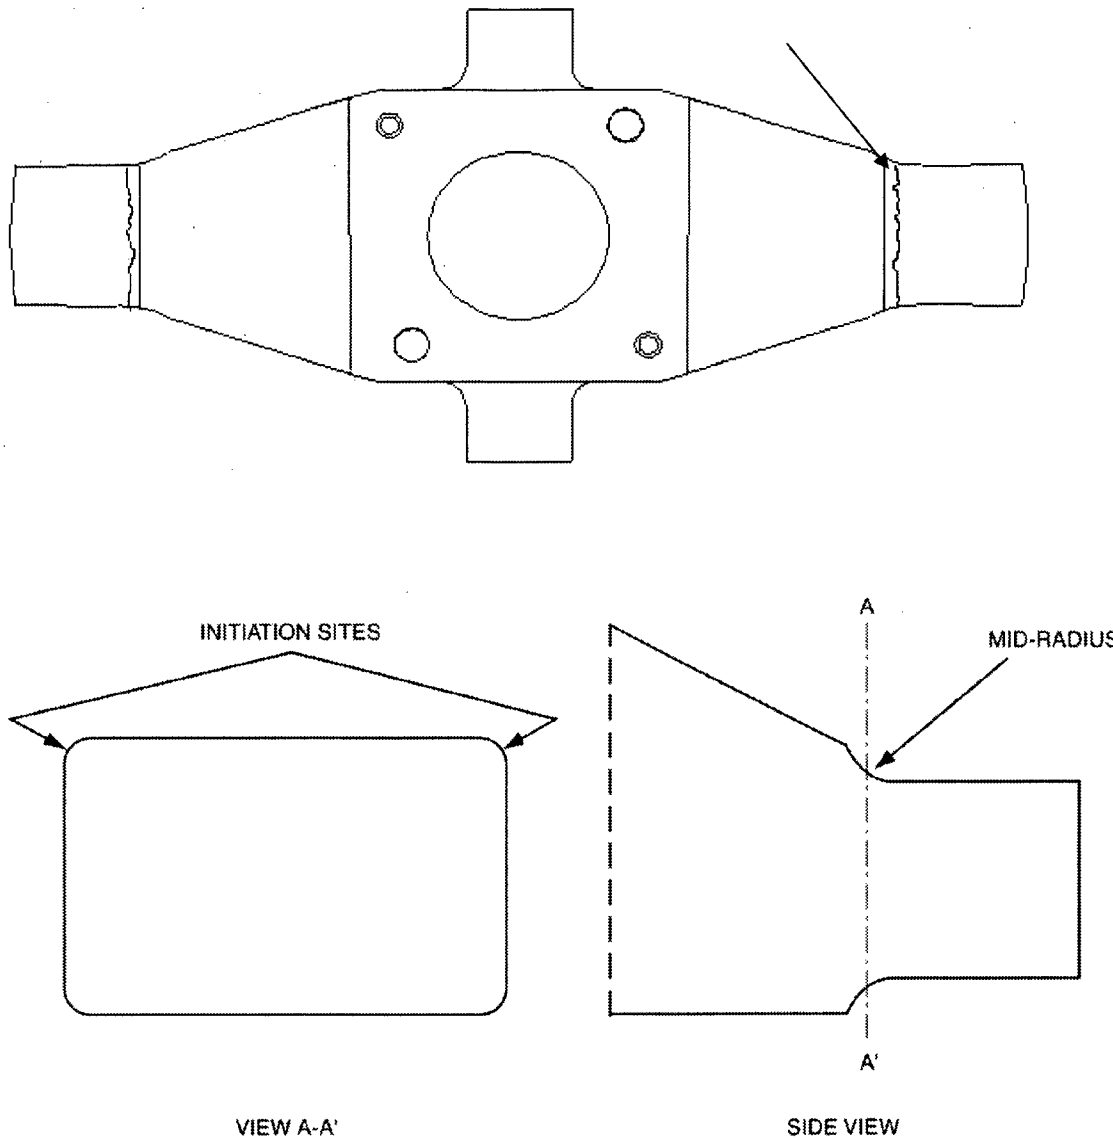
The second region of cracking was associated with the loss of a jet pump inlet mixer in a BWR/6 in September 1993 [5]. The reactor scrammed on high water level following initiation of the high pressure core spray (HPCS) system while the reactor was operating normally near rated power and core flow. An investigation subsequent to restarting the plant revealed that a jet pump failure caused a disturbance in a vessel level sensing line that taps into the vessel near the failed jet pump, initiating the HPCS system. The event was verified by further flow testing and confirmed by in-vessel inspection following reactor shutdown. The inspection confirmed that the beam failure was responsible for the event. The beam was of the Group 1 design, again being in the EQA heat treat condition. Subsequent metallurgical analysis established that the cracking mechanism was IGSCC, consistent with the past failures. Cracking was found to have been present in both transition regions with the second (non-failed) crack being ~50% through the section.

The location of cracking in these two failed beams was situated in the radius region. Figure 3-2 displays the schematic of the first failed beam. The documentation showed that the initiation locations were approximately mid-radius. Initiation also was associated with the edges of the beam.

Figure 3-2
Schematic of the Typical Cracking in a BWR Jet Pump Beam at the Transition Region.
The Initiation Location was Determined to be in the Radius Region

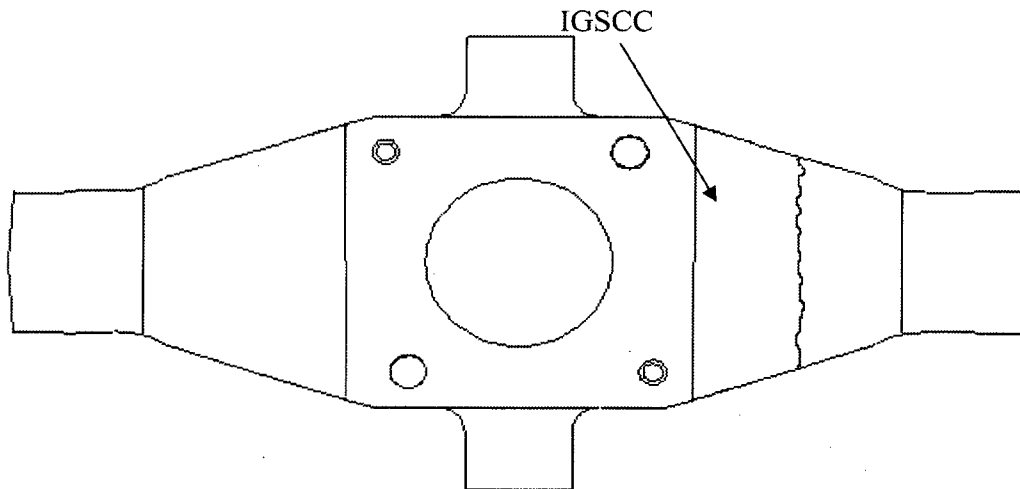
Figure 3-3
Schematic of the Typical Cracking in a BWR Jet Pump Beam at the Tapered Region.
The Initiation Location was Determined to be in the Radius Region

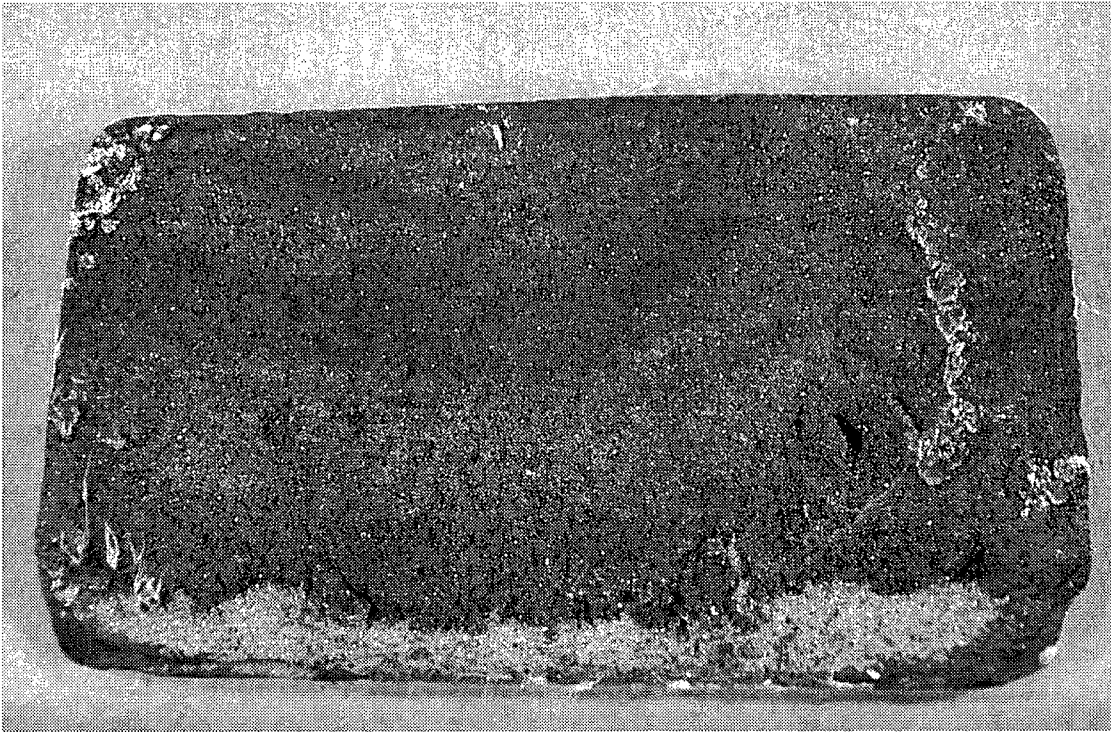
In January 2002, a new jet pump beam failure occurred at Quad Cities Unit 1, a GE BWR/3 in a beam region that has not previously experienced cracking and that is not normally inspected [6]. The plant was operating at full power when a jet pump flow anomaly was observed. The

Figure 3-4
Cross-Section of the Broken Jet Pump Beam from the Quad Cities Unit 1 Plant.
The Surface Shows Different Discoloration Consistent with the Slow Crack Growth Rates. The Light Section at the Bottom is the Final Fracture Region

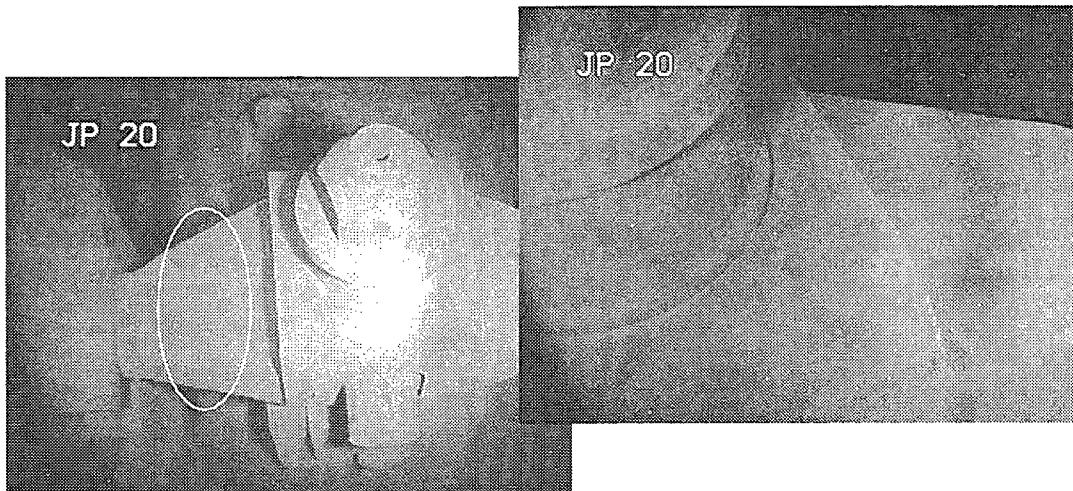
Figure 3-5
Enhanced Visual Inspection Photographs from 1998 Inspection. The Existence of Cracking on Both the Top and Side Surface is Apparent

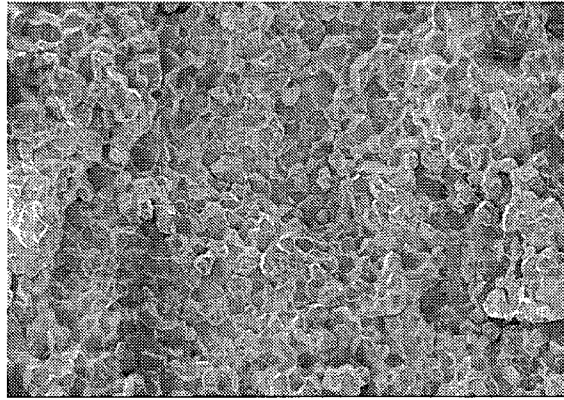
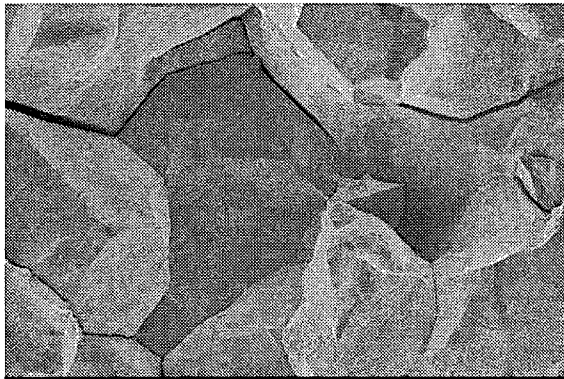
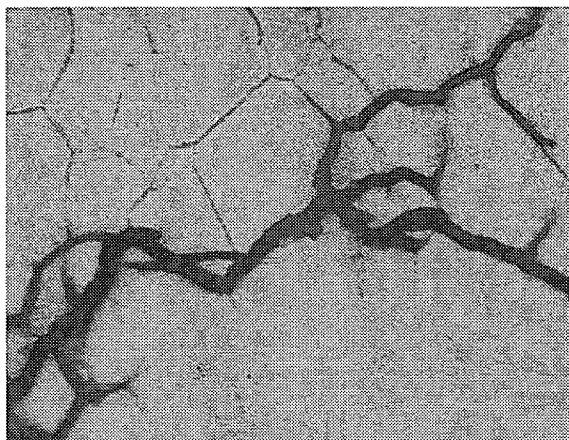
A detailed laboratory evaluation of the failed beam was conducted [7]. The visual observations as well as the metallographic examination established the cracking to be IGSCC. Based on detailed evaluation of the fracture surface (Figure 3-4), the pattern of cracking supported slow crack growth up to a depth of approximately 0.4 inch (10 mm) followed by more rapid crack propagation until a point was reached where final ductile rupture of the remaining ~10% of the beam occurred. Metallographic evaluation confirmed that the cracking mode was IGSCC. Figure 3-6 displays fracture surface at different magnifications. An assessment of the material properties confirmed that the forging material met the specifications. The evaluation did not establish a specific initiation location. However, it did establish that the surface had been ground, which occurred during initial fabrication per the fabrication drawing.

Figure 3-6
(a) Jet Pump Beam IGSCC Failure at Low Magnification, (b) IGSCC at Higher Magnification
and (c) Metallographic Confirmation of IGSCC Cracking Mode

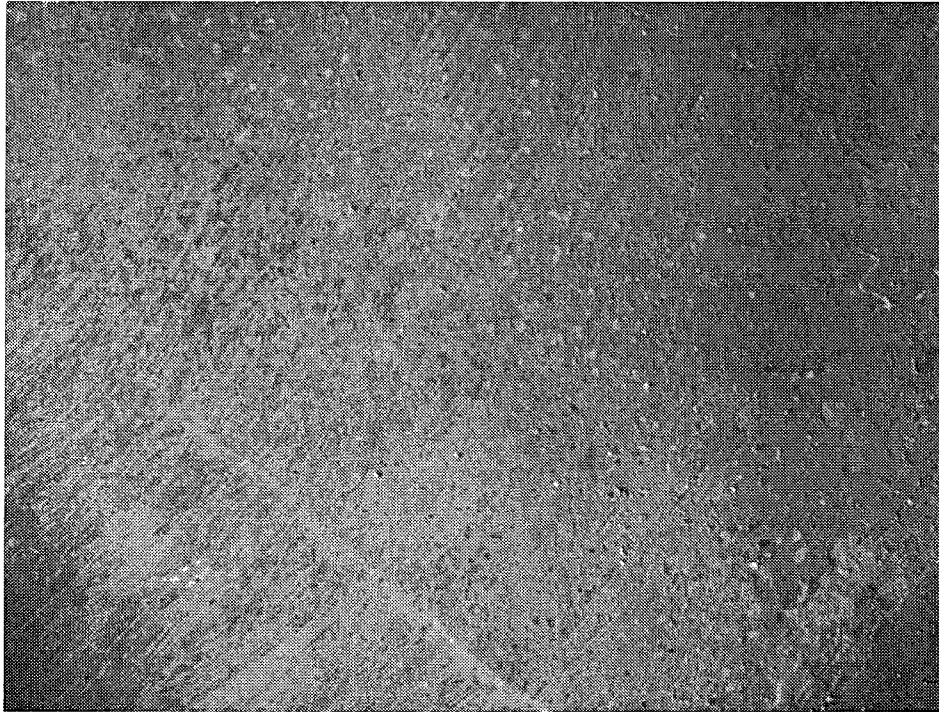
Figure 3-7
Ground Surface Condition Evaluated on BWR/3 Beam Removed from Quad Cities
Unit 1 Beam. Typical of all Removed Beams

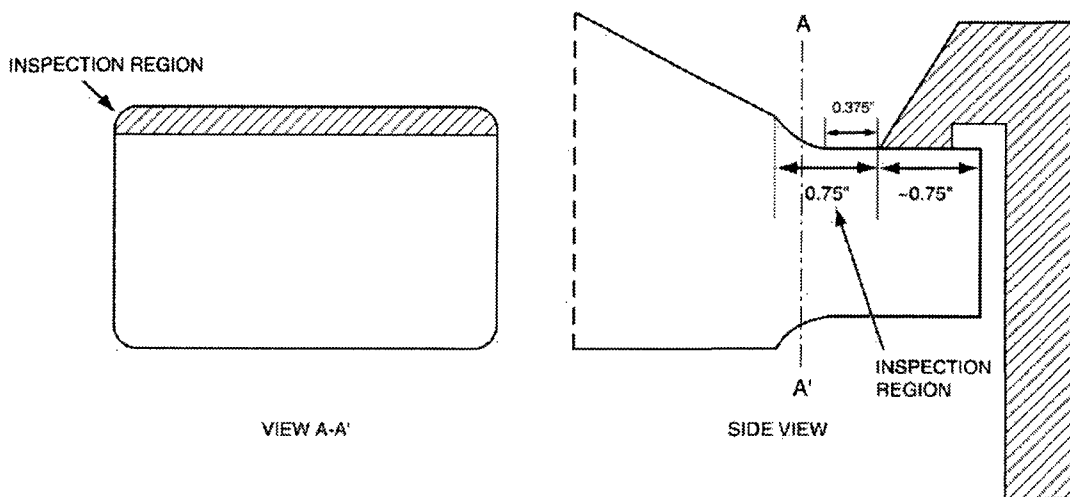
Figure 4-1
Inspection Regions for BB-2

The transition (or ear) regions of the beam extend approximately 1.50" (38 mm) in from the ends. The top surface of the ends make contact with holddown arms that are attached to the inlet riser pipe which in turn is attached to the reactor vessel wall. The contact area between the holddown arms and the beam can be up to 0.75" (19 mm) from the beam end. Since this area is under compressive load, it is not necessary to inspect the surface or volume directly under the contact area. It is however, necessary to consider inspecting from the end of the contact area at approximately ~0.75" (19 mm) from the end, to the transition into the tapered region which starts to occur at about 1.50" (38 mm) from the end. The examination region is along the length of the beam from the end of arm contact (~0.75", 19 mm) to the beginning of the tapered section (~1.50", 38 mm) on both beam ends; see Figure 4-1. Corners are typically stress-risers and would most likely be the originating point of IGSCC. In consideration of this issue, it would be desirable for the examination to extend around the corners and along the sides of this region. Since initiation and growth of cracks is stress dependent, cracks initiating at a corner would inevitably grow at a greater rate on the top surface than along the sides.

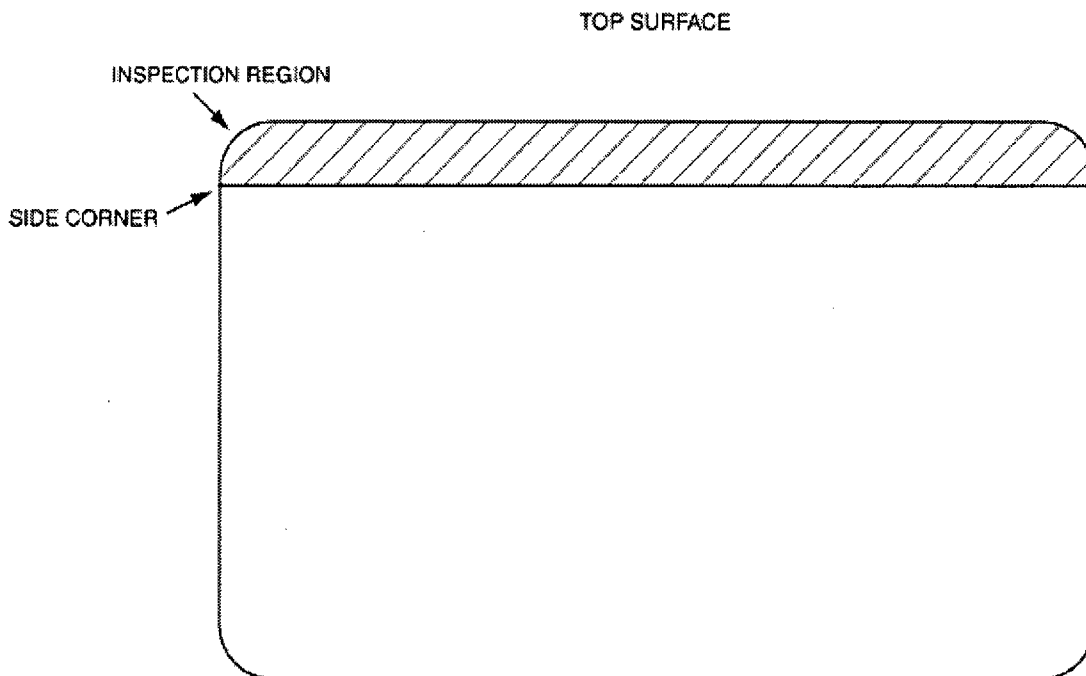
Figure 4-2
Inspection Regions for BB-3 Showing Cross Section with Corner Regions of Interest

The tapered region of the beam extends from approximately 1.50" to 4.00" (38 to 100 mm) from the ends. Although this region has lower bending stress compared to the other regions, the recent failure has confirmed that this region can be vulnerable to IGSCC. The examination should cover the entire top surface extending to the side corners (See Figure 4-2). Corners are typically stress-risers and would most likely be the originating point of IGSCC. In consideration of this issue, it would be desirable for the examination to extend around the corners and along the sides of this region. Since initiation and growth of cracks is stress dependent, cracks initiating at a corner would inevitably grow at a greater rate on the top surface than along the sides.
