Event # 44896

## PART 21 NOTIFICATION - DEFECTIVE HK AND K-LINE CIRCUIT BREAKER TENSION SPRINGS

Subject: Amended Report -- 10 C.F.R. Part 21 Notification of Deviation re. P/N 716539A00 Tension Springs

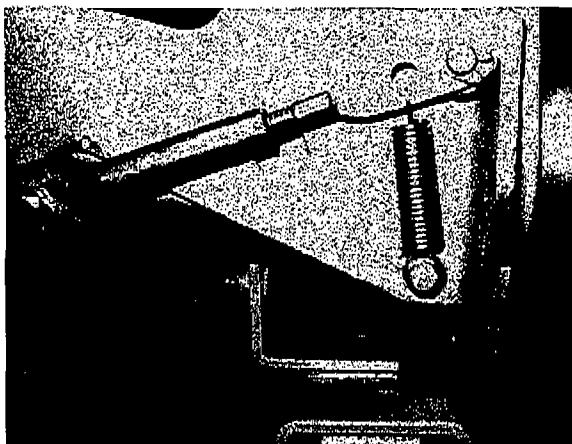
The identification of the Subject component is as follows: ABB P/N 716359A00 Tension Spring. These springs are used in both HK (Medium Voltage) and K-Line (Low Voltage) circuit breakers. In the HK breaker, the spring is used on the racking mechanism to position the racking mechanism interlock latch. In the K-Line circuit breaker, the spring resets the prop latch mechanism following a circuit breaker trip. See photos below:

HK Racking Mechanism Latch

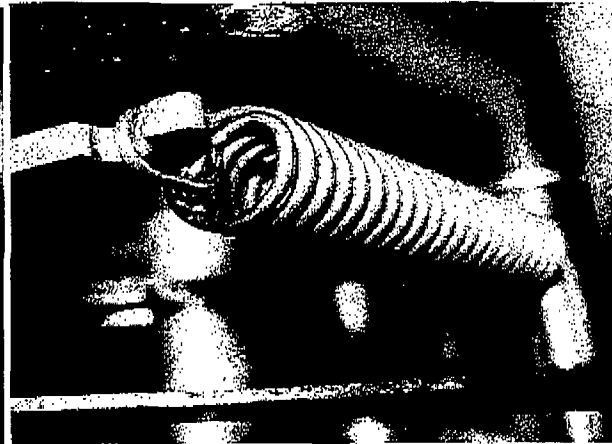
K-Line Prop Latch Reset Arm
