Canaral Information or Other (PAR)

PART 21 NOTIFICATION - DEFECTIVE HK AND K-LINE CIRCUIT BREAKER TENSION SPRINGS

Subject: Amended Report -- 10 C.F.R. Part 21 Notification of Deviation re. P/N 716539A00 Tension Springs

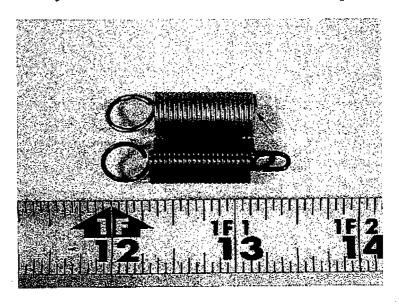
Metallurgical analysis of a failed spring concluded that the failure originated in pre-existing cracks in the bend area at the base of the fully formed round hook. Subsequent investigation at the vendor site determined that a production run in April 2008 was manufactured using a different method than prior production runs, in that the fully formed round end of the spring was made using a manual press instead of an automatic hydraulic/pneumatic press. The manual press forming cycle was significantly faster, in that the loop was formed in approximately one second, versus six seconds for the automatic press. Additionally, the manual forming operation was done after tempering and stress-relieving the spring, while the automatic forming occurred prior to tempering and stress relief.

An additional issue was identified during the investigation in that the opposite end rectangular hook had tool marks from the forming operation that could result in premature spring failure. One spring failed after 6000 cycles in the concave bend area at this end. See photo below:

- c. Worked with our vendor, Ace Wire, to determine how future incidents can be prevented and developed quality assurance means to minimize the possibility of a recurrence. As of March 9, 2009, tooling has been polished to minimize tooling marks, and the fully formed hook will be made using the automatic forming machine on future orders.

- d. A cycle test has been completed to compare springs produced before and after Ace Wire polished the hook forming tools to validate that the corrective actions are sufficient. To date, 12,000 cycles on (20) springs have been completed, with no further failures. Microscopic inspection has also been done that confirmed the tooling marks have been reduced.
