## RI - DNMS Licensee Event Report Disposition

Event Description: Cesium-137 leaked from its container.

**TO: RECORD**  
**FROM: DIRECTOR, MEDICAL PHYSICS**  
**DATE: 3 March 2009**  
**SUBJECT: LEAKING CHECK SOURCE in High Dose Rate After loader  
(HDR) Room 8 JAN 09**

Subj: Cs-137 Decontamination in HDR Room

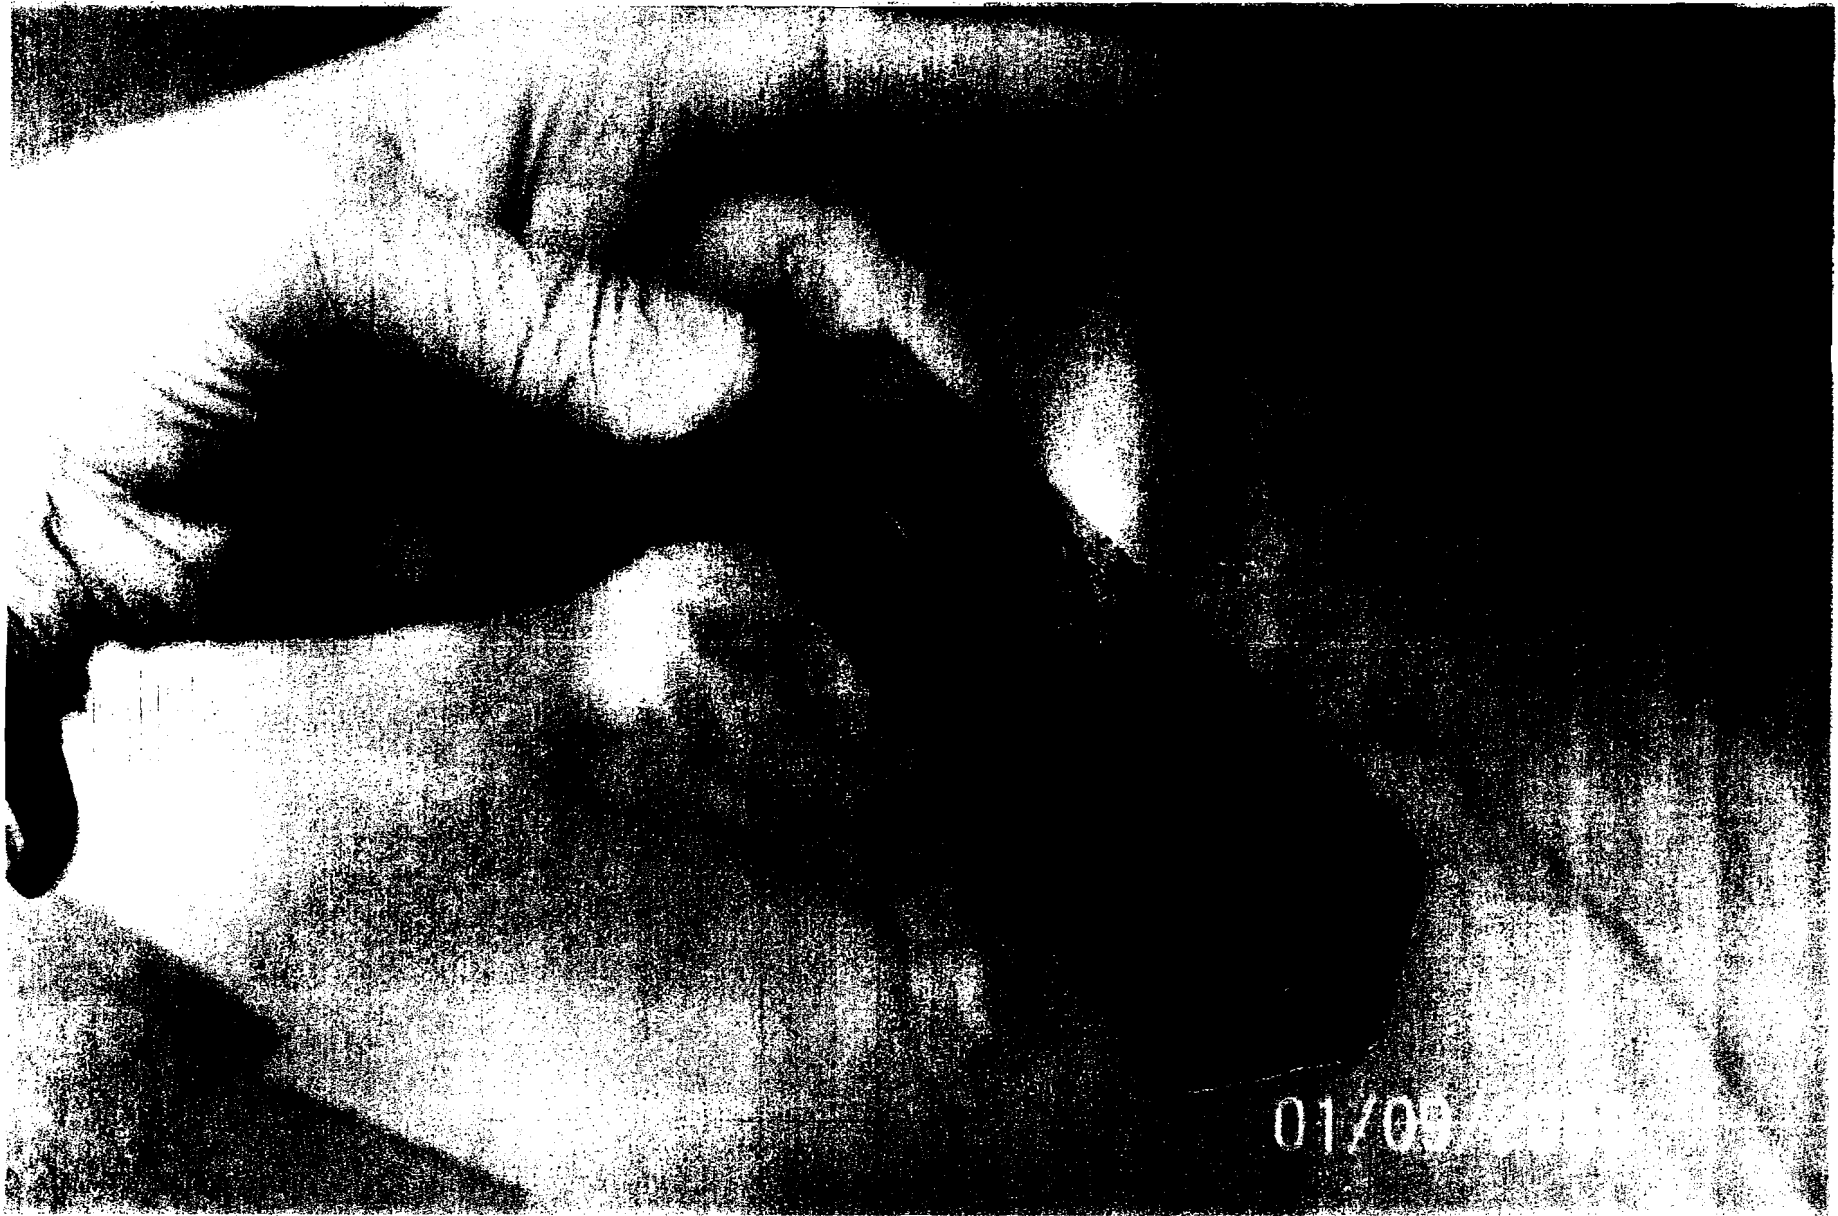
Attachment 4

- i. This was a very old source, and unlike any other in the Inova system. Current sources are imbedded in a plastic matrix that is reportedly waterproof. This check source must have been made in which the radioactive material was placed a cavity, then sealed with glue. The check source was determined to be a pocket dosimeter (ionization chamber) response source. On the check source was an identifying label stating the source was Cs-137 and 90 micro-Curies in strength, but no date of calibration. Post measurements of this source in a dose calibrator, measured 43 micro-Curies. Cesium has a half life of 30 years, so it can be assumed the source has been in the system for one half life.
- ii. After drying, HP personnel encased the source in epoxy. There is no loose surface contamination after this coating was applied.

Cs-137  
90 uCi  
unknown date  
unknown manufacturer

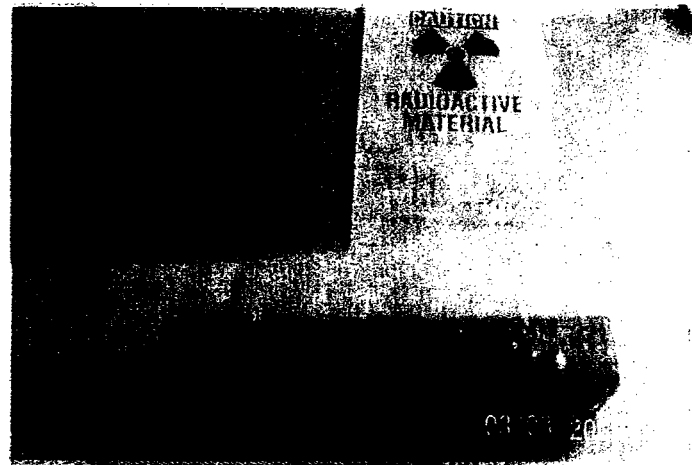
check source after epoxy coating
