Subject: 10 C.F.R. Part 21 Notification of Deviation re. P/N 716359A00 Tension Springs

The identification of the Subject component is as follows: ABB P/N 716359A00 Tension Spring. These springs are used in both HK (Medium Voltage) and K-Line (Low Voltage) circuit breakers. In the HK breaker, the spring is used on the racking mechanism to position the racking mechanism interlock latch. In the K-Line circuit breaker, the spring resets the prop latch mechanism following a circuit breaker trip. See photos below:

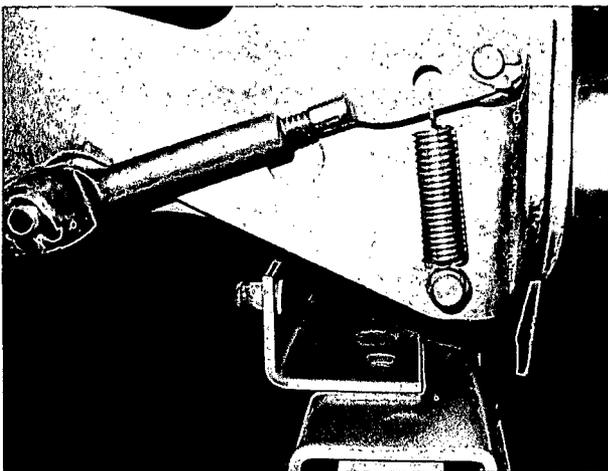
HK Racking Mechanism Latch

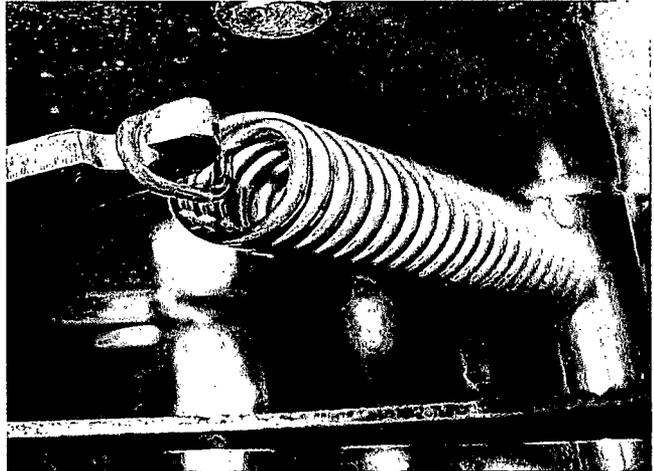
K-Line Prop Latch Reset Arm

Nature of the deviation: Micro-cracks in the base of the hooked end of the springs may result in failure of the springs after repetitive cycles. A broken spring could potentially affect the ability of a K-Line or HK breaker to reset and close after an opening operation. Initial report of the nonconformance was generated 2/11/2009 (NCR #68999JL), reporting springs failed during mechanical life testing being performed on a K-Line Breaker. Three springs failed after approximately 2800 cycles each.

Metallurgical analysis of a failed spring concluded that the failure originated in pre-existing cracks in the bend area at the base of the fully formed round hook. Subsequent investigation at the vendor site determined that a production run in April 2008 was manufactured using a different method than prior production runs, in that the fully formed round end of the spring was made using a manual press instead of an automatic hydraulic/pneumatic press. The manual press forming cycle was significantly faster, in that the loop was formed in approximately one second, versus six seconds for the automatic press. Additionally, the manual forming operation was done after tempering and stress-relieving the spring, while the automatic forming occurred prior to tempering and stress relief.

Given the large number of applications for the affected circuit breakers, ABB (Medium Voltage Service) cannot determine if the potential for a substantial safety hazard exists at any licensee's facility if a similar failure of the tension spring occurs. Licensees are requested to evaluate the history of inspections, maintenance practices, and circuit breaker operating cycles for K-Line breakers, and racking cycles for HK breakers to determine if the circuit breaker spring should be replaced immediately or at the next convenient maintenance opportunity. ABB recommends that any suspect spring with greater than 1400 operating cycles be replaced as soon as possible.

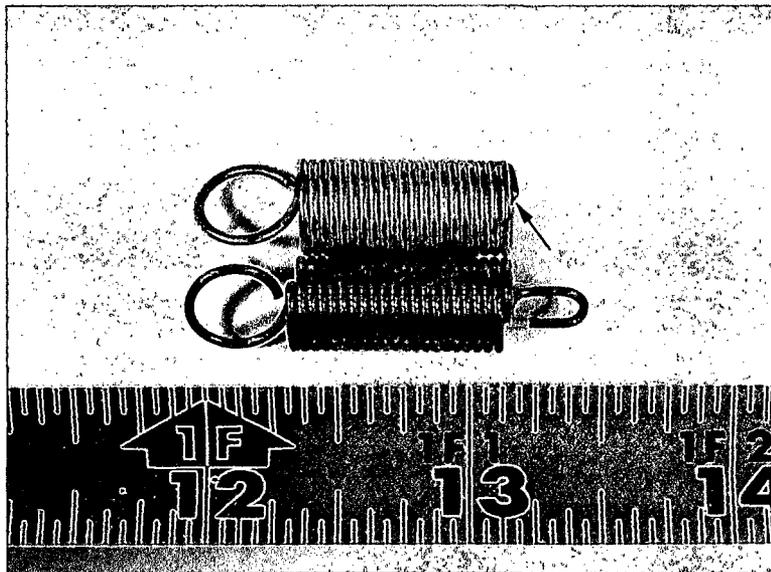
An additional issue was identified during the investigation in that the opposite end rectangular hook had tool marks from the forming operation that could result in premature spring failure. One spring failed after 6000 cycles in the concave bend area at this end. See photo below:

- c. Worked with our vendor, Ace Wire, to determine how future incidents can be prevented and developed quality assurance means to minimize the possibility of a recurrence. As of March 9, 2009, tooling has been polished to minimize tooling marks, and the fully formed hook will be made using the automatic forming machine on future orders.
