March 11, 2009

Subject: 10 C.F.R. Part 21 Notification of Deviation re. P/N 716359A00 Tension Springs

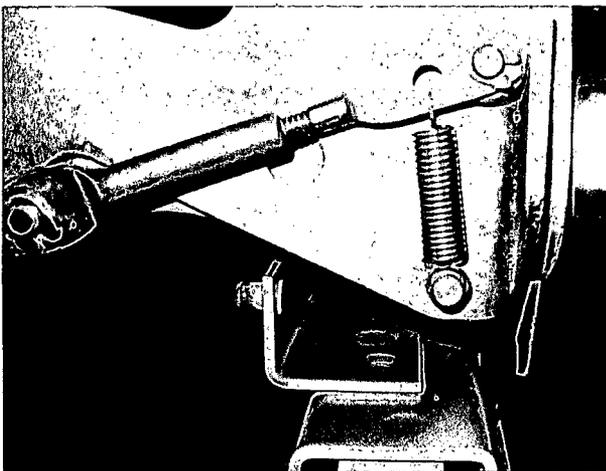
HK Racking Mechanism Latch

The identification of the Subject component is as follows: ABB P/N 716359A00 Tension Spring. These springs are used in both HK (Medium Voltage) and K-Line (Low Voltage) circuit breakers. In the HK breaker, the spring is used on the racking mechanism to position the racking mechanism interlock latch. In the K-Line circuit breaker, the spring resets the prop latch mechanism following a circuit breaker trip. See photos below:

Nature of the deviation: Micro-cracks in the base of the hooked end of the springs may result in failure of the springs after repetitive cycles. A broken spring could potentially affect the ability of a K-Line or HK breaker to reset and close after an opening operation. Initial report of the nonconformance was generated 2/11/2009 (NCR #68999JL), reporting springs failed during mechanical life testing being performed on a K-Line Breaker. Three springs failed after approximately 2800 cycles each.

Metallurgical analysis of a failed spring concluded that the failure originated in pre-existing cracks in the bend area at the base of the fully formed round hook. Subsequent investigation at the vendor site determined that a production run in April 2008 was manufactured using a different method than prior production runs, in that the fully formed round end of the spring was made using a manual press instead of an automatic hydraulic/pneumatic press. The manual press forming cycle was significantly faster, in that the loop was formed in approximately one second, versus six seconds for the automatic press. Additionally, the manual forming operation was done after tempering and stress-relieving the spring, while the automatic forming occurred prior to tempering and stress relief.

- c. Worked with our vendor, Ace Wire, to determine how future incidents can be prevented and developed quality assurance means to minimize the possibility of a recurrence. As of March 9, 2009, tooling has been polished to minimize tooling marks, and the fully formed hook will be made using the automatic forming machine on future orders.

Given the large number of applications for the affected circuit breakers, ABB (Medium Voltage Service) cannot determine if the potential for a substantial safety hazard exists at any licensee's facility if a similar failure of the tension spring occurs. Licensees are requested to evaluate the history of inspections, maintenance practices, and circuit breaker operating cycles for K-Line breakers, and racking cycles for HK breakers to determine if the circuit breaker spring should be replaced immediately or at the next convenient maintenance opportunity. ABB recommends that any suspect spring with greater than 1400 operating cycles be replaced as soon as possible.
