South Texas Project Electric Generating Station P.O. Box 289 Wadsworth, Texas 77483

South Texas Project
Unit 2
Docket No. STN 50-499
Request for Relief from ASME Boiler and Pressure Vessel Code
Section XI Requirements for the Essential Cooling Water System
(Relief Request RR-ENG-2-52)

**SOUTH TEXAS PROJECT
UNIT 2
REQUEST FOR RELIEF FROM ASME BOILER AND PRESSURE VESSEL CODE
SECTION XI REQUIREMENTS FOR THE ESSENTIAL COOLING WATER SYSTEM
(RELIEF REQUEST RR-ENG-2-52)**

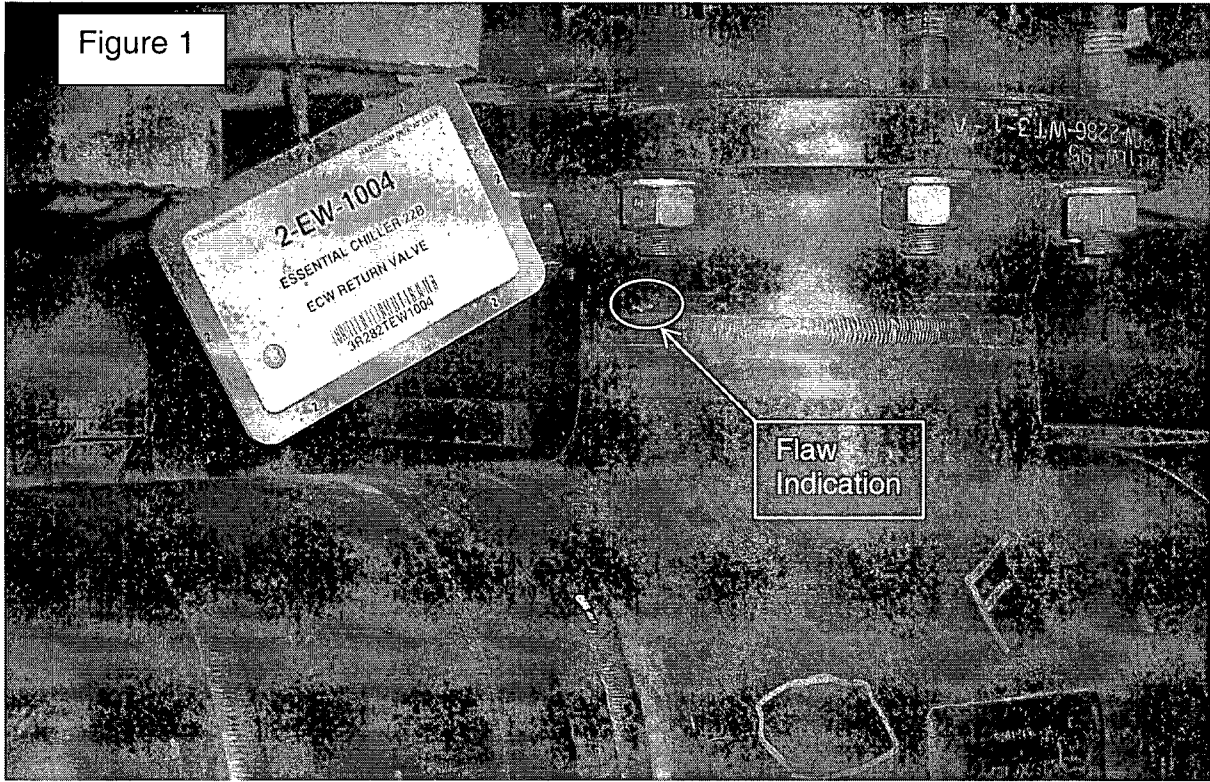
An indication of a through-wall flaw is located on the downstream flange of Essential Chiller 22B ECW return throttle valve 2-EW-1004. Leakage residue buildup in a line parallel to the circumferential weld was found at the weld on the downstream flange of the valve, with an underlying flaw of approximately 3/8-inch in length. The flaw appears to be a tight crack as leakage is not readily measurable. The attached pictures show the location (Figure 1) and the appearance (Figure 2) of the residue buildup.

Evidence of a through-wall flaw was identified on an 8-inch flange of Essential Cooling Water (ECW) return line from the essential chiller 3V112VCH005. There is a residue buildup that provides a linear indication located on the flange side of the flange-to-pipe weld. The flaw appears to be a tight crack approximately 3/8-inch long. This portion of pipe is subjected to normal operating pressure of the ECW system. The residue buildup suggests ongoing seepage through the flaw, although the leakage is not readily measurable.

The flaw is due to dealloying. The root cause of dealloying is a combination of corrosion and stress. The dealloying process normally initiates from a crevice such as the area behind a backing ring, a fabrication-induced flaw, or a casting flaw. Dealloying in this case is believed to be similar to dealloying seen in other susceptible aluminum-bronze components. The process by which dealloying of aluminum-bronze occurs has been described in previous communications with the NRC (Reference 8.1).

Repair of the defect is to be performed when adequate time is available for the repair, but no later than the next Unit 2 refueling outage. The next Unit 2 refueling outage is currently scheduled to begin in March 2010 (2RE14). Compensatory action has been implemented to detect changes in the condition of the flaw until a repair can be implemented.

Repair of the defect will be deferred until adequate time is available for the repair, but no later than the next Unit 2 refueling outage, provided the condition continues to meet the acceptance criteria of Generic Letter 90-05. The next Unit 2 refueling outage is scheduled to begin in March 2010.
