**Metallurgical Evaluations of a 'Boat' Sample from the #68 CRDM Penetration  
on Byron Unit 2**

**EXELON POWERLABS PROJECT BYR-48053**

**REPORT DATE: MAY 23, 2007**

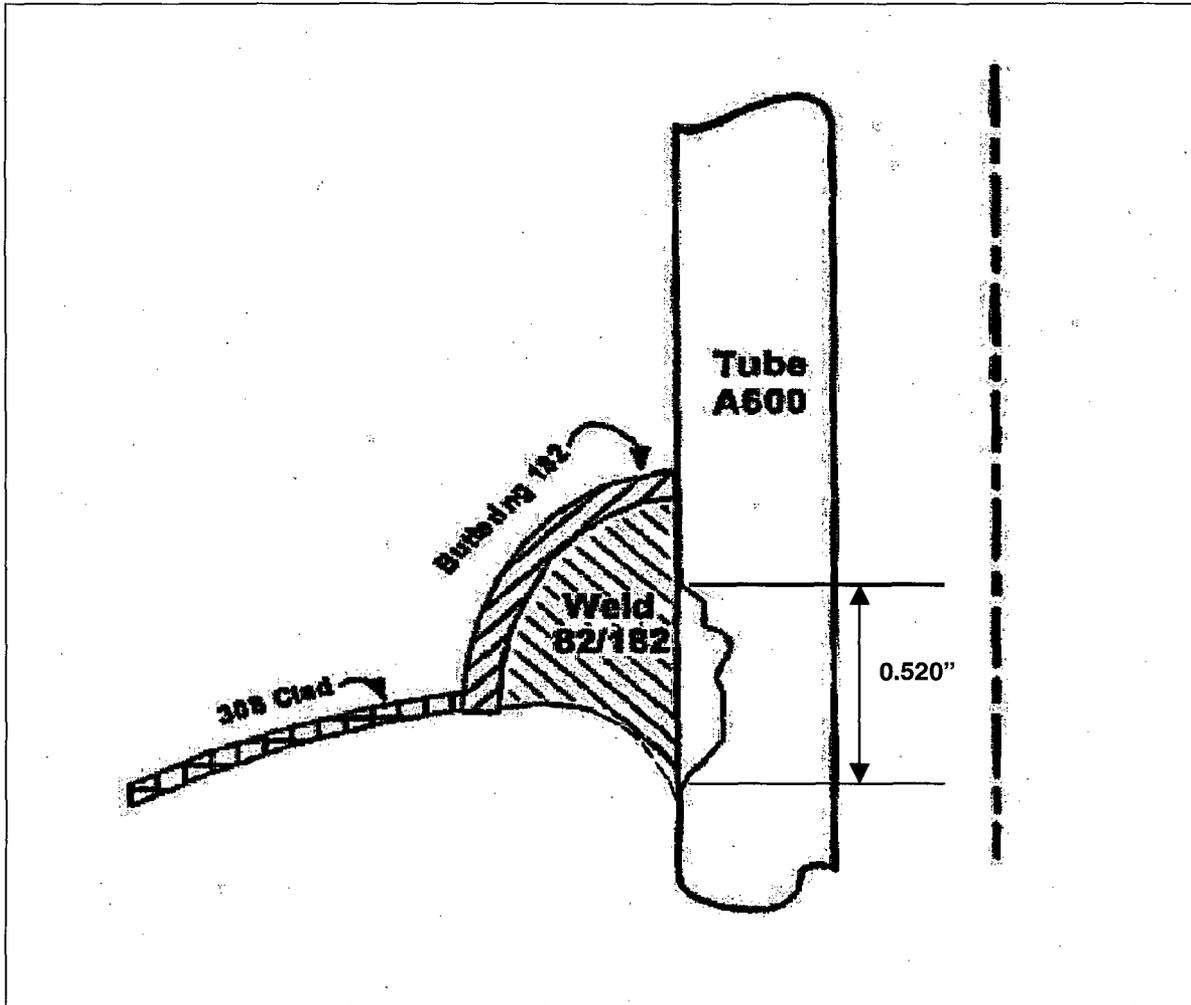
Figure 1 – A non-scale sketch of the ultrasonic indication identified in the Reference 1 report. The inspection identified a 0.520" long x 0.326" deep axial, external indication in the #68 CRDM penetration tube near the J-groove elevation. The 0.326" depth corresponds to approximately 52% of the 0.625" tube thickness. The maximum ultrasonic reflector was approximately 16.5 degrees counter clockwise from the zero reference (as looking upward). The zero reference was the downhill side of the periphery tube. A follow-up eddy current exam detected no relevant indications on the inner surface of the tube.

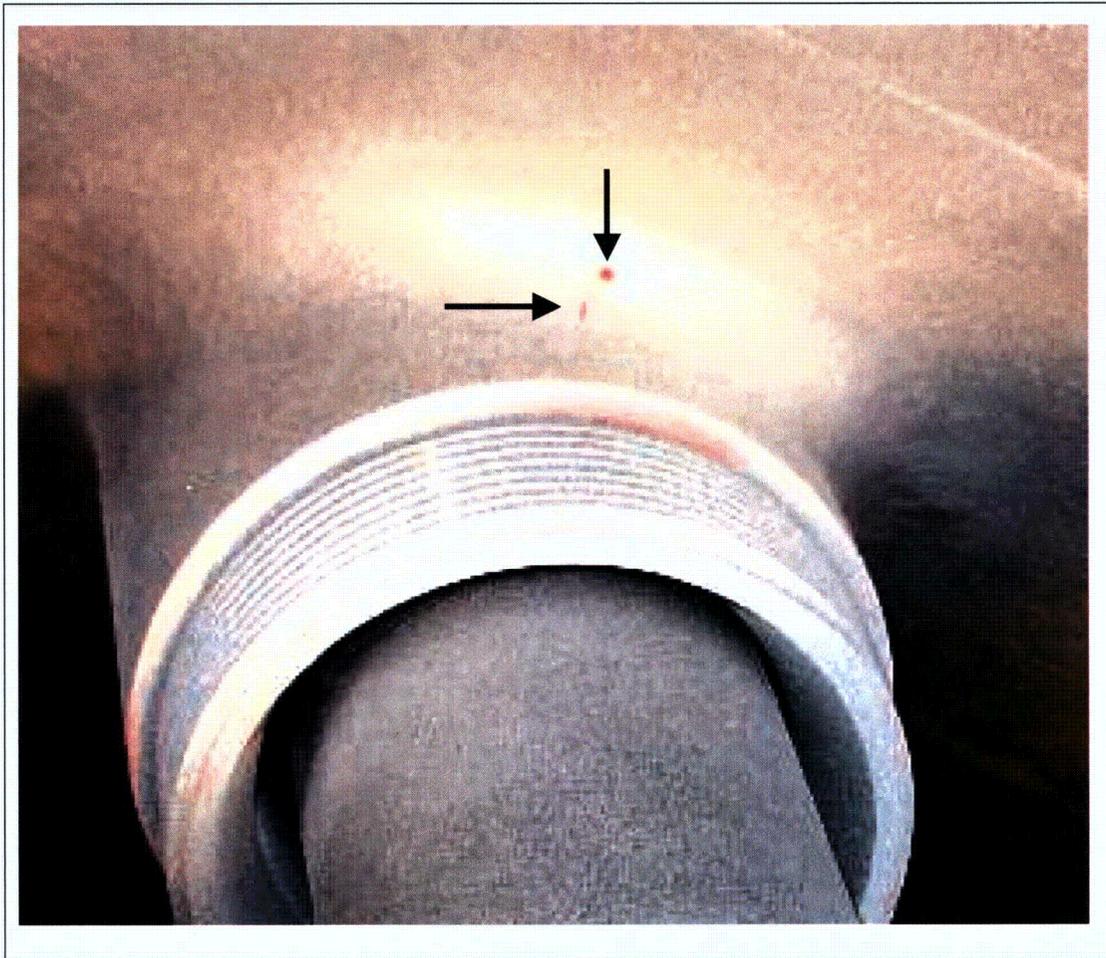
Figure 2 – A photo showing two dye penetrant indications on the surface of the J-groove weld zone for the #68 CRDM penetration (Ref. 2). The axial indication (left arrow) measured 0.150” long and corresponded to the approximate location of the axial ultrasonic reflector. A rounded 0.050” diameter indication was also detected (upper arrow). The lab evaluations indicated the J-groove weld toe was below the axial indication.

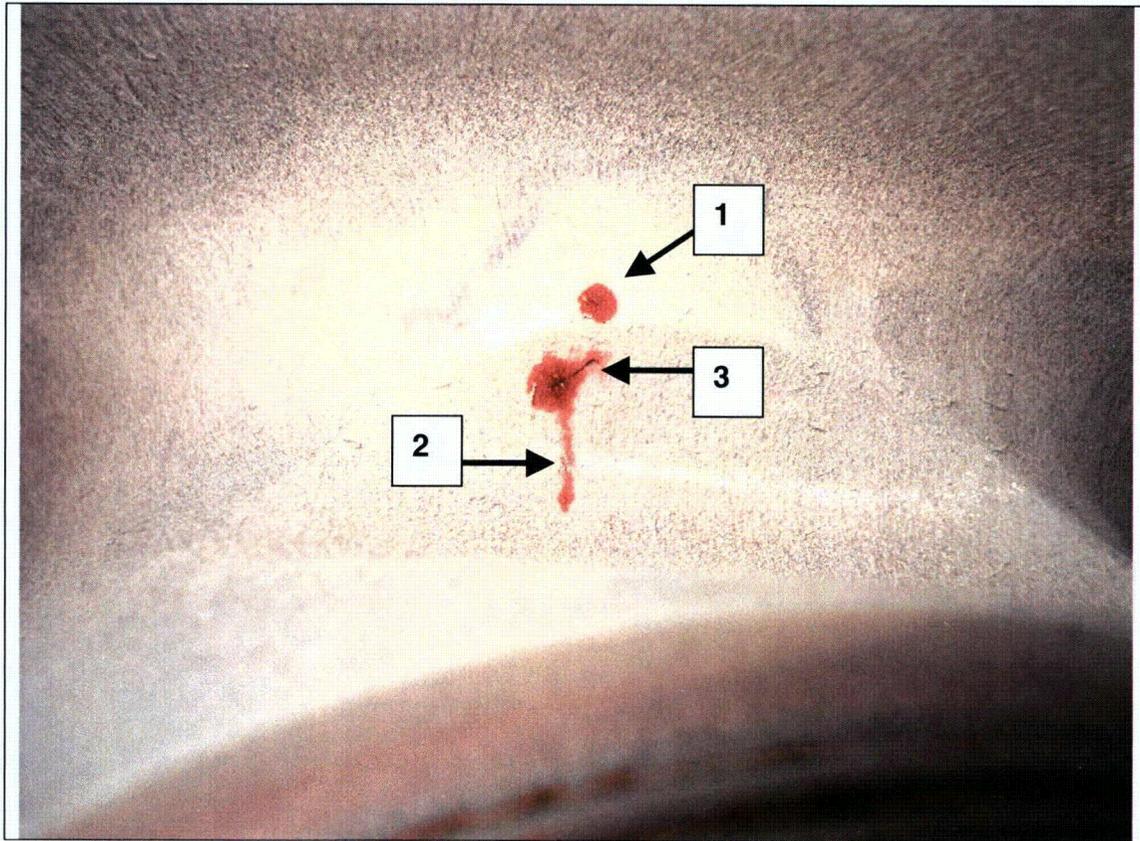
Figure 3 – A photo showing the field dye penetrant results for the excavation site after the boat sample was removed (Ref. 3). The boat sample did not capture the rounded indication (#1) or the deepest portion of the axial indication (#2). In addition, the excavation uncovered an angled, sub-surface linear defect (#3) that intersected the axial indication.

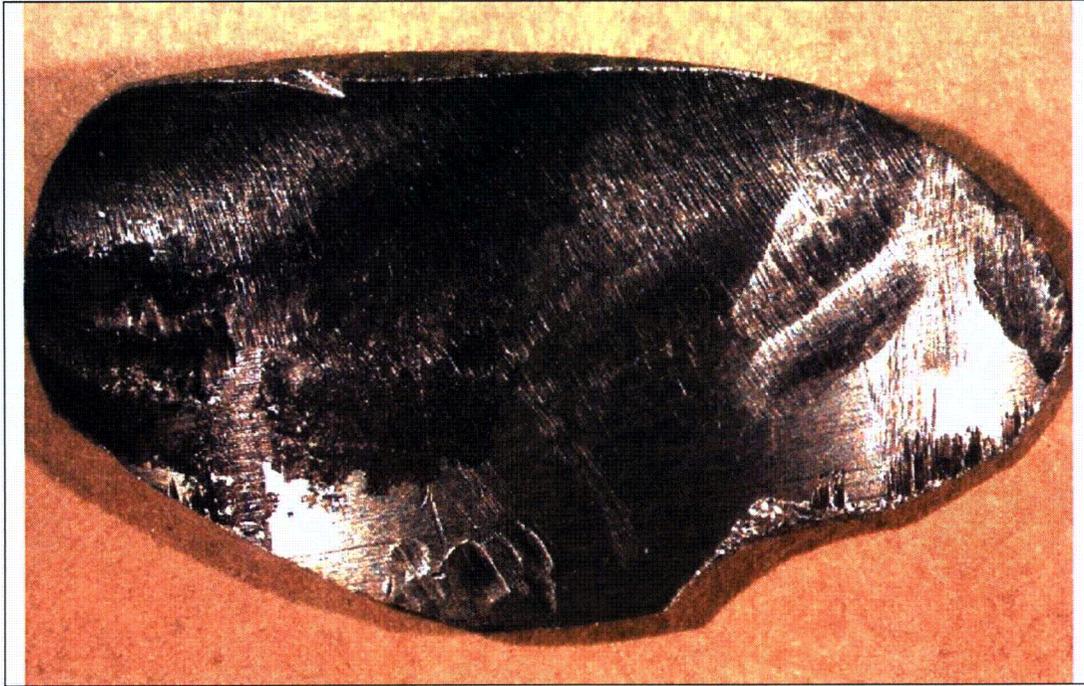
The visual inspections did not identify cracking or other linear indications that corresponded to the field dye penetrant indications. The most significant observation was the presence of heavy surface grinding toward the upper half (i.e., weld side) of the sample. Due to the surface grinding, the weld toe could not be identified by the visual inspection. The EDM surface exhibited smooth, rounded features that were typical of the EDM cutting process.

Figure 4 – The non-cut (i.e. wetted) surface of the boat sample. Note the relatively heavy grinding toward the upper half (weld side) of the sample. The sample measured 1.5” long x 0.75” wide. No crack-like indications were visible. (4x Magnification)

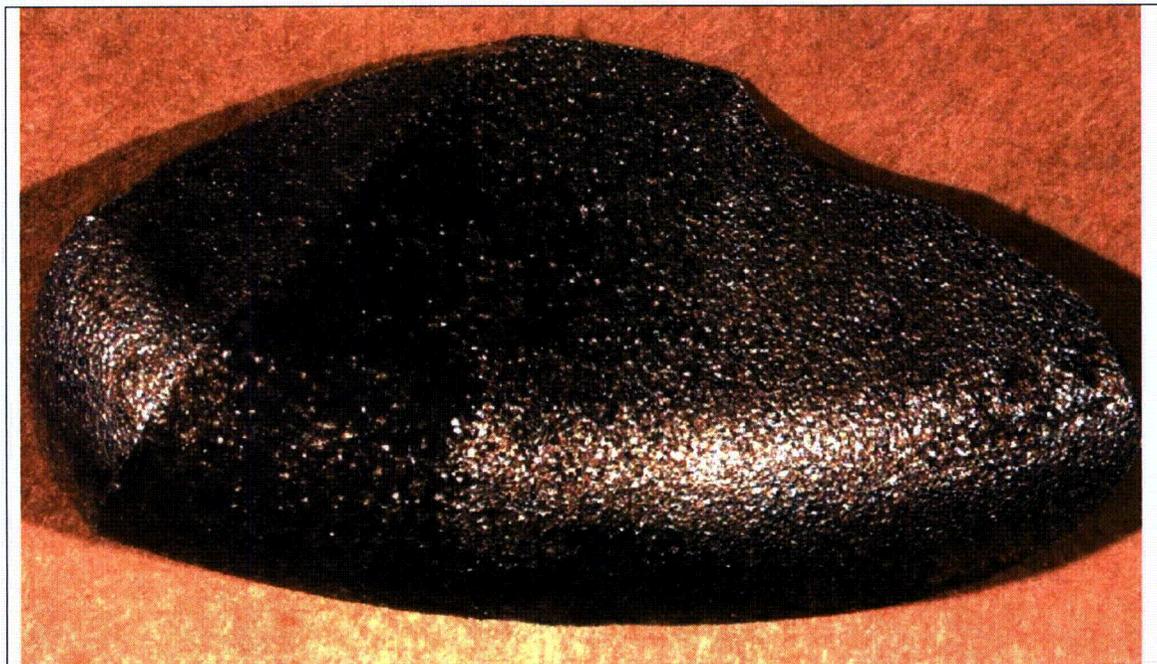
Figure 5 – The EDM cut surface. No cracking was visible. (4x Magnification)

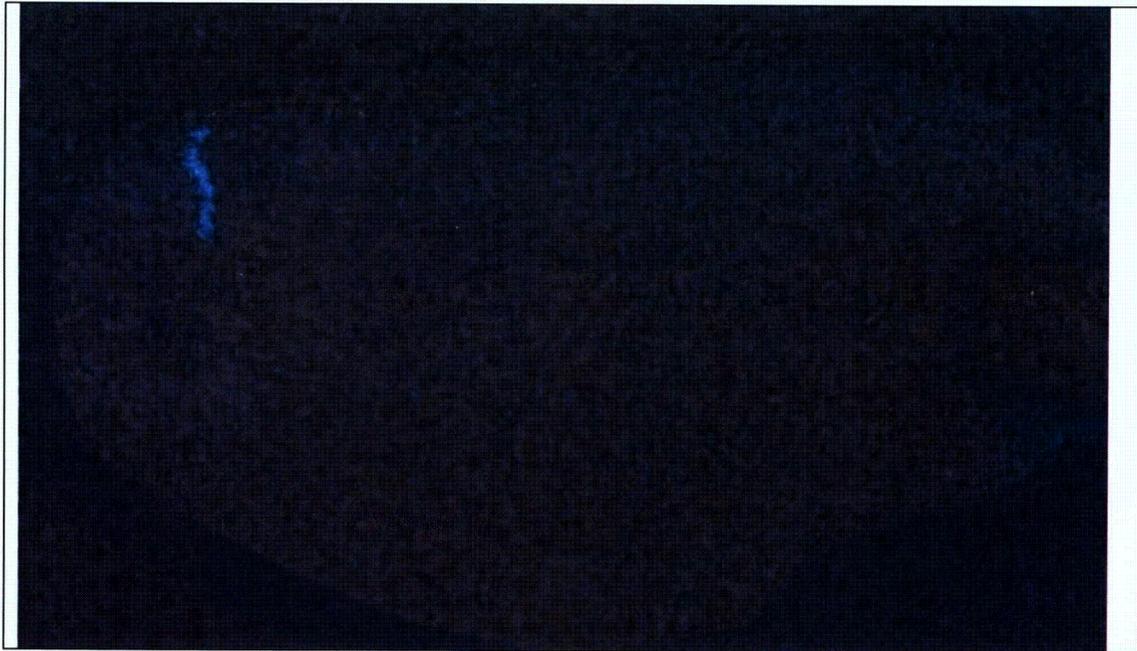
Figure 6 – A photo showing the fluorescent dye penetrant indication on the non-cut surface of the boat sample. The indication measured 0.18” long and followed an irregular path.

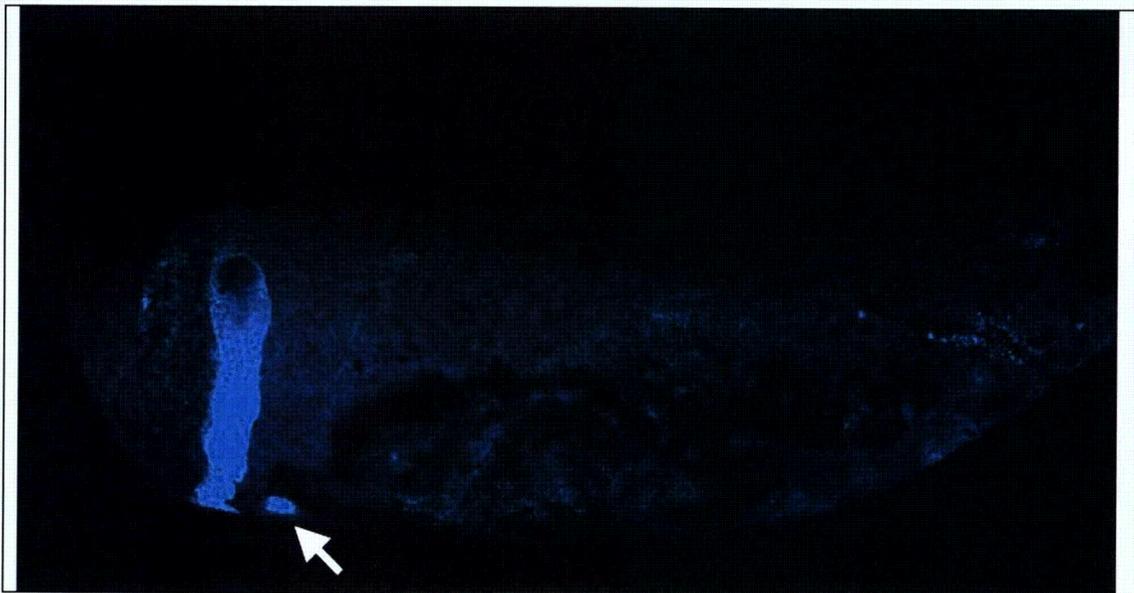
Figure 7 – The fluorescent dye penetrant result for the EDM surface. The large indication measured 0.375” long. Also note the smaller rounded indication (arrow).

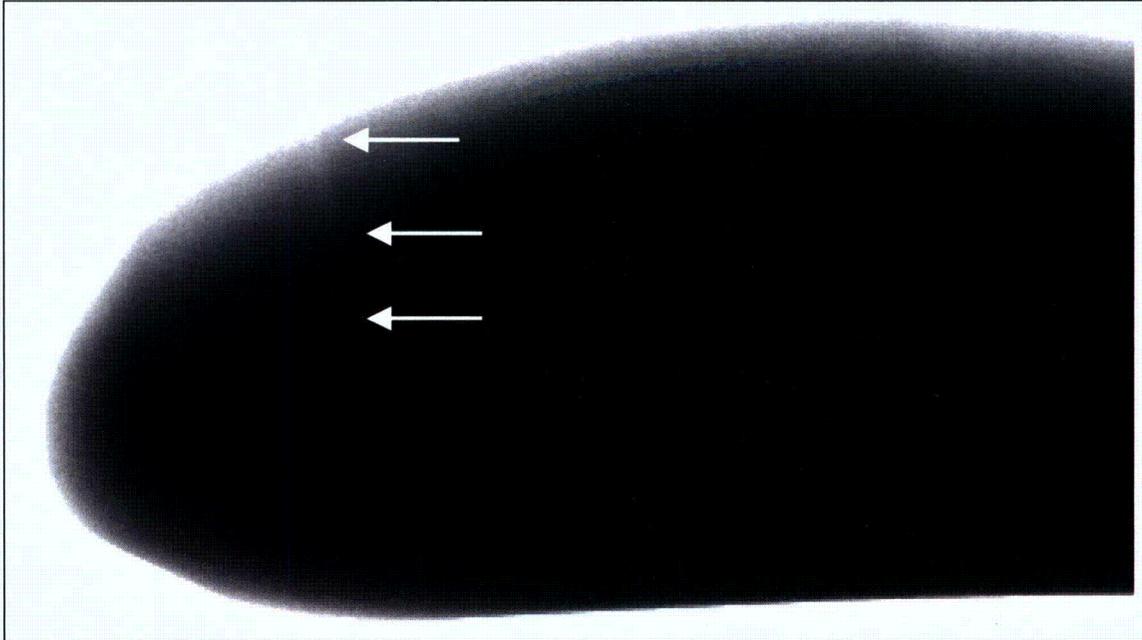
Figure 8 – An X-ray photo with the axial indication highlighted by arrows.

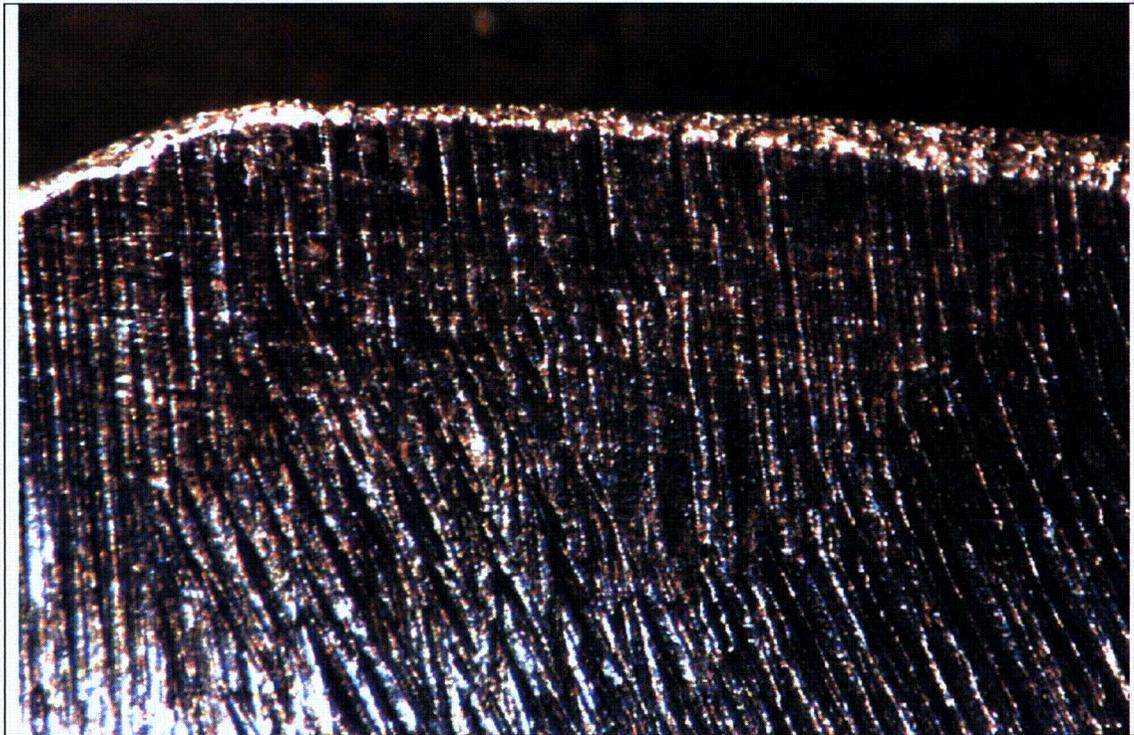
Figure 9 – A stereoscope view in the area of the axial indication region on the non-cut surface. Due to the grinding marks, the indication is not visible. (27x Magnification)

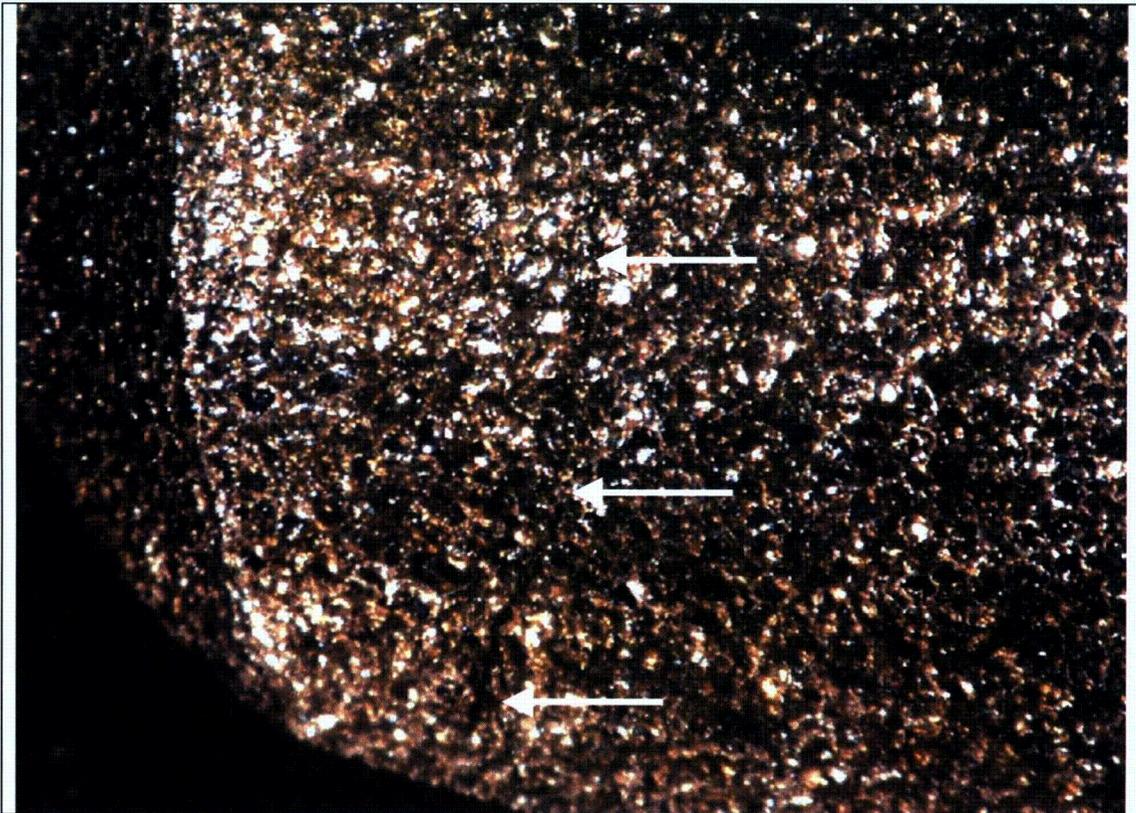
Figure 10 – A stereoscope photo showing the axial crack on the EDM cut surface. (17x Magnification)

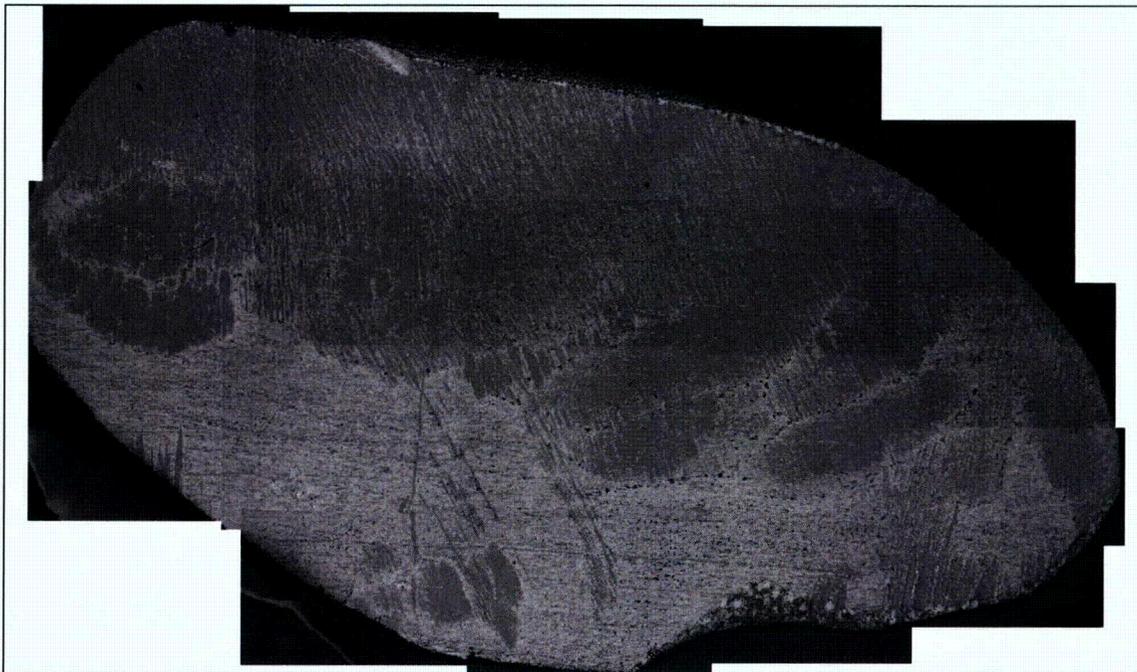
A low magnification SEM view of the non-cut surface is shown in Figure 11. On the non-cut surface, the axial indication was relatively tight and could only be detected at high magnifications. The indication followed a non-branching irregular path that did not necessarily coincide with the local grinding marks (Figures 12 & 13). In one region, the indication coincided with a local patch of ductile features, which appeared to be related to smeared metal from the surface grinding (Figure 14). No crack branching was observed on the non-cut surface.

Figure 11 – A low magnification SEM photo of the non-cut surface. (4x Magnification)

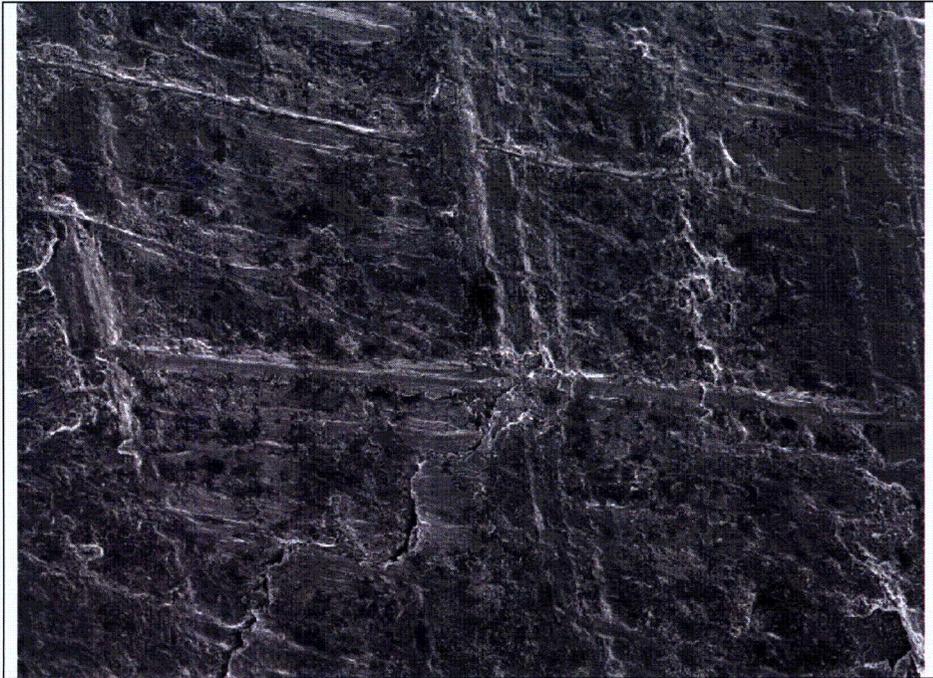
Figure 12 – An SEM photo near the upper end of the axial indication on the non-cut surface. There is evidence of smearing from the surface grinding. (500x Magnification)

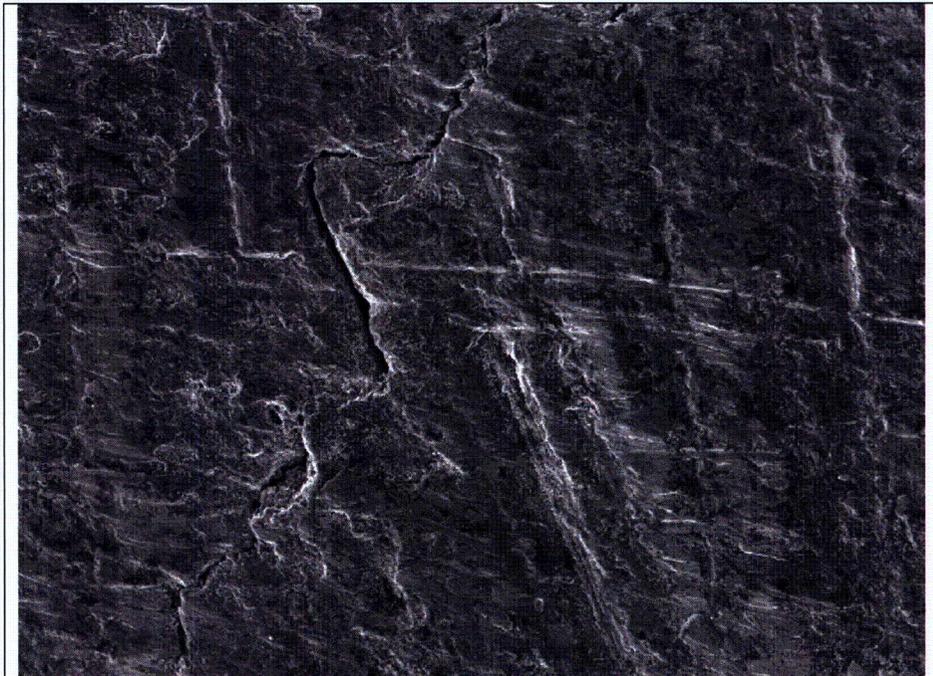
Figure 13 – An SEM photo of the axial crack on the non-cut surface. The crack followed an irregular path and was non-branching. In this area, the crack did not follow the local grinding marks. (500x Magnification)

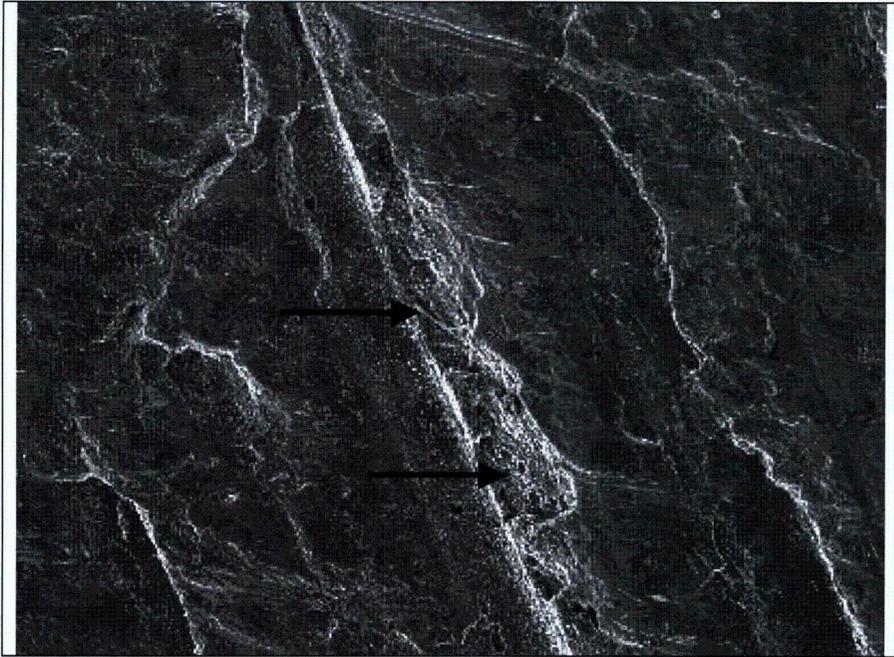
Figure 14 – A local patch of ductile appearing dimples (arrows) in the axial indication on the non-cut surface. The dimples were likely related to the surface grinding. In this area the indication followed the grinding direction. (500x Magnification)

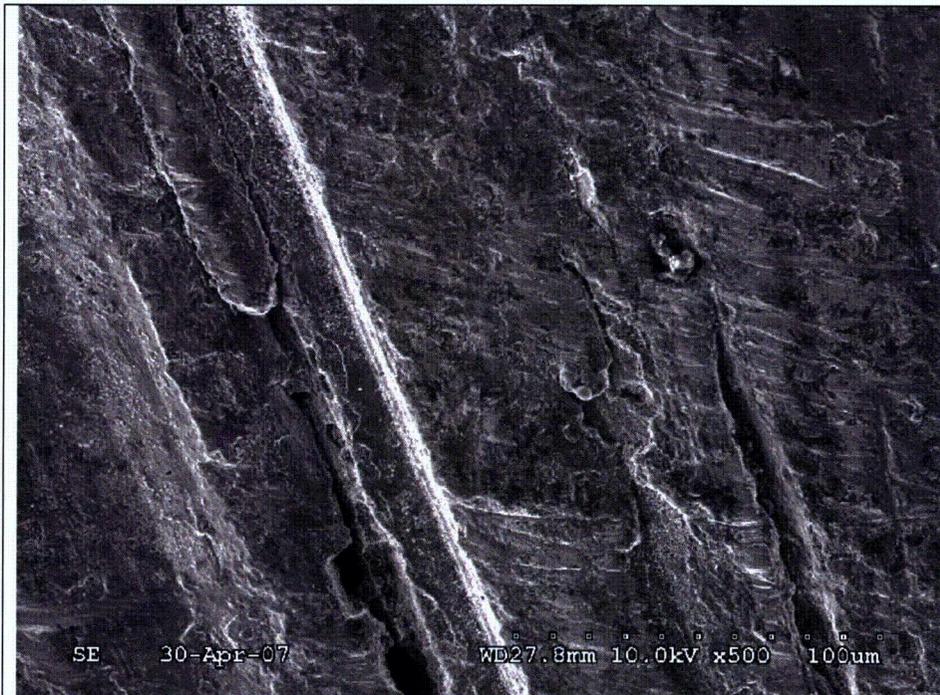
During the SEM inspections of the non-cut surface, several angled fissures were also detected (Figures 15). The fissures tended to follow to the local grinding direction.

Figure 15 – A representative SEM photo showing fissures that were detected on the non-cut surface. The fissures tended to follow the local grinding marks. None of the fissures were detected by the dye penetrant examination. (500x Magnification)

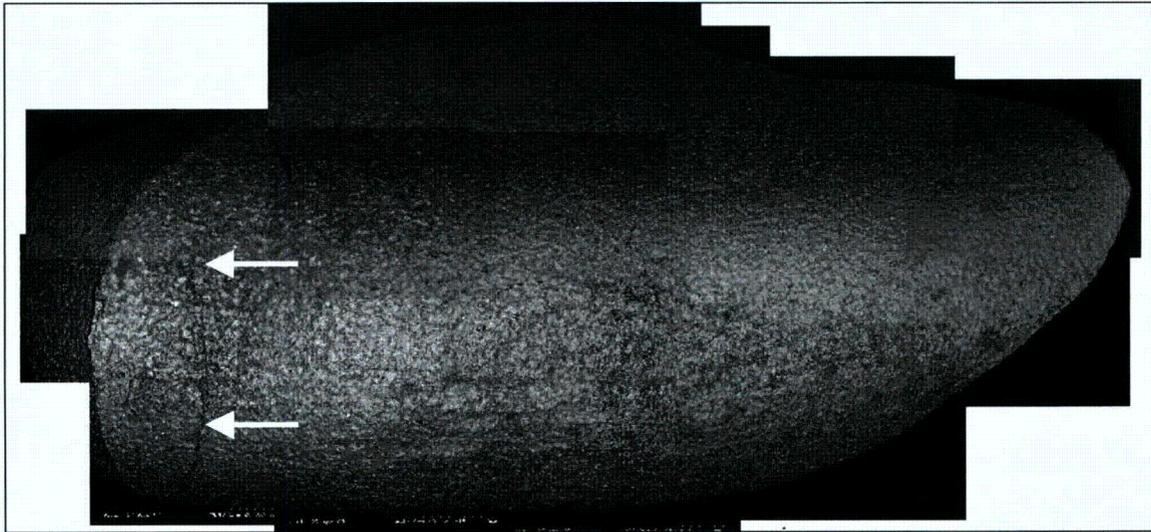
The axial indication was easily detected by the SEM examination of the EDM surface (Figure 16). Figures 17 and 18 provide typical views of the crack. There was little crack branching, except near the ends of the indication.

Figure 16 – A backscatter SEM montage of the EDM cut surface. The arrows point to the crack. (4x Magnification)

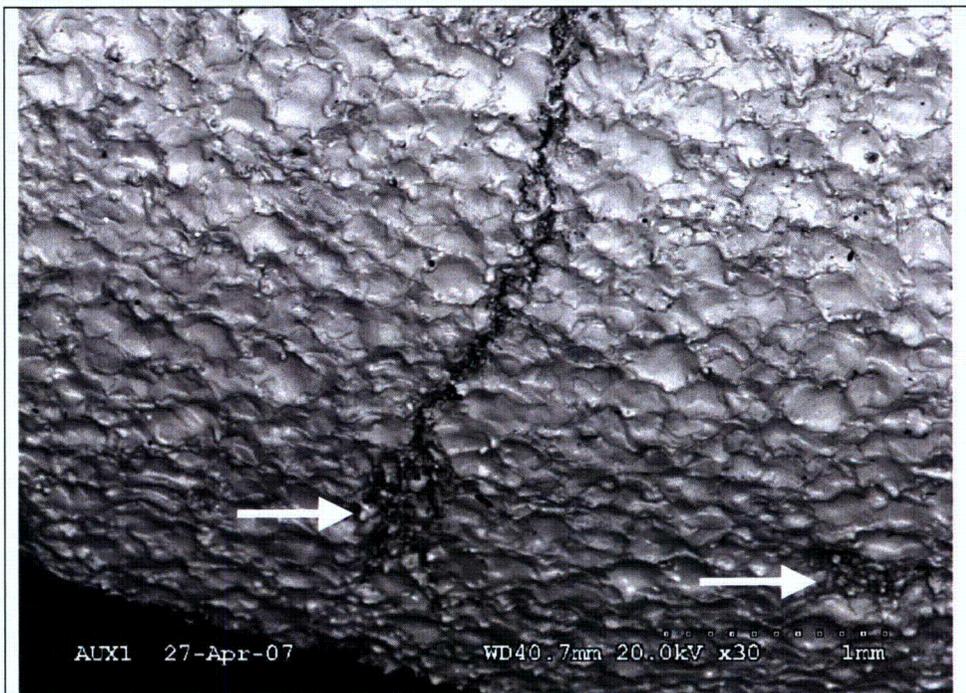
Figure 17 – An SEM photo near the upper end of the axial indication on the EDM surface. The left arrow points to crack branching near the non-cut surface edge. The right arrow points to the globular particles that covered the rounded dye penetrant indication. (30x Magnification)

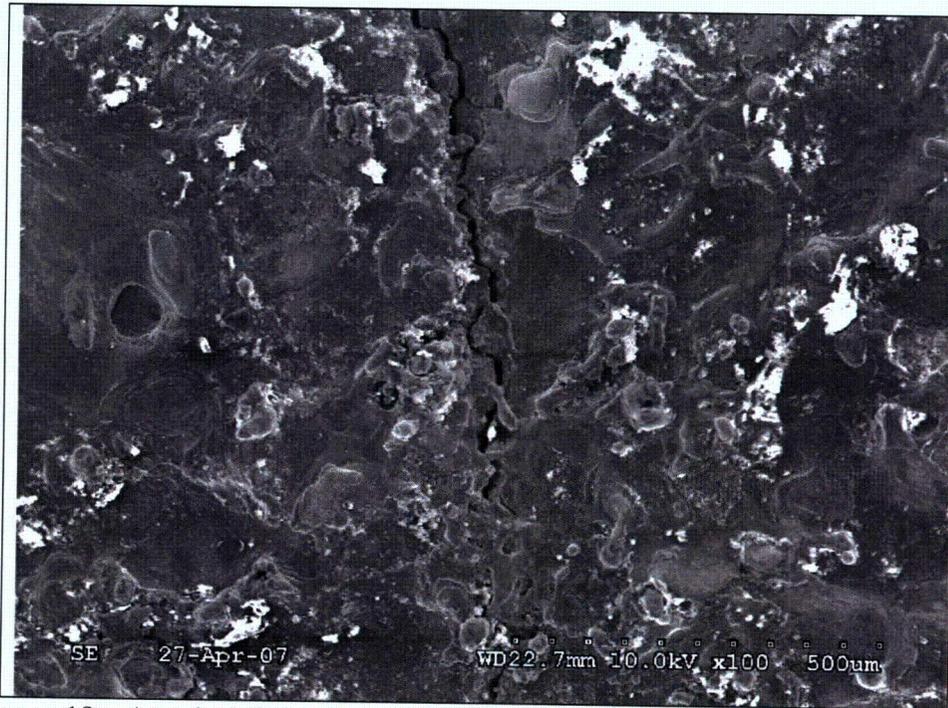
Figure 18 – A typical SEM view of the axial indication on the EDM surface. The crack generally appeared to have intergranular features, although interpretation was difficult due to the EDM process. (100x Magnification)

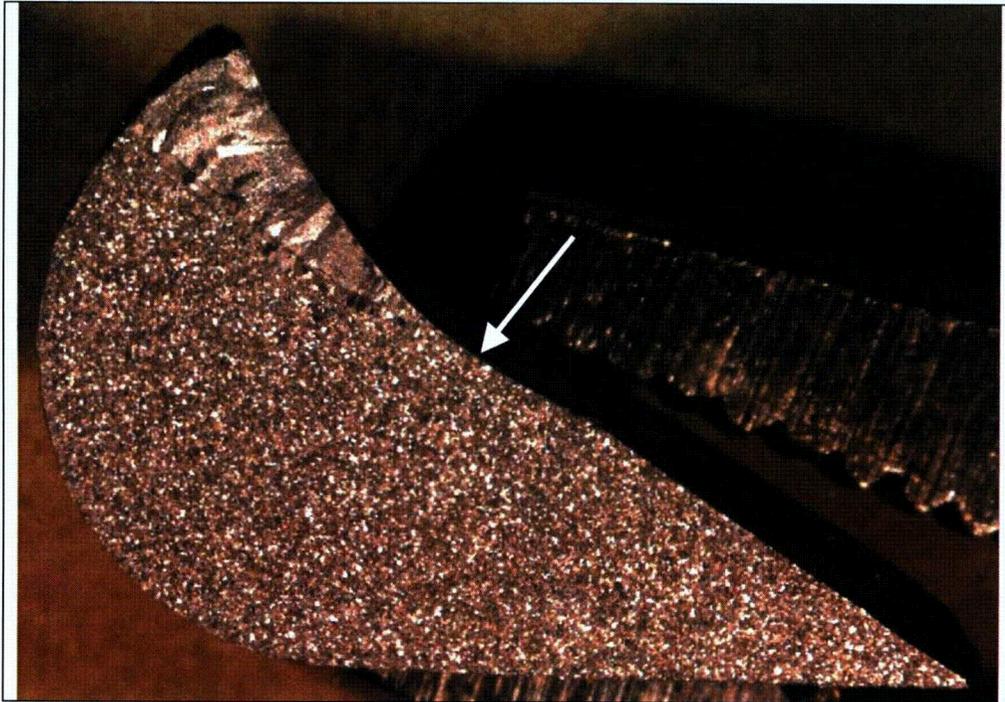
Figure 21 – A macro-etched view of the Sample C cut face. The arrow points to the location of the weld toe on the wetted surface of the boat sample. The tube profile indicates there was minor grinding past the weld toe. (7x Magnification)

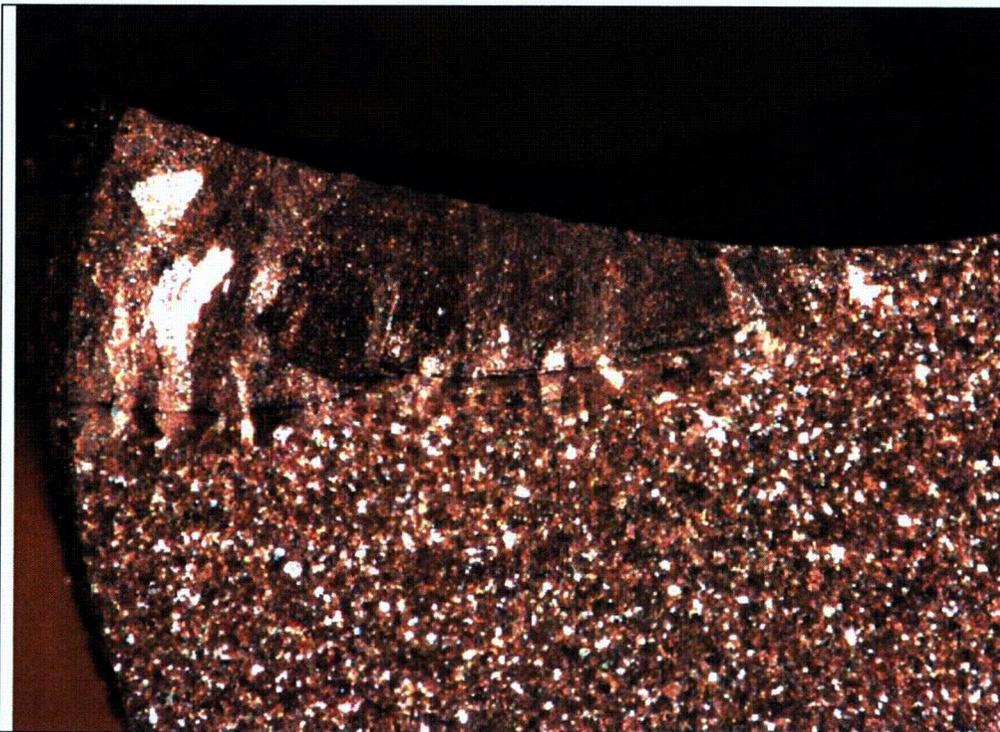
Figure 22 – A closer look at the macro-etched weld. The boat sample contained portions of the last two weld passes. (15.2x Magnification)

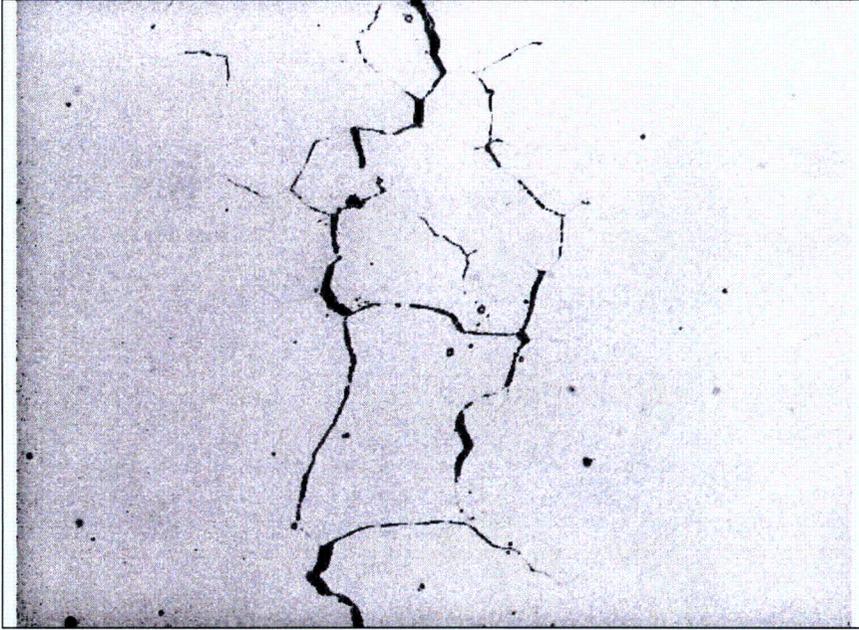
The horizontal cut face on Sample B was prepared in a metallurgical mount. The tube base metal contained branched, intergranular cracking (Figures 23-25) that was typical of PWSCC. The crack branches had sharp tips and contained little oxidation. No crack blunting was observed. There was limited interdendritic cracking into the weld (Figure 26). Within the Sample B mount, none of the cracking extended to the wetted surface of the boat sample.

Figure 23 – An un-etched view showing branched, intergranular cracking in the tube portion of the Sample B metallurgical mount. (375x Magnification)

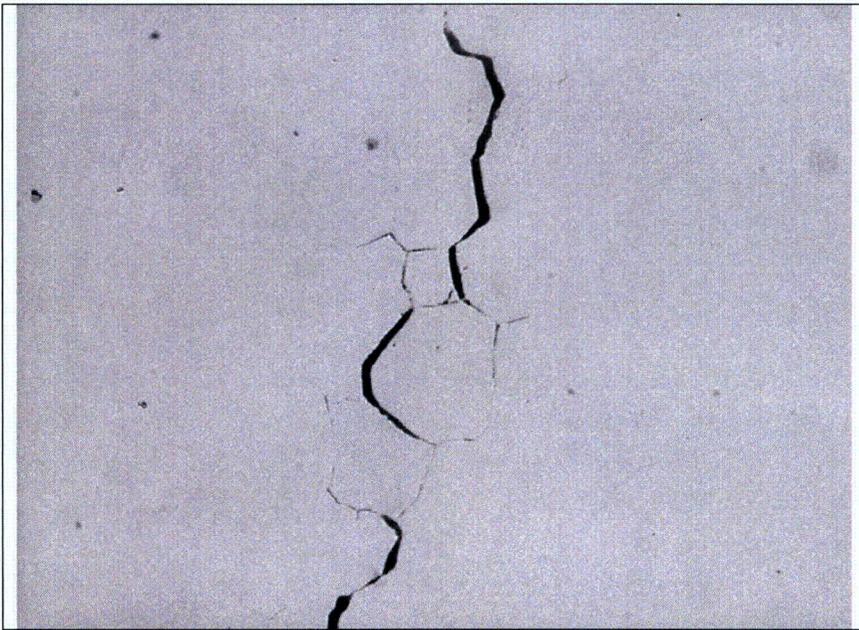
Figure 24 – Additional branched, intergranular cracking in the Sample B tube material. (375x Magnification, Un-etched)

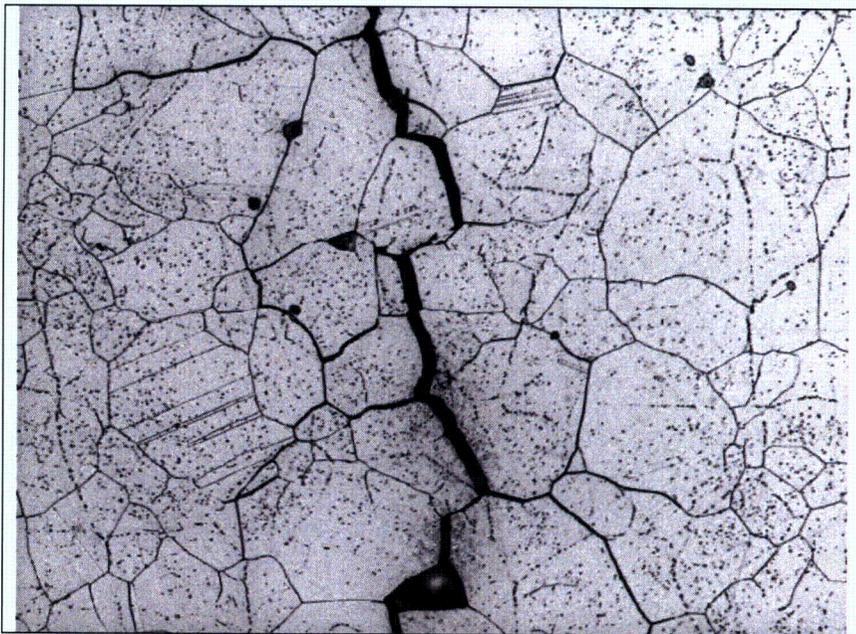
Figure 25 – An etched view of the branched, intergranular cracking in the Sample B tube material. (375x Magnification, Electrolytic Phosphoric-Nital Dual Etch)

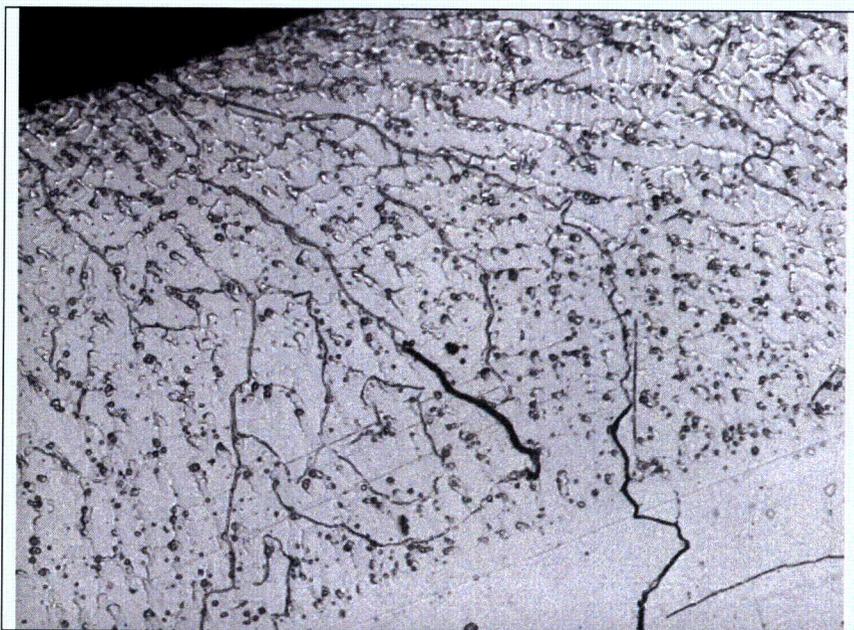
Figure 26 – An etched view near the weld metal crack end in Sample B. The two cracks have an intergranular appearance. Within Sample B, the cracking did not extend to the wetted surface of the mount. (375x Mag., Electrolytic Phosphoric-Nital Dual Etch)

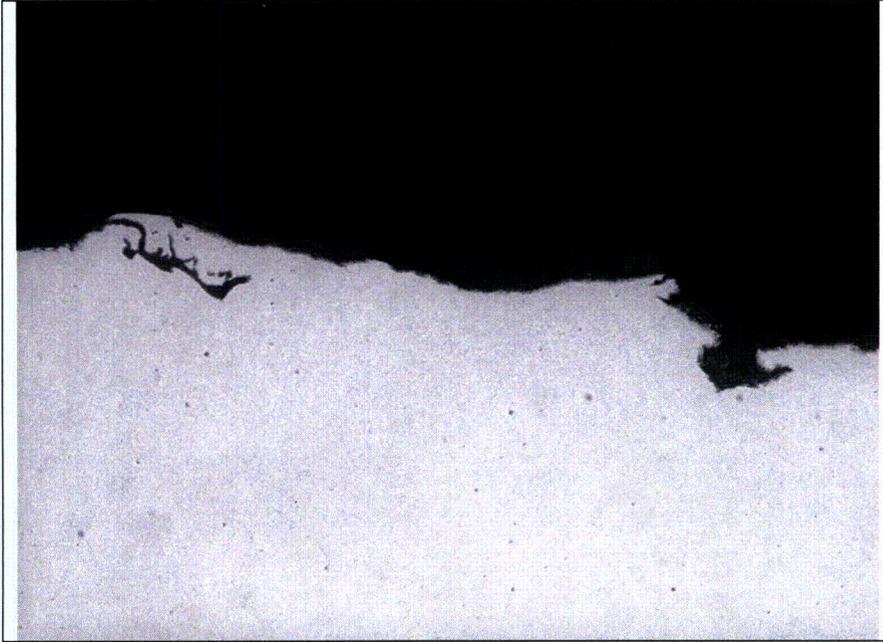
The surface of the weld exhibited an irregular contour and several linear indications were observed (Figure 27 – 29). Based on the heavily deformed surface microstructure, the linear indications appeared to be laps that were formed by metal deformation during grinding. In the examined section, the deformed layer measured up to 0.0007" thick. There was no evidence of service related crack initiation from the indications. The deformed metal and local crevices are believed to be the source of the fissures that were detected by the SEM examination of the wetted surface.

Figure 27 – An un-etched view of two linear irregularities on the weld surface in the Sample B mount. (375x Magnification)

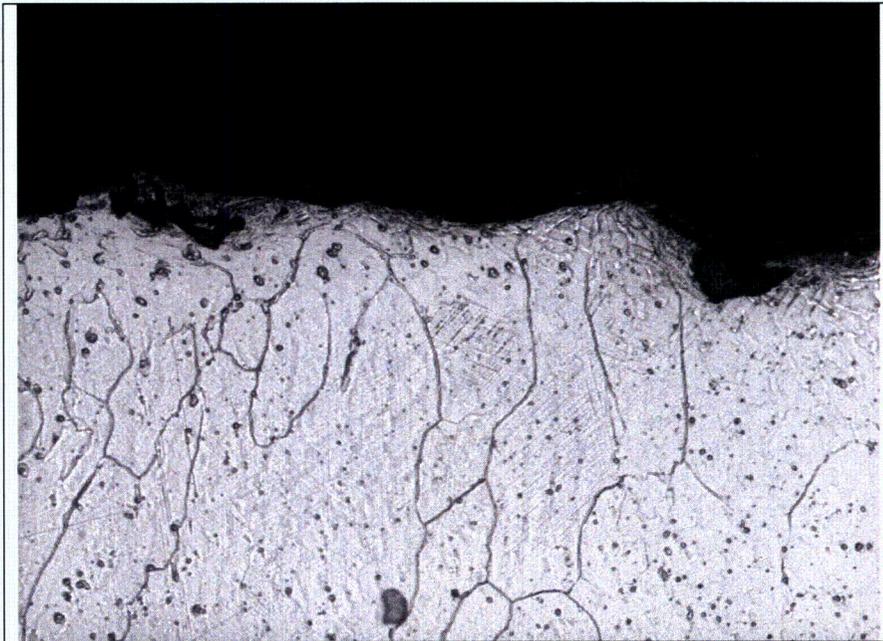
Figure 28 – An etched view of the Figure 27. The locally deformed microstructure suggests the indications were laps from surface grinding. (375x Mag., Electrolytic Phosphoric-Nital Dual Etch)

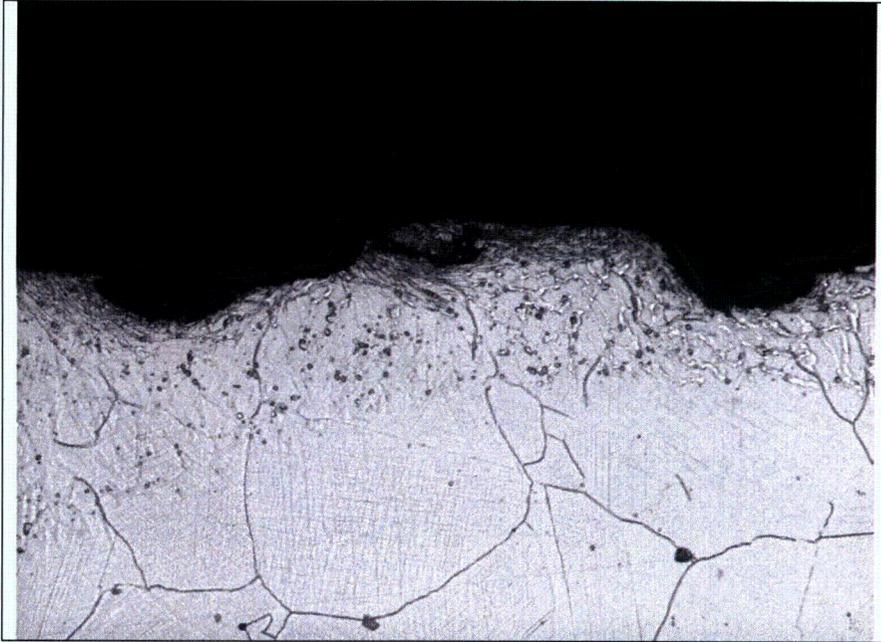
Figure 29 – Another surface indication in the Sample B mount. There was no evidence of crack extension from any of the surface indications. (375x Mag., Electrolytic Phosphoric-Nital Dual Etch)

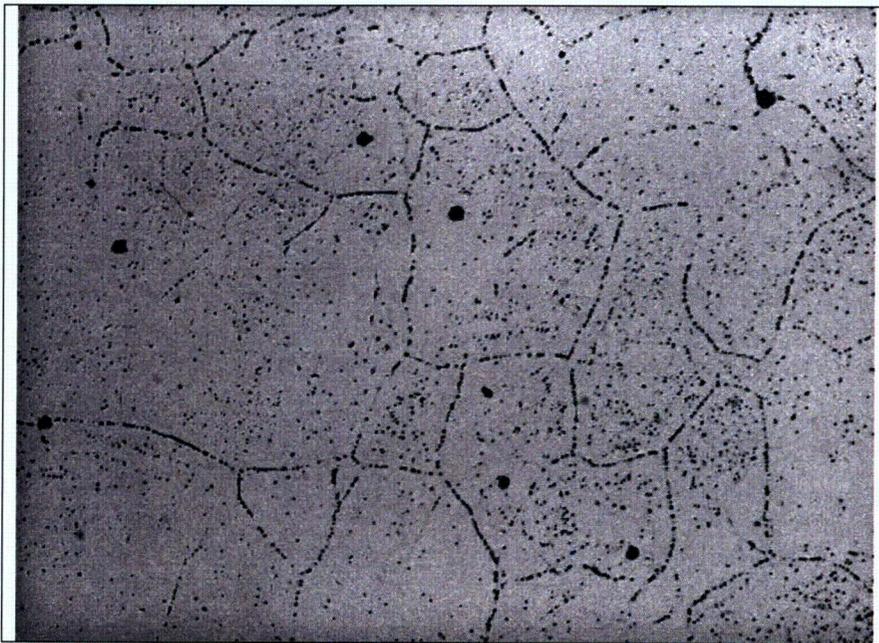
The tube material had a relatively fine duplex grain structure with the smallest grains measuring ASTM Size 7 and the largest grains ASTM Size 5. The microstructure contained large quantities of random intragranular carbides and the grain boundaries were partially decorated with carbides (Figure 30). Nuclear industry literature indicates this microstructure will have a relatively high susceptibility to PWSCC (Ref. 4, 5). The microstructure is considered typical for mill annealed Alloy 600 tubing that was fabricated during the 1970's.

Figure 30 – The Sample B tube material with an electrolytic phosphoric acid etch to reveal the carbide structure. The tube microstructure contained significant intragranular carbides and partially decorated grain boundaries. (375x Magnification)
