**Metallurgical Evaluations of a 'Boat' Sample from the #68 CRDM Penetration  
on Byron Unit 2**

**EXELON POWERLABS PROJECT BYR-48053**

**REPORT DATE: MAY 23, 2007**

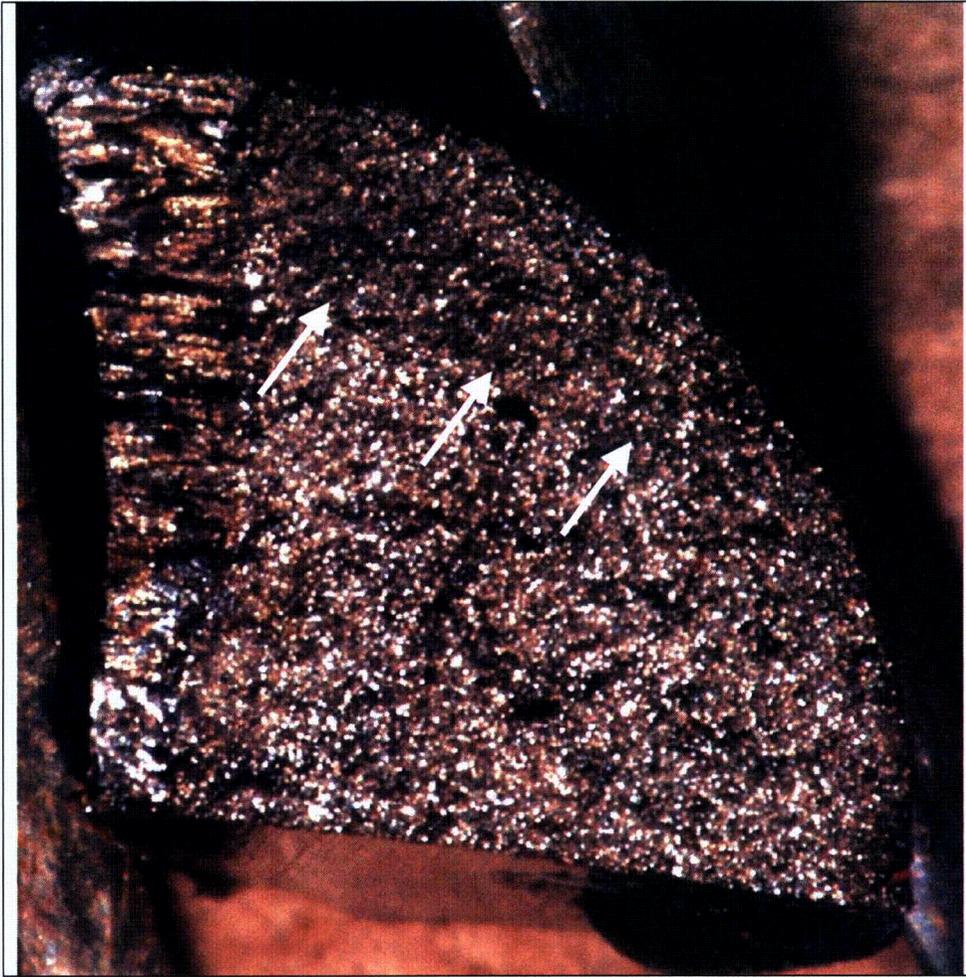
The axial indication was exposed by bending and the Sample A1 side of the crack is shown in Figure 31. The crack surface was reflective and appeared intergranular. There were no clear indications of crack age; although, a thumbnail-shaped region on the tube appeared to be more oxidized than the remainder of the sample.

Figure 31 – A stereoscope view of the exposed surface of the axial crack in Sample A1. The weld is toward the left side of the sample. The crack surface was reflective and had an intergranular/interdendritic appearance. The arrows point to the edge of a thumb-nail-shaped region that appeared to be more oxidized than the remainder of the surface.

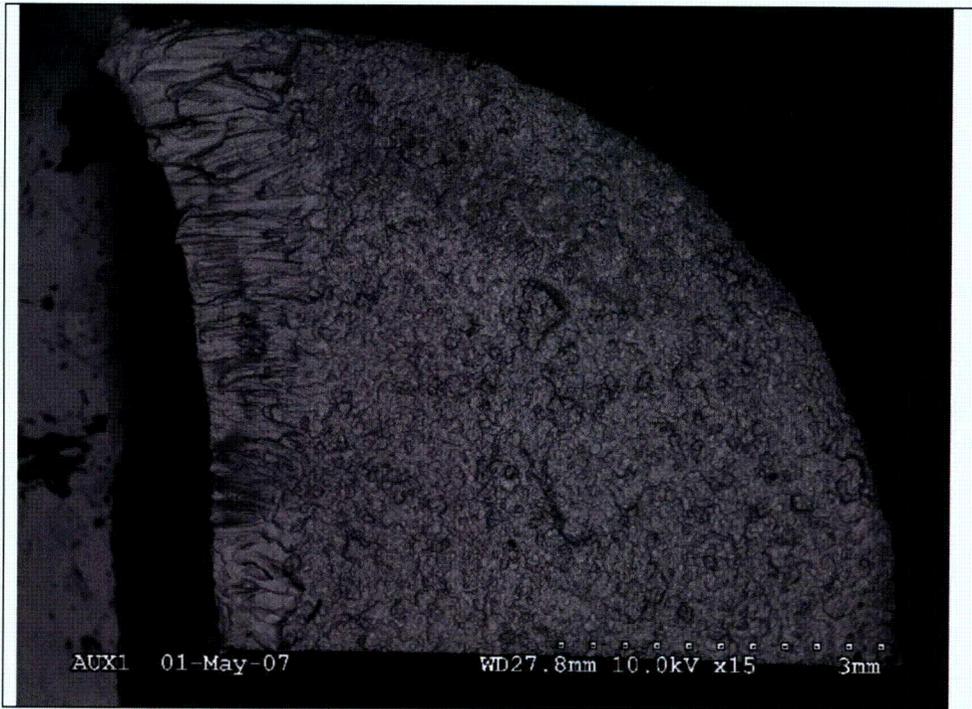
A low magnification SEM view of the A1 crack surface is shown in Figure 32. The general shape of the thumbnail region in the vicinity of the fusion line suggested the direction of crack propagation was from the tube material into the weld (i.e., toward the wetted surface of the J-groove weld along the tube side fillet leg). The tube portion of the sample exhibited an intergranular morphology in all examined regions (Figures 33-35). A close examination of the 'thumbnail' region revealed fine globular particles on the surface. Several of the particles were evaluated by energy dispersive X-ray spectrometry (EDS) techniques and found to contain tungsten, oxygen and the base metal elements (i.e., nickel, chromium, iron). As a result, it was concluded that the thumbnail region was contaminated during the EDM cutting process.

Figure 32 – A low magnification backscatter SEM view of the Sample A1 crack surface with the weld along the left edge of the sample. The ‘thumbnail’ region is also visible. (15x Mag.)

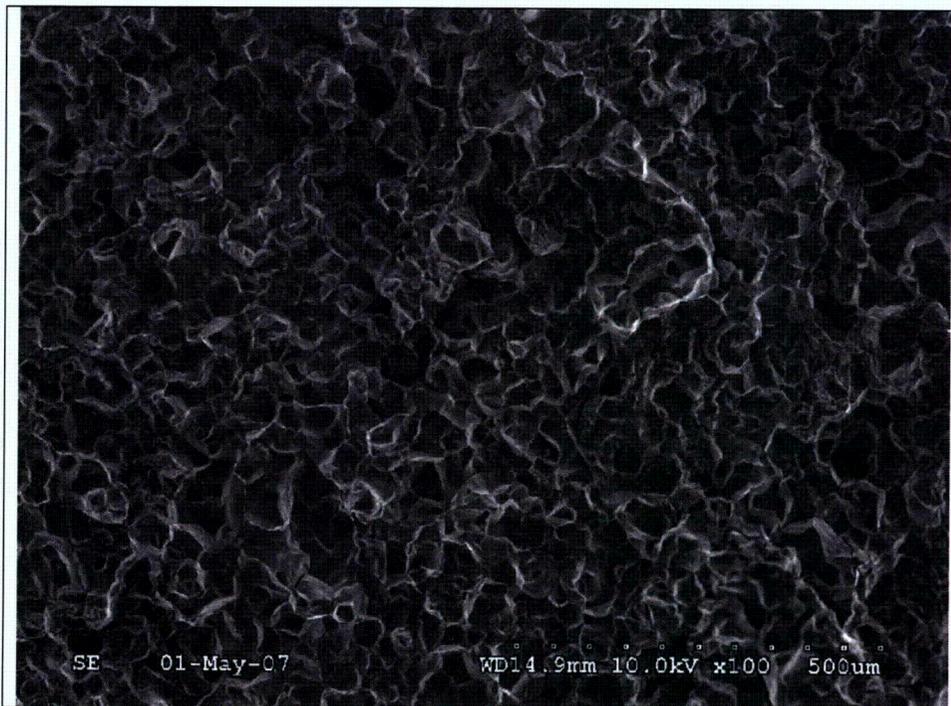
Figure 33 – A typical SEM view of the tube crack surface in the Sample A1. The tube material exhibited intergranular features throughout the sample. (100x Magnification)

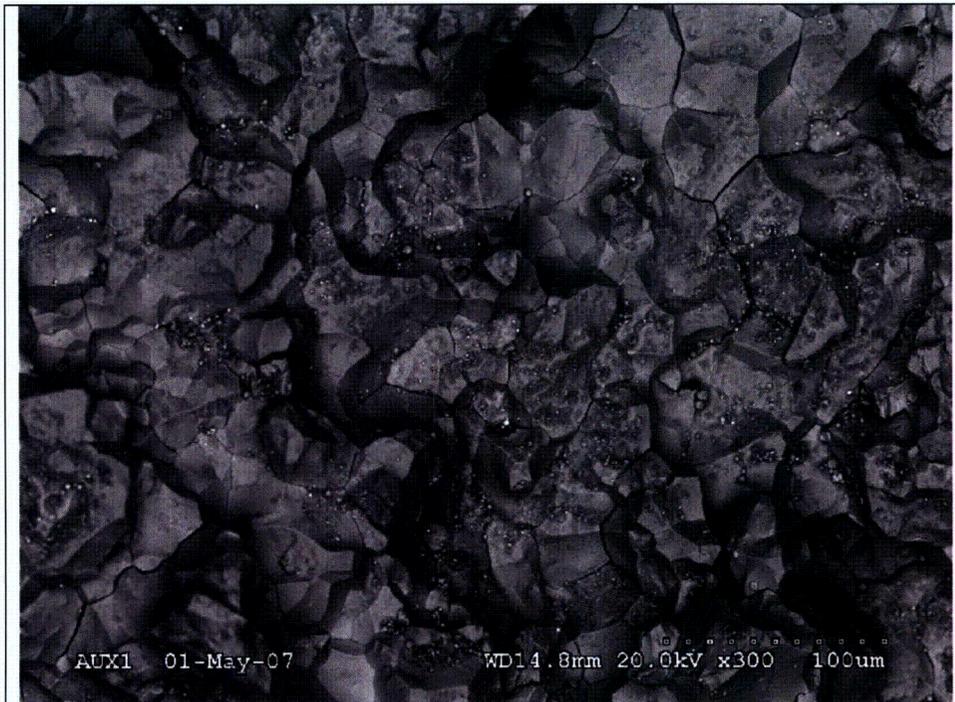
Figure 34 – A backscatter SEM image of the intergranular cracking in the dark ‘oxidized’ region in the Figure 31 stereoscope photo. An EDS evaluation indicated the fine globular particles contained tungsten, which suggests the surface was contaminated with debris from EDM cutting process. (300x Magnification)

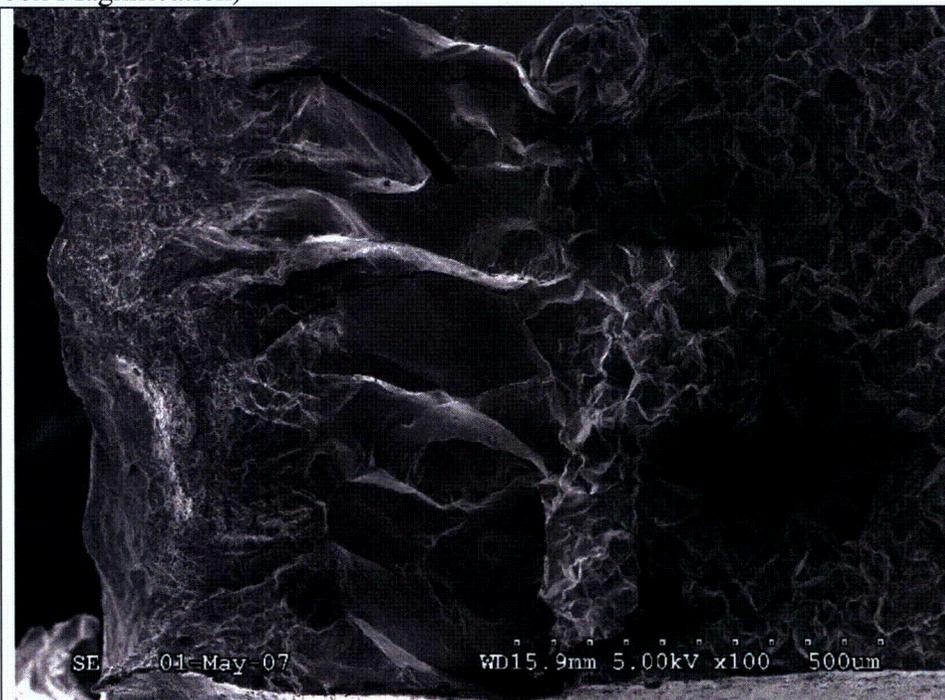
Figure 35 – The lower portion of the exposed crack surface in Sample A1. The left side of the sample is intact weld metal that was broken open in the lab. The large grained area near the center of the photo was located in the base metal heat affected zone. (100x Magnification)

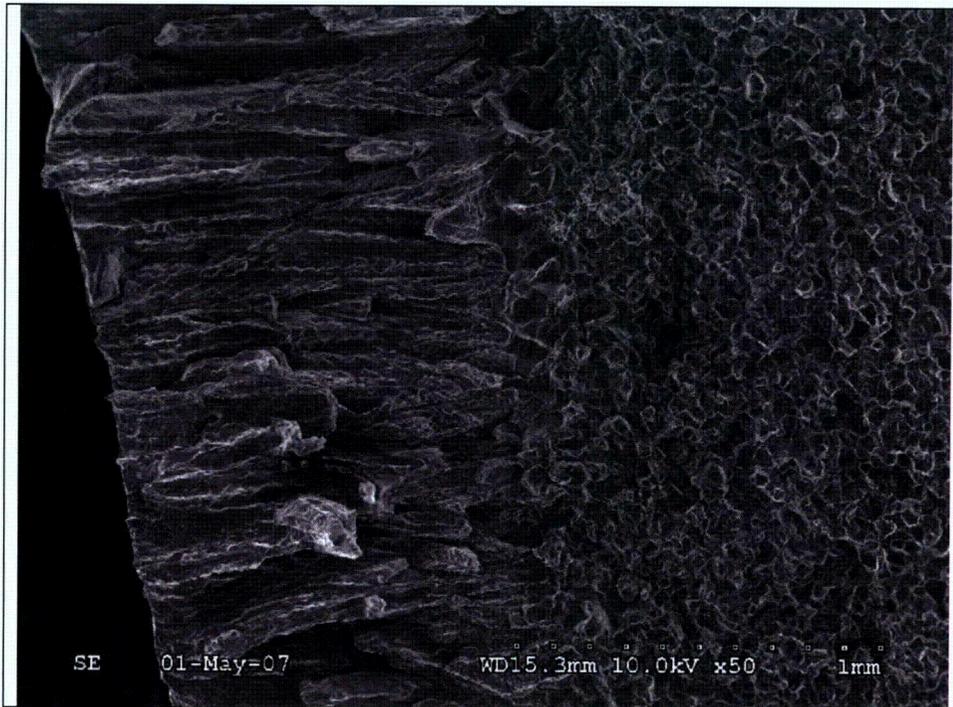
cracking appeared to follow the columnar interdendritic features of the solidification pattern (Figure 36), which is typical of stress corrosion cracking. However, at higher magnifications, some of the features were smoother than is typical for PWSCC (Figure 37 & 38). Industry literature indicates the smooth interdendritic features are more indicative hot cracking than PWSCC (Ref. 6). Several of the smooth regions were evaluated by EDS techniques; however, the areas did not exhibit manganese segregation that can be associated with hot cracks. Based on the crack surface features, it was concluded that there was evidence of both PWSCC and hot cracking in the weld.

Figure 36 – An SEM photo near the center of the exposed crack in the sample A1 weld. At low magnification, the weld cracking appeared to follow the columnar, interdendritic features of the weld solidification pattern. (50x Magnification)

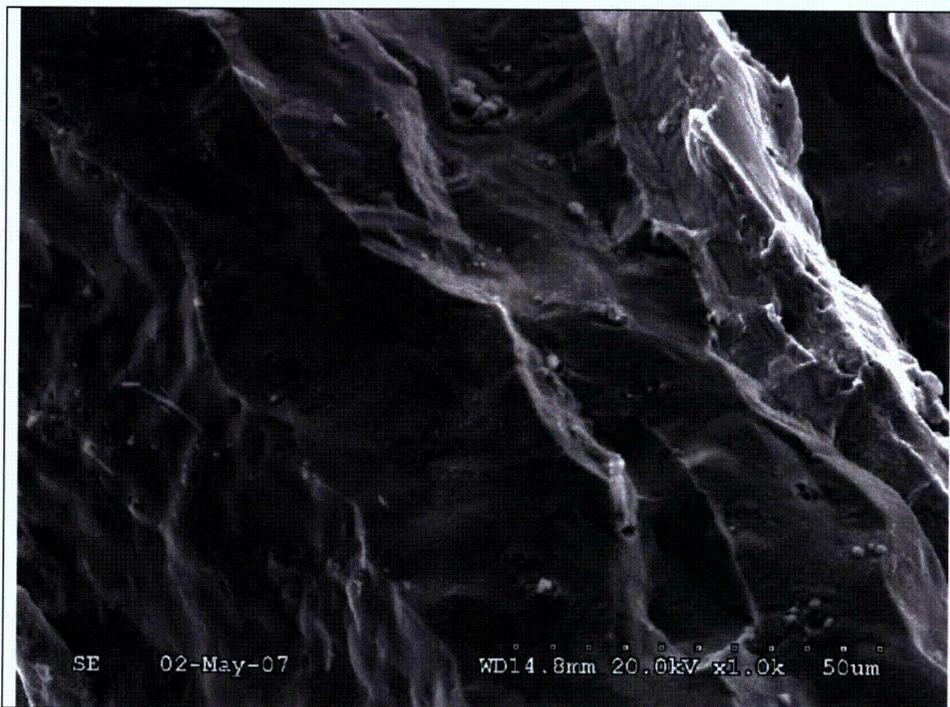
Figure 37 – An SEM photo showing a relatively smooth region of the exposed crack surface of the Sample A1 weld. (1000x Magnification)

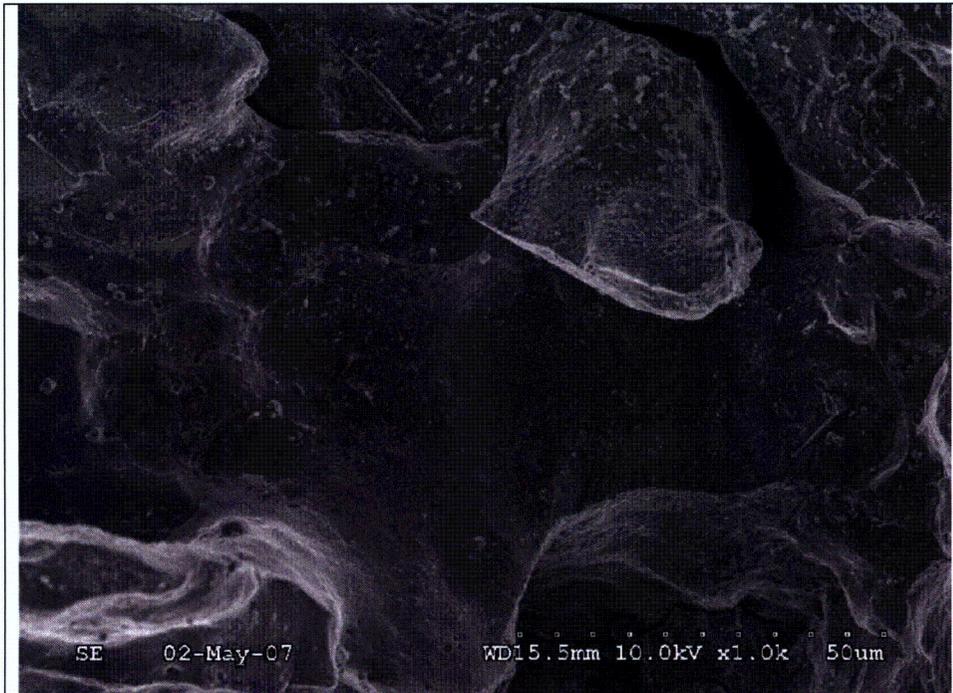
Figure 38 – Another smooth crack surface region in the Sample A1 weld. The smooth appearance is considered more typical of a hot crack than stress corrosion cracking. (1000x Magnification.)

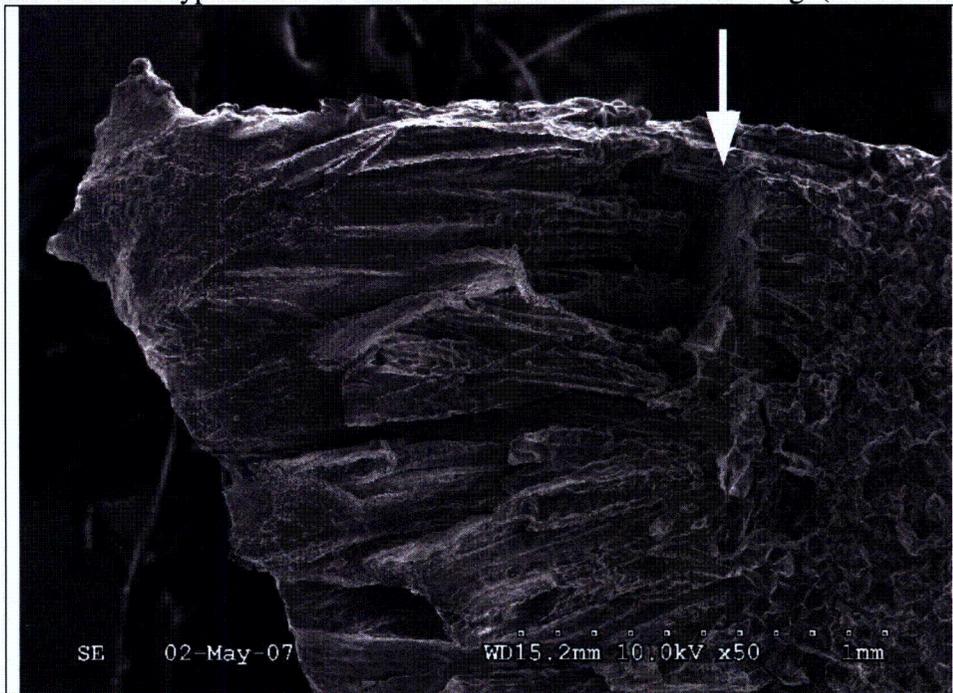
The exposed weld surface also contained a planar defect that was parallel to the fusion line (Figures 39 & 40). Based on defect location and orientation, the defect was caused by lack of fusion between weld passes. Within the weld, there were several cracks that were connected to the defect.

Figure 39 – A SEM view of the Sample A1 crack surface near the upper end of the weld. The arrow points to a planar defect in the weld. There are several cracks within the weld that are connected to the defect. The ductile region toward the upper left corner of the sample was broken open in the lab. (50x Magnification)

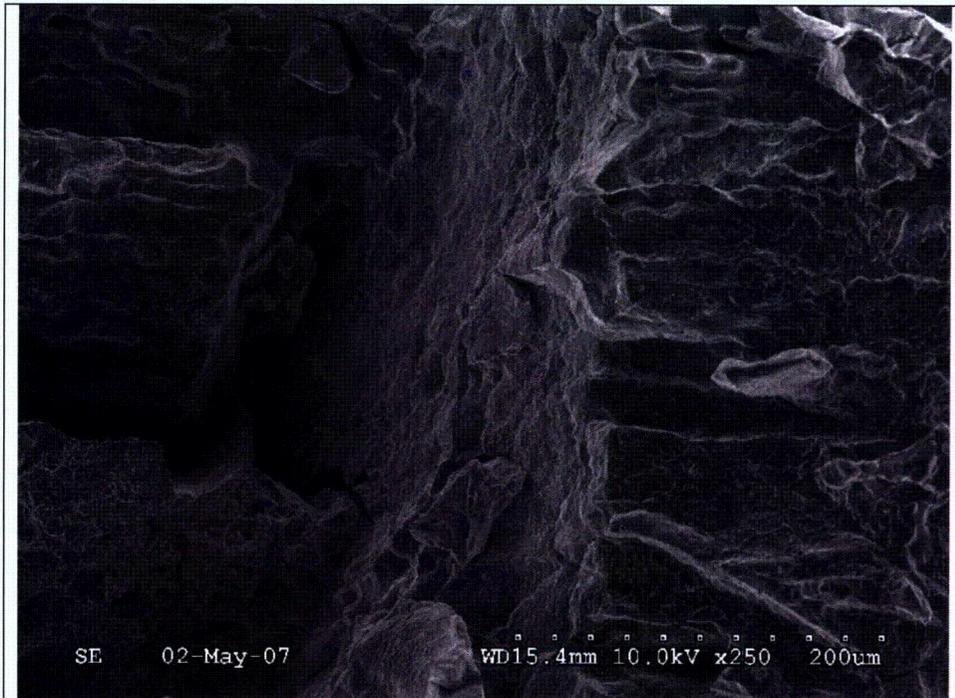
Figure 40 – A higher magnification view of the Figure 39 defect. The defect location and orientation is consistent with lack of fusion between weld passes. (250x Magnification)

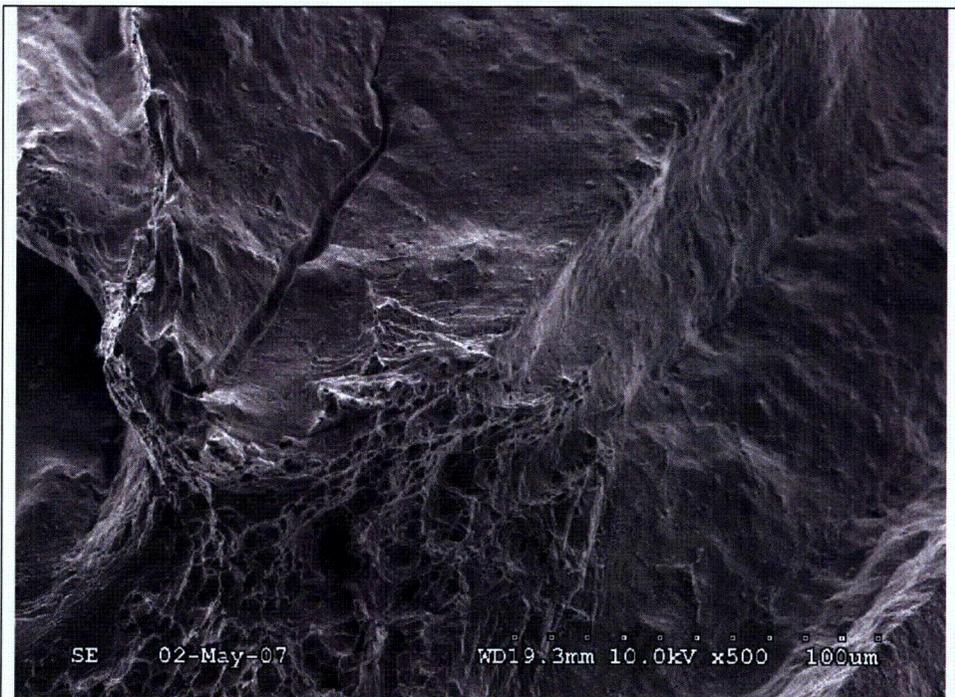
Various portions of the weld contained local patches of dimpled voids, which are indicative of ductile tearing (Figure 41). The tearing may have occurred during service PWSCC propagation due to residual stresses from the welding process, but it is also possible the regions were small intact ligaments that failed when the crack surface was broken open in the lab. In general, there were more ductile tearing regions toward the wetted surface of the sample.

Figure 41 – A local patch of ductile dimples on the exposed crack surface in Sample A1. In general, most of the ductile patches were located toward the wetted surface of the weld. (500x Magnification)

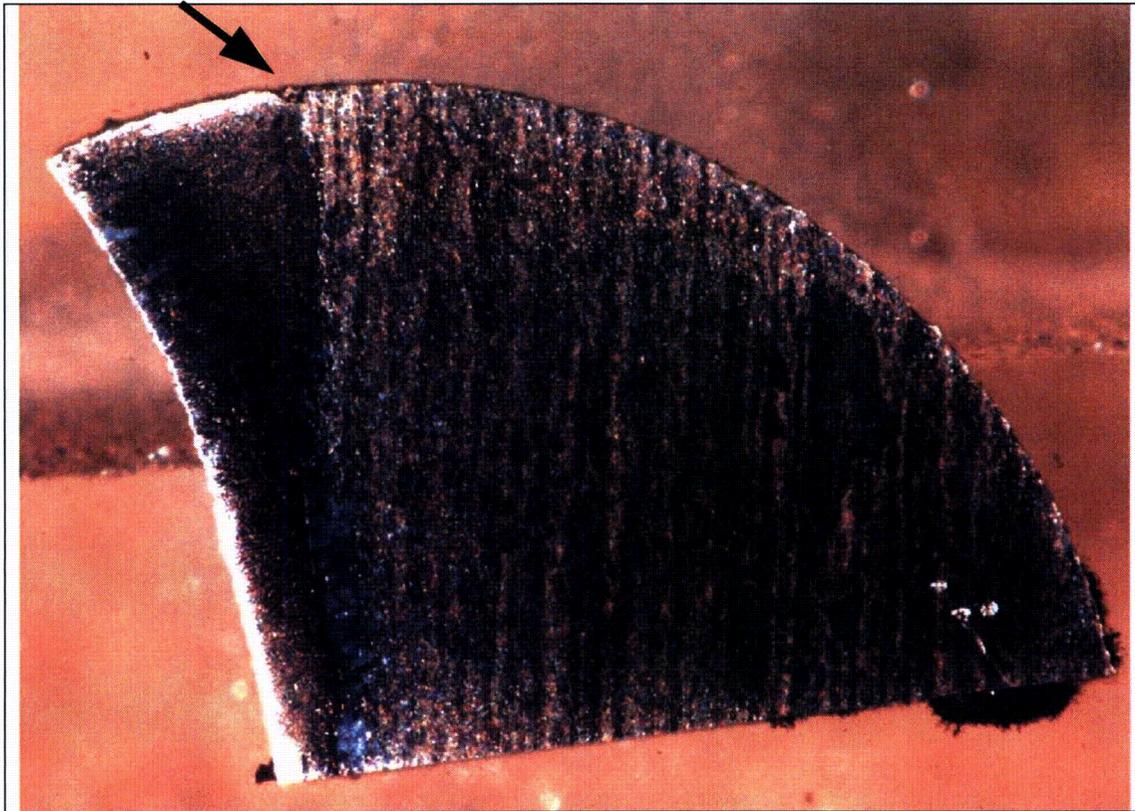
The Section A2A axial cut was located approximately 0.040" from the rounded dye penetrant indication on the EDM surface. The cut face was placed in a metallurgical mount and multiple grind-polish-examine steps were performed until the indication was uncovered. The indication was identified as a weld lack of fusion defect between the surface of the tube and the weld (Figures 42-44).

Figure 42 – A stereoscope view of metallurgical Sample A2A. The arrow points to the lack of fusion defect. (17x Magnification)

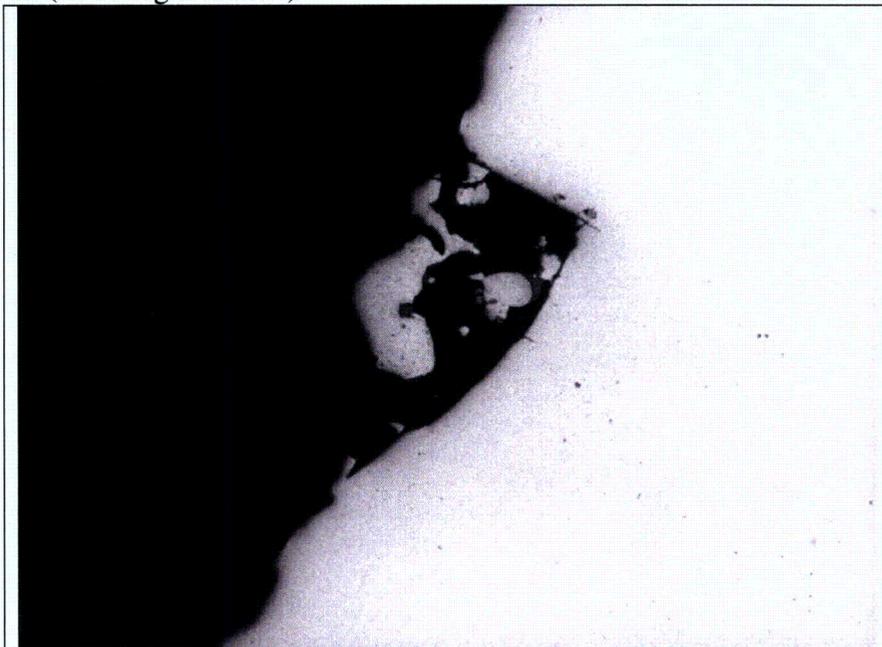
Figure 43 – An un-etched view of the lack of fusion defect. Note the globular debris from the EDM cutting process. The flat region is the tube side of the defect (190x Magnification)

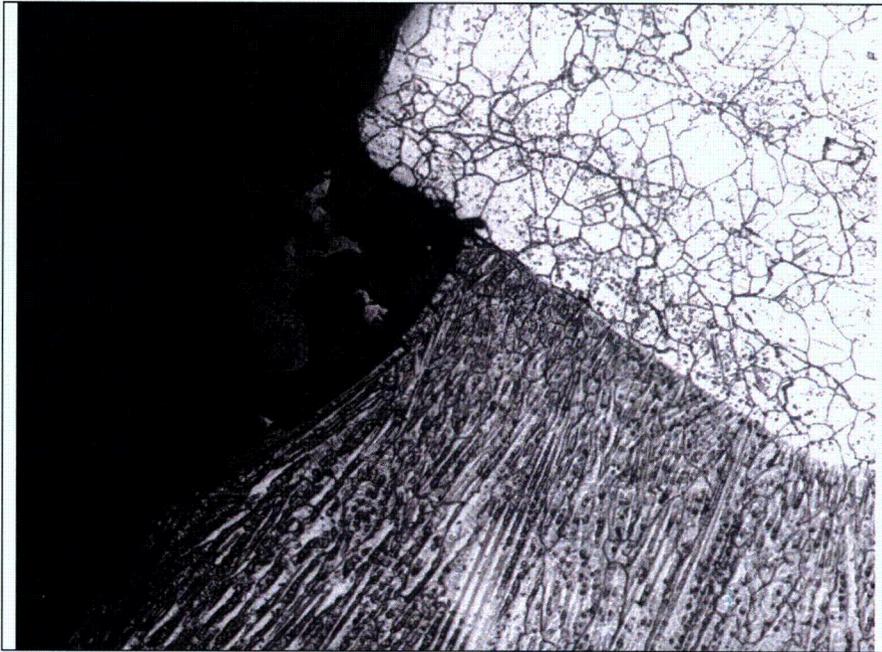
Figure 44 – An etched view of the lack of fusion defect in Sample A2A. Also note the flat interface at the fusion line, which indicates there was little penetration at this location. (190x Magnification, Electrolytic Phosphoric-Nital Dual Etch)

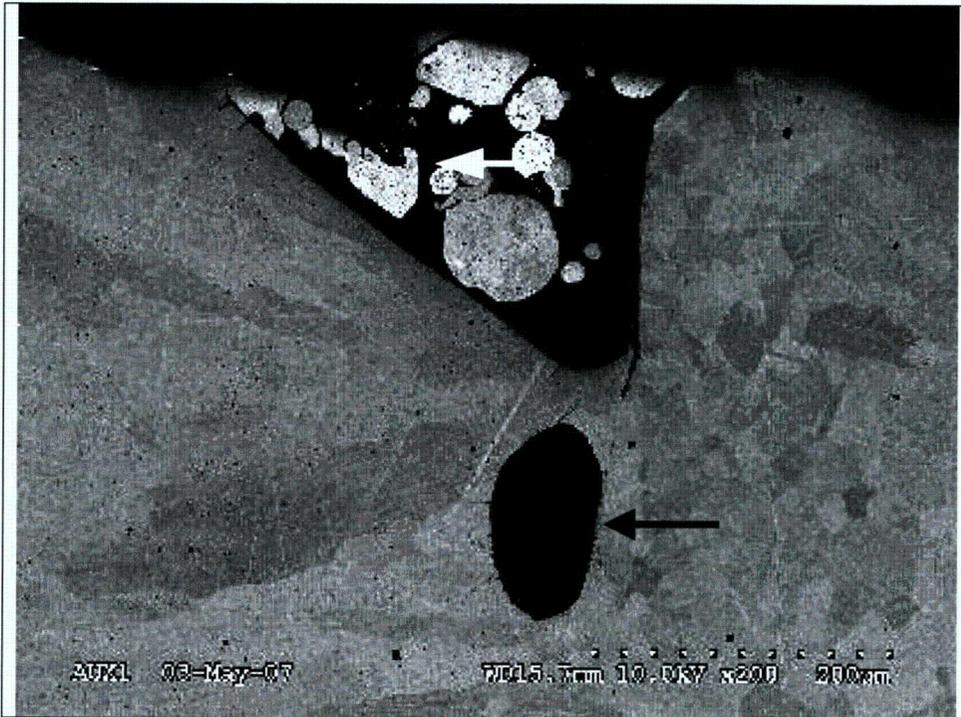
The metallurgical sample was re-polished in preparation for an SEM exam. The polishing step uncovered a porous inclusion near the edge of the lack of fusion crevice (Figure 45). Several incipient interdendritic cracks had initiated from the edge of the inclusion and the lack of fusion crevice (Figures 46 & 47). Most of the cracks appeared to be hot cracks; however, the angular appearance of two indications appeared similar to incipient PWSCC.

Figure 45 – A SEM photo of the Sample A2A metallurgical mount. Note the large inclusion (arrow) that is adjacent to the lack of fusion defect (200x Magnification).

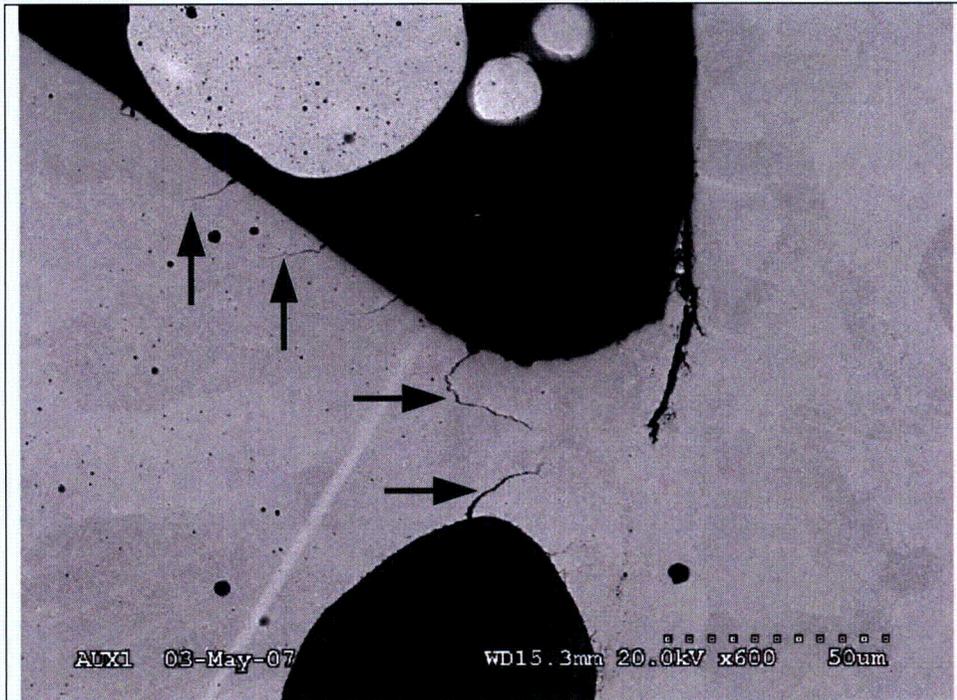
Figure 46 – A SEM photo of the Sample A2A mount. The arrows point to several incipient cracks that initiated from the inclusion and the lack of fusion defects. The defects are typical of hot cracking. (600x Magnification)

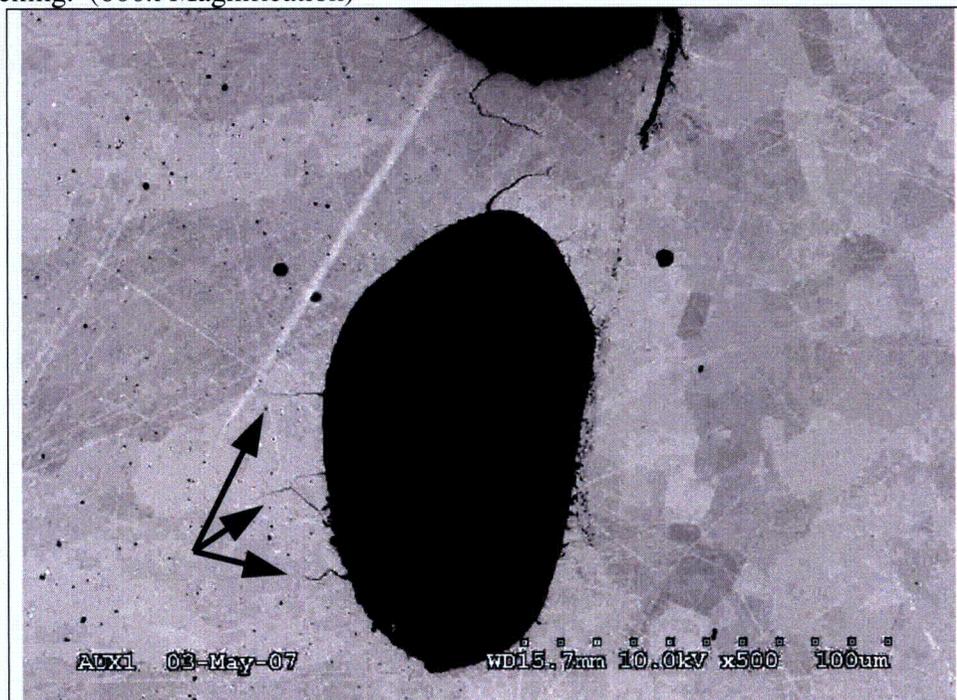
Figure 47 – Another SEM photo with arrows pointing to several cracks that initiated from the edge of the inclusion. The angled appearance of the lower two cracks appears similar to incipient PWSCC. Also note the incipient penetrations along the tube (right) side of the inclusion. (500x Magnification)

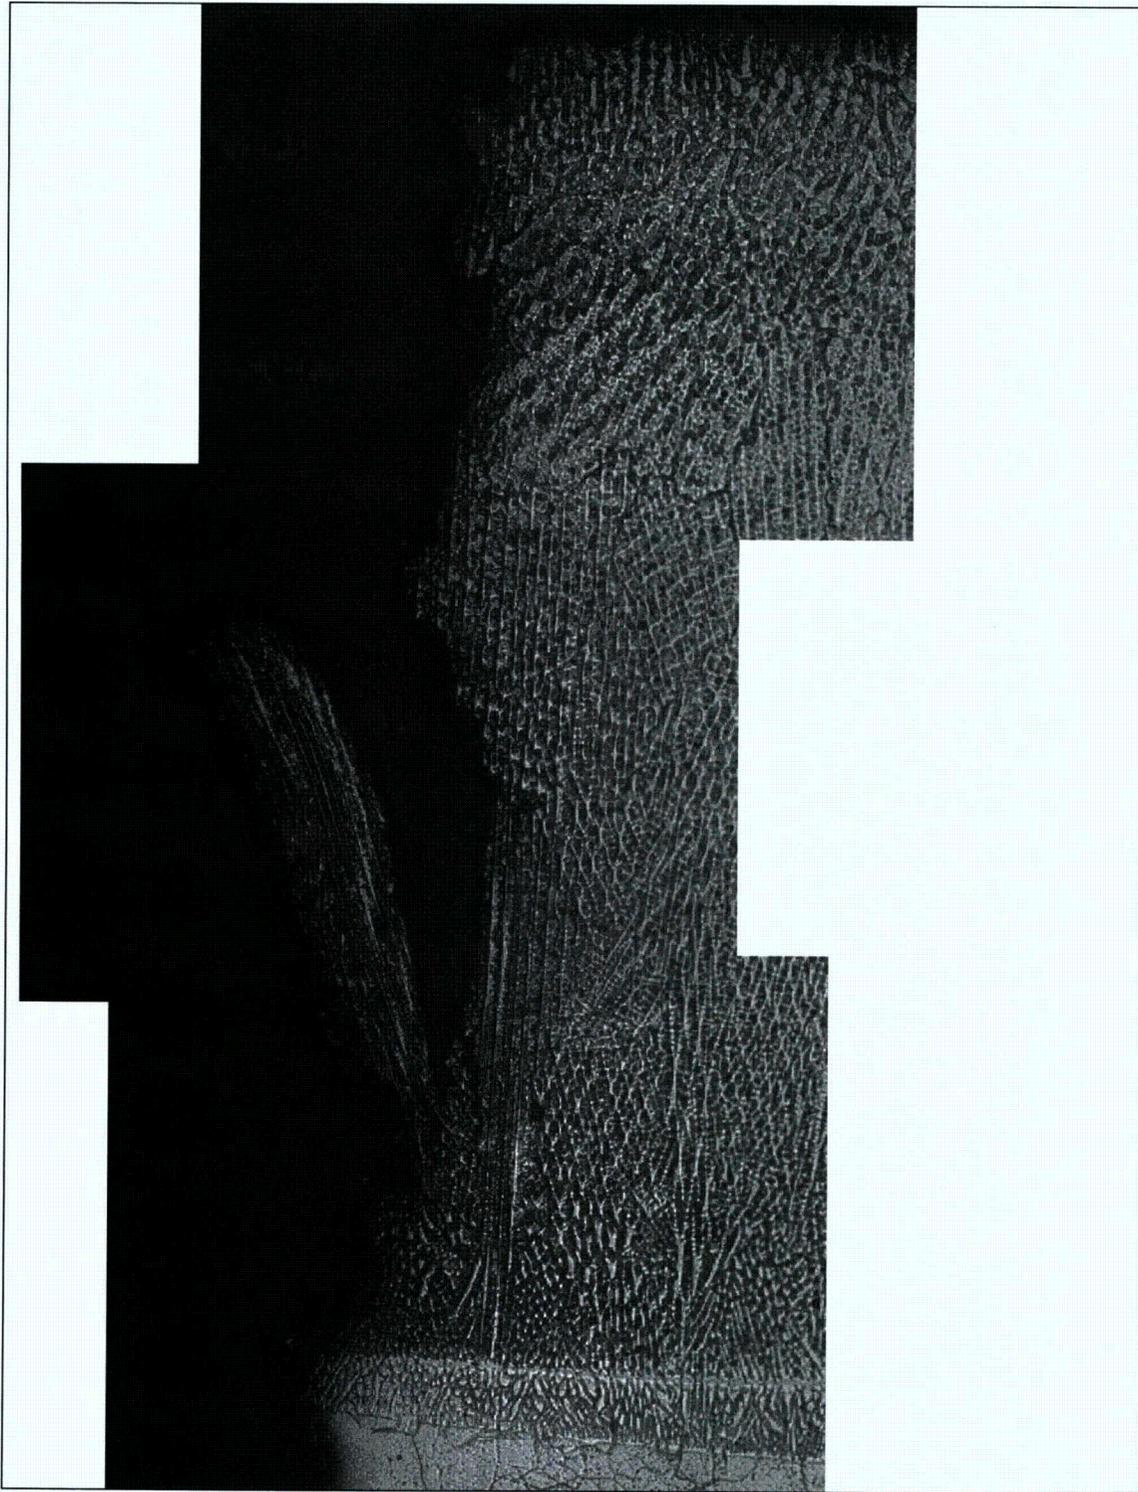
Figure 48 – A montage showing the edge of the axial crack in the Sample A2A weld. There was limited crack branching within the weld. The angled flap was likely pulled open when the crack surface was exposed in the lab. (190x Magnification)

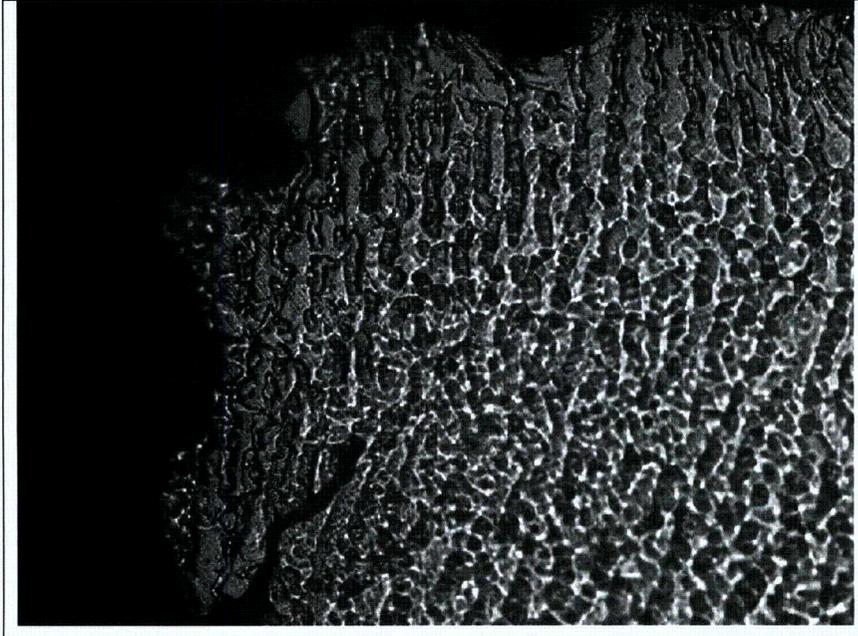
Figure 49 – A higher magnification view of Figure 48 near the wetted surface. In this region, the only branch was angled toward the wetted surface. (375x Magnification, Electrolytic Phosphoric-Nital Etch)

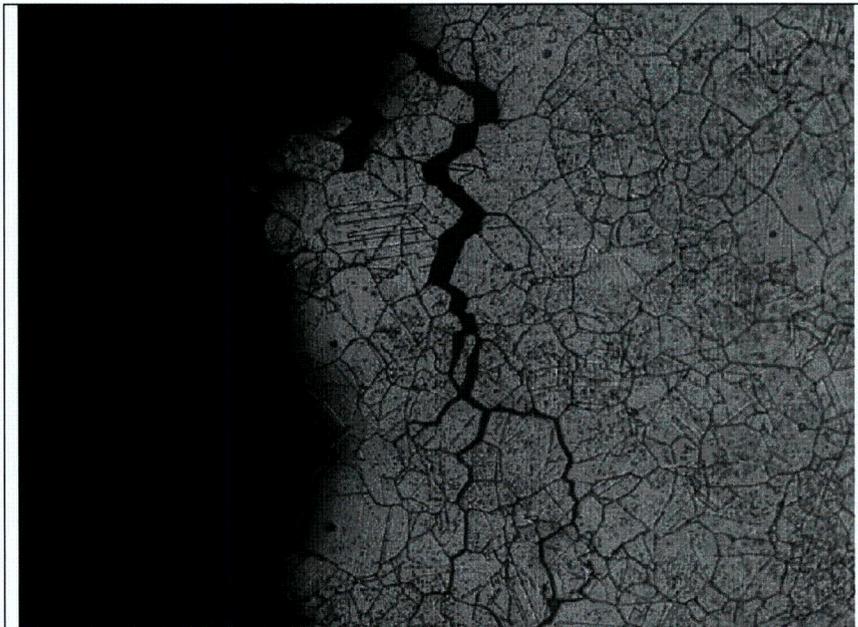
Figure 50 – An intergranular, branched crack that was connected to the axial crack in the Sample A2A tube material. (375x Magnification, Electrolytic Phosphoric-Nital Dual Etch)

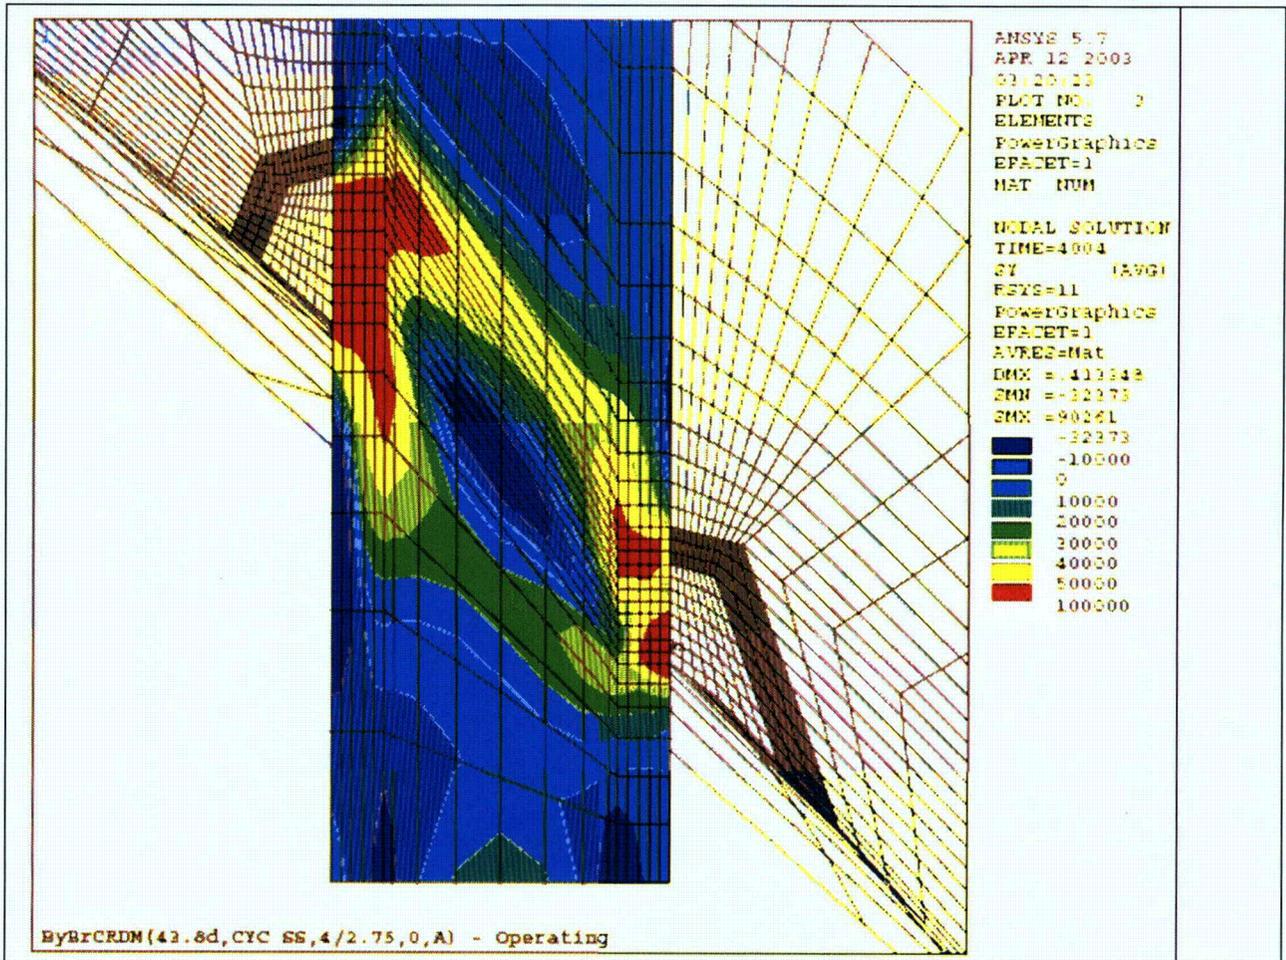
Figure 51 – A hoop stress plot from Reference 9 for the configuration that is applicable to the #68 CRDM penetration. The calculation included residual welding stresses and the stress from the operating pressure. The red areas highlight the high stress regions, which have calculated stresses between 50,000 to 100,000 psi. Note the high stress region at the downhill side of the weld corresponds to the approximate location of the axial indication in the #68 CRDM penetration.
