Summary of SABIA's Root Cause Analysis concerning the incident February 29th 2008 at the Idaho Falls manufacturing facility at 2300 N. Yellowstone Highway Idaho Falls, ID 83401 bay 3 & 4.

This refers to the breached strontium-90 radioactive source at our manufacturing facility. Our findings have found several discrepancies in the NRC INSPECTION REPORT 030-35997/08-001.

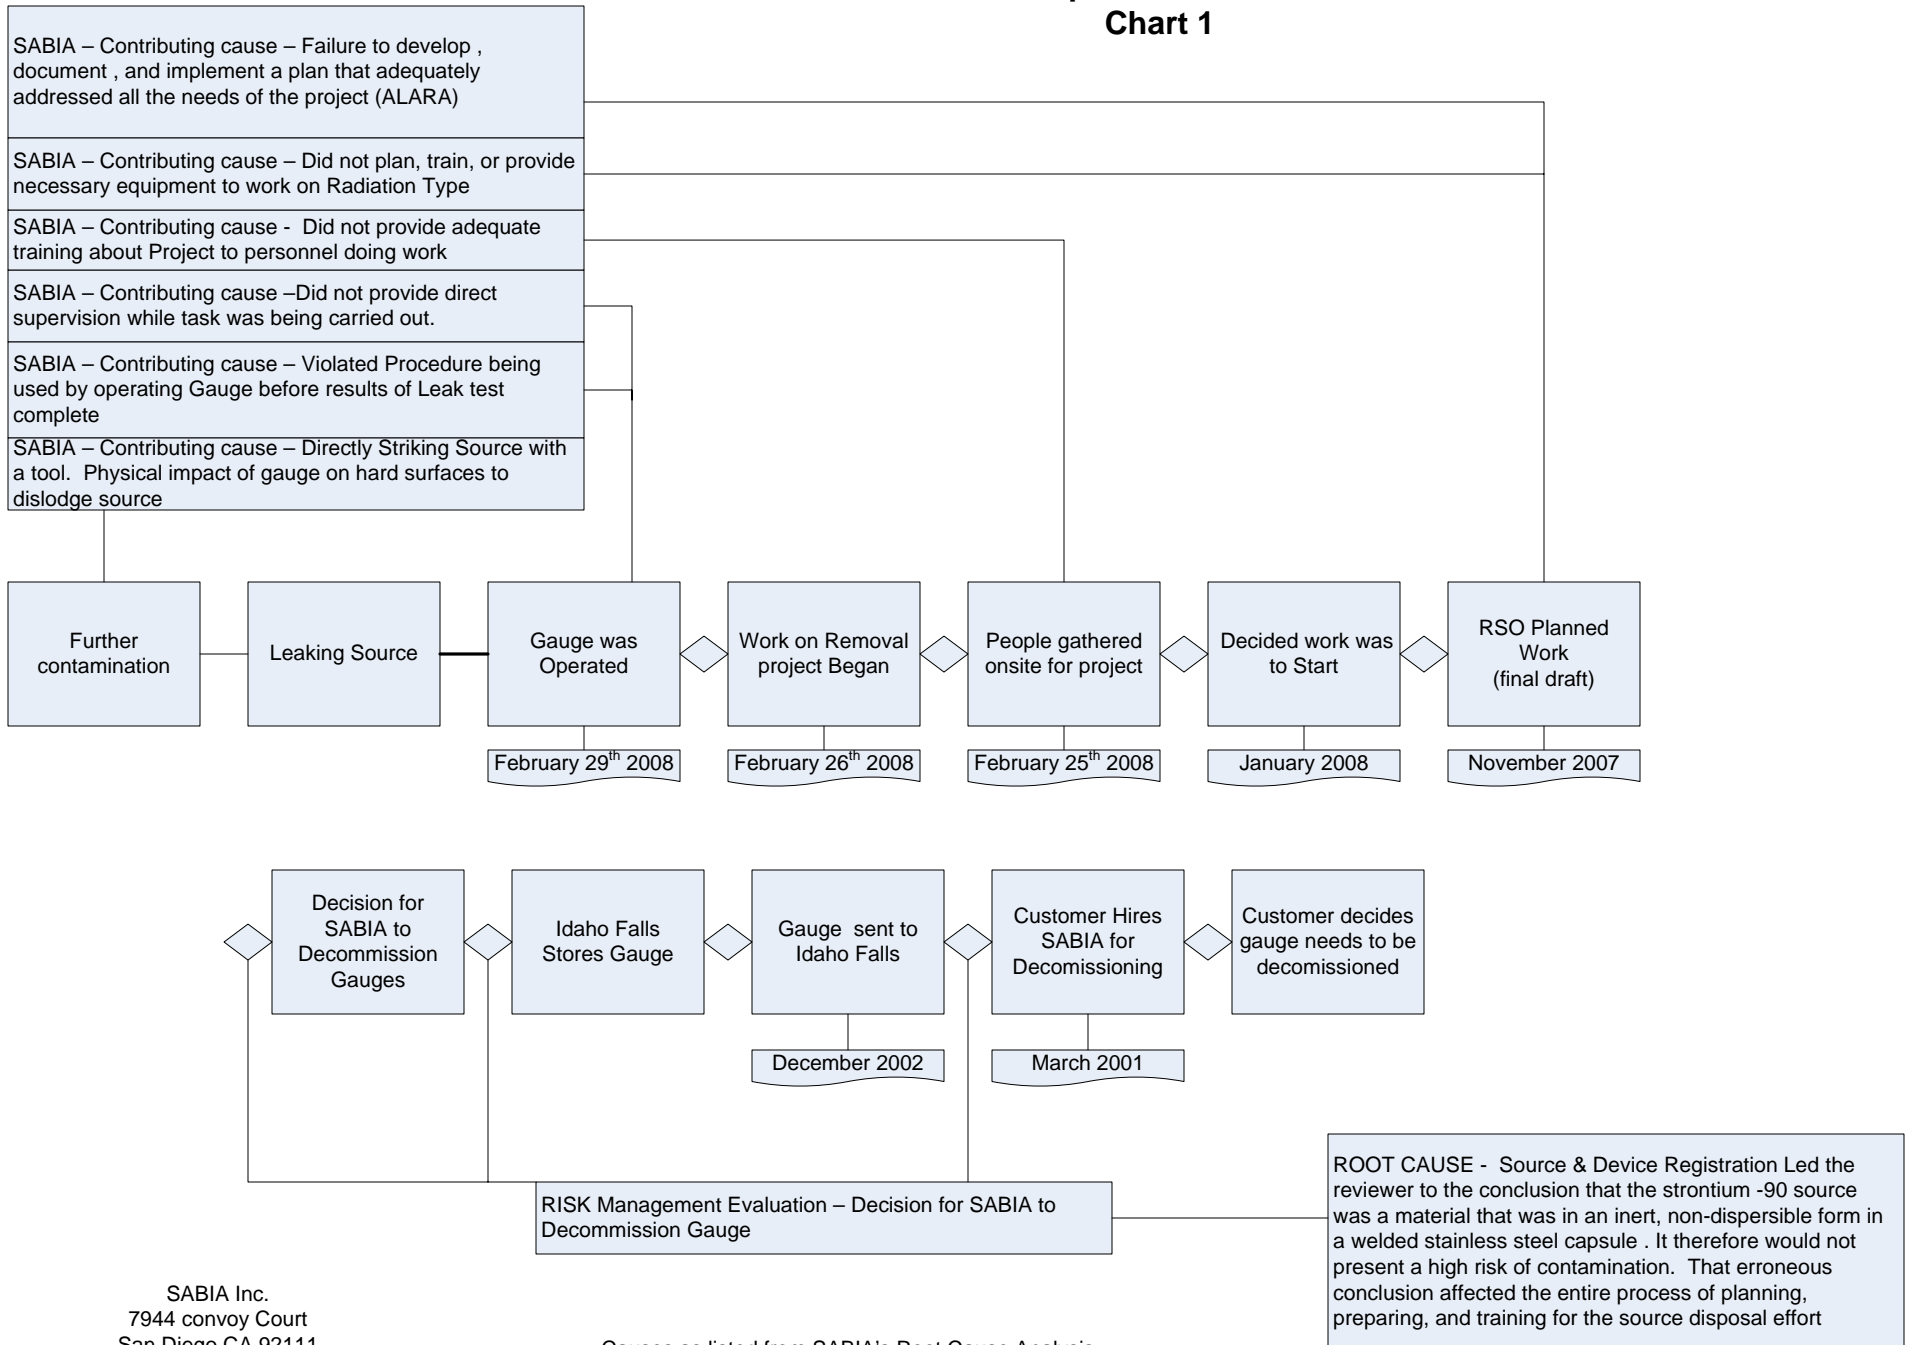
Two charts are part of this report. Chart 2 shows the causes listed by the NRC and where they fall in the incident timeline. Chart 1 shows the main findings of the SABIA analysis and where those causes fall on the timeline.

ROOT CAUSE -Source & Device Registration led the reviewer to the conclusion that the strontium -90 source was a material that was in an inert, non-dispersible form in a welded stainless steel capsule . It therefore would not present a high risk of contamination. That erroneous conclusion affected the entire process of planning, preparing, and training for the source disposal effort.

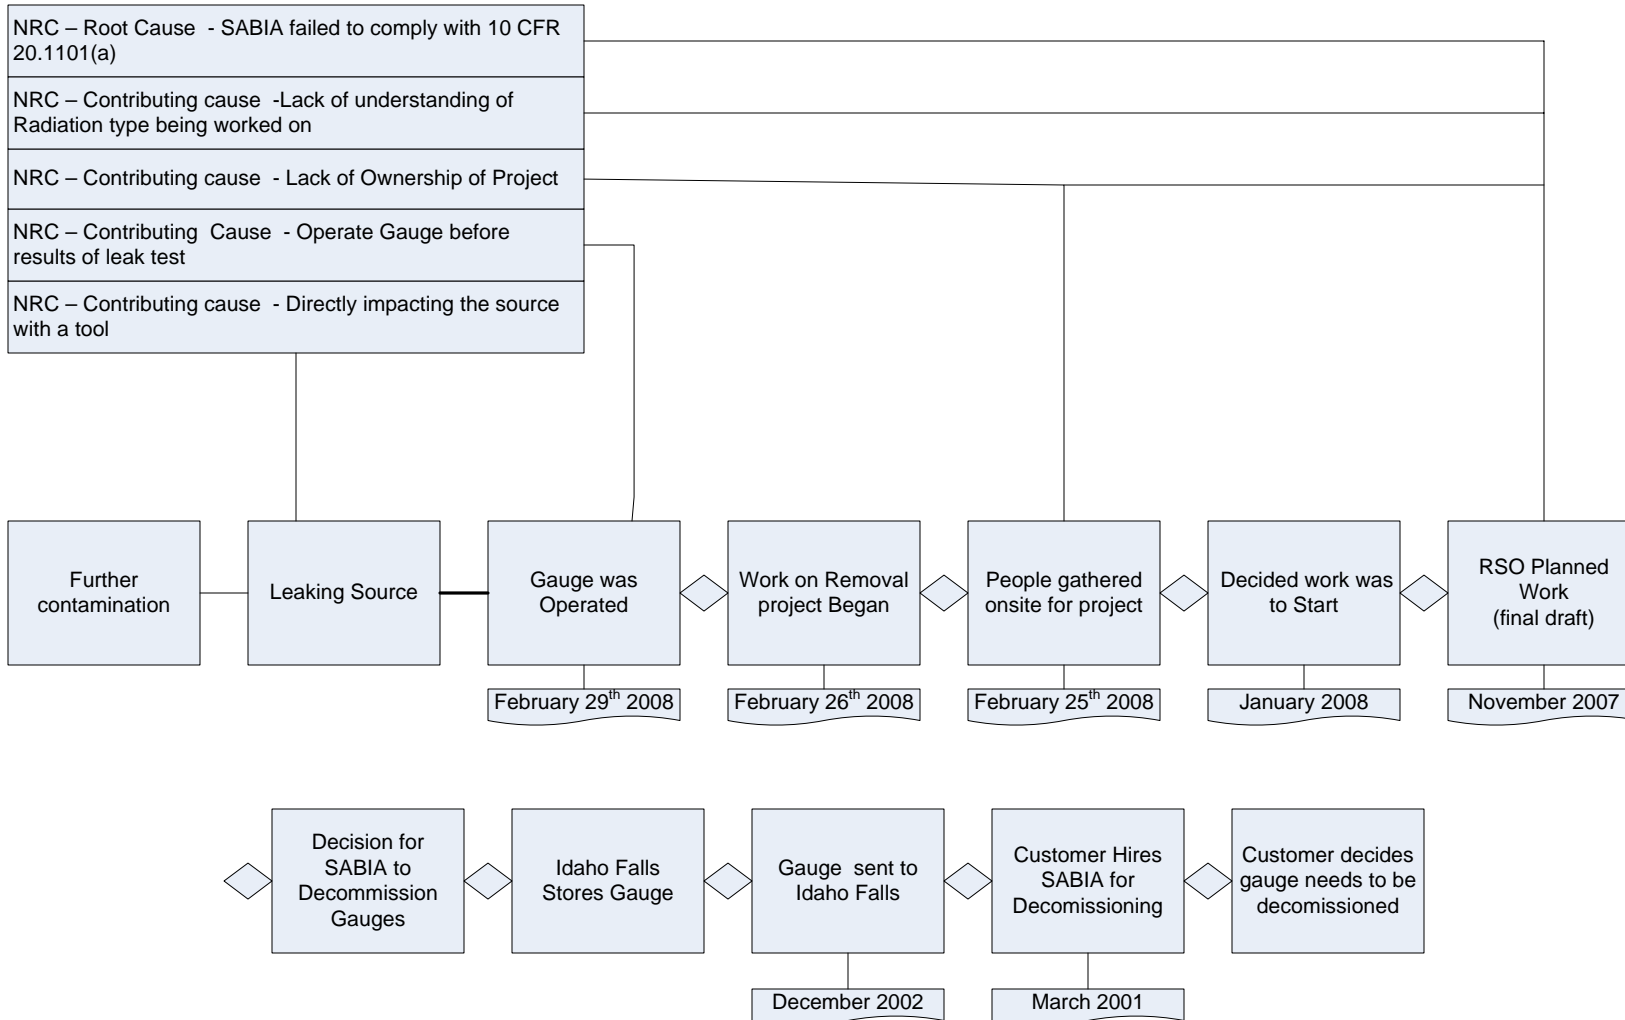
Chart 2

Causes as listed in the NRC Report 030-35997/08-001
