PVP2009-77790

## Severe Transportation Accidents: Impacts of Severe Fires on Radioactive Material Transportation

Christopher S. Bajwa, PE  
U.S. Nuclear Regulatory Commission  
301-492-3333  
[Chris.Bajwa@nrc.gov](mailto:Chris.Bajwa@nrc.gov)

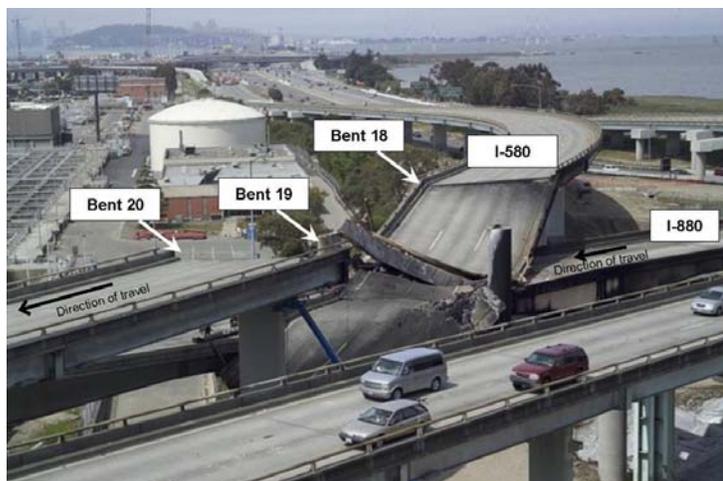
The main portion of the fire spread along a section of the I-880 roadway. Some of the gasoline went through the scupper drain on I-880 and burned on the ground around the support pillar. A photograph of the scene after the fire was extinguished is shown in Figure 2<sup>1</sup> [2].

**Fig. 2. Post-fire aerial view of the collapsed section of I-580, looking west. Picture from Caltrans**

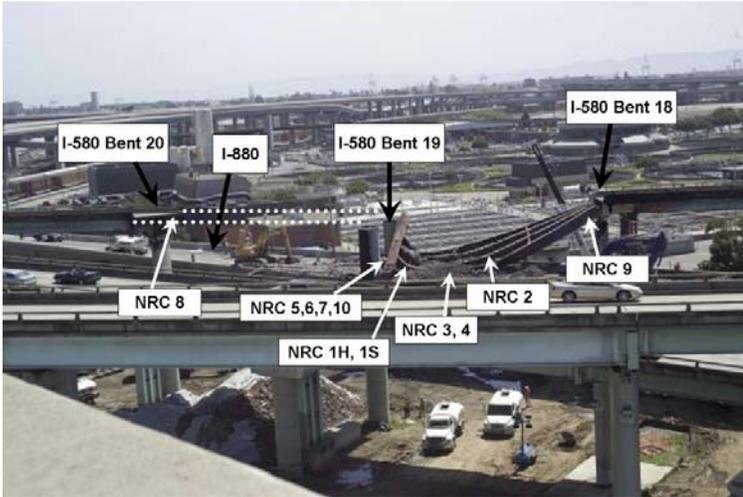
**Fig. 3. View of damage during demolition looking southwest.<sup>2</sup>**

Between Bent 18 and Bent 19, the plate girders from I-580 were in contact with the I-880 roadway. Significant beam distortion is apparent as a consequence of heating, the resultant weakening of the steel structure, and the load of the concrete structure. No paint was noted on these beam sections. Based on this observation, it was determined that the plate girder section designated as Plate Girder 5 in Figure 4, and shown in detail in Figure 5, was originally located between Bent 18 and Bent 19 where the I-580 overpass was in contact with the I-880 road bed. Originally, the plate girder was approximately 122 cm [48 in] high. As shown in Figure 5, the end of Plate Girder 5, that was believed to be closest to Bent 19, buckled as the result of a loss of strength at elevated temperature and the subsequent impact with the I-880 road bed.

<sup>2</sup> Bent 18, 19, and 20 and approximate locations of collected specimens are indicated. Dotted lines represent pre-accident overpass structure that was demolished and removed prior to this photograph. Original picture from Caltrans website <http://www.dot.ca.gov/dist4/photography/images/070430/index2.html>

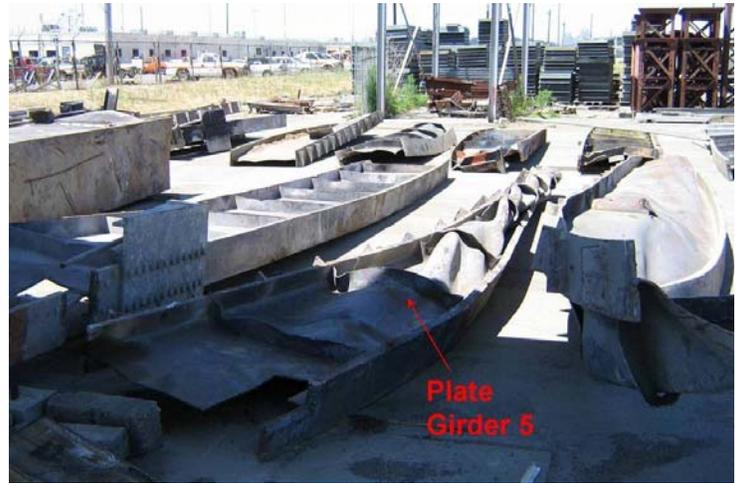
**Fig. 4. Girders at the Caltrans storage yard**

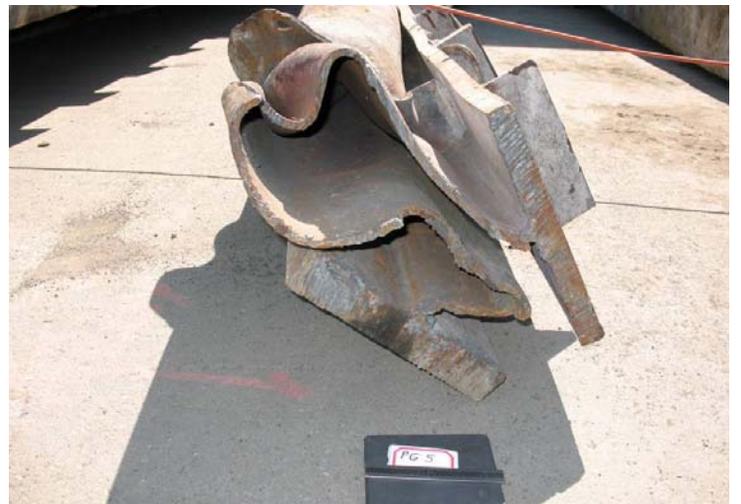
overpass was in contact with I-880. Originally, the plate girder was approximately 122 cm [48 in] high. As shown in Figure 6, the end of Plate Girder 5, that was believed to be closest to Bent 19, buckled as a result of the loss of strength at elevated temperature.

**Fig.5. Photograph of Plate Girder 5 believed to be between Bent 18 and Bent 19**

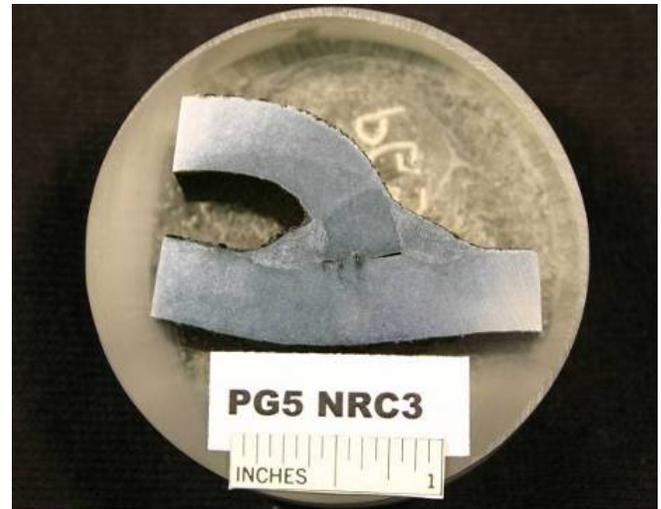
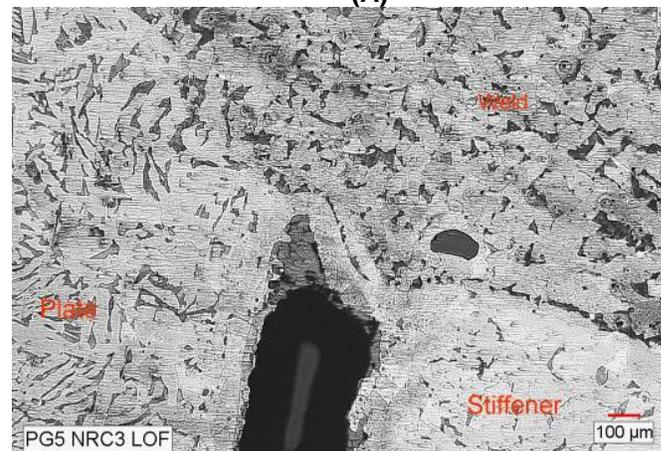
Figure 6 (A) shows a specimen from Sample NRC 3 after mounting, polishing, and etching. The distortion of the plate and the stiffener are obvious, given that the plate and stiffener were originally perpendicular to each other. Figure 6 (B) shows the microstructures of the plate girder, the stiffener, and the weld. As expected, the plate and the stiffener consist of ferrite and pearlite. The welds are also ferrite and pearlite and contain no indication of a dendritic structure that would have been present immediately after welding.

**Fig. 6. Metallurgical specimen from NRC 3 after mounting, polishing, and etching (A). Microstructure of stiffener fillet weld, plate girder, and stiffener (B)**

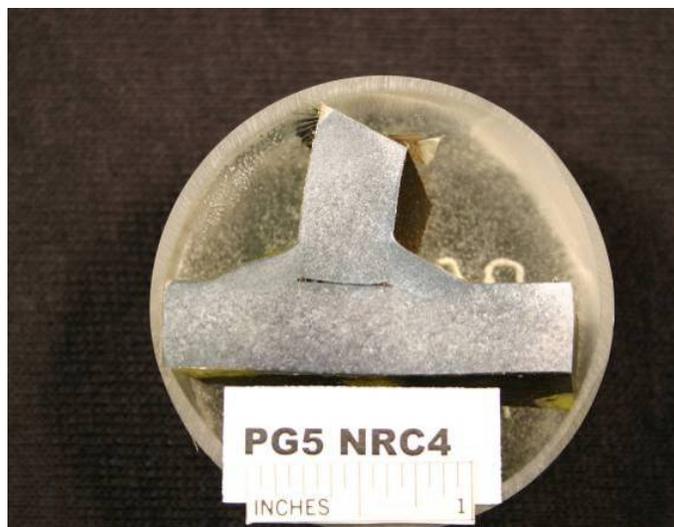
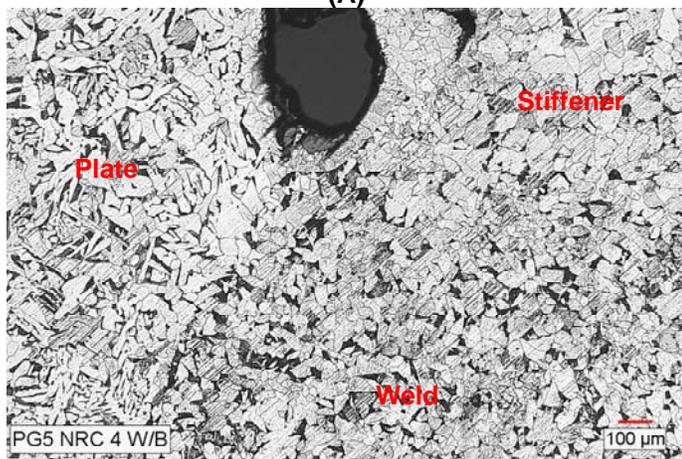
A specimen from Sample NRC 4 is shown in Figure 7. The microstructure of the weld, plate, and stiffener consists of ferrite and pearlite. Similar to Sample NRC 3, the weld on Sample NRC 4 shows no signs of any dendritic structure that was likely to be present after welding. The stiffener welds in both Samples NRC 3 and NRC 4 are fully transformed and practically indistinguishable from the plate.

**Fig. 7. Metallurgical specimen from NRC 4 after mounting, polishing, and etching (A). Microstructure of stiffener fillet weld, plate girder, and stiffener (B)**

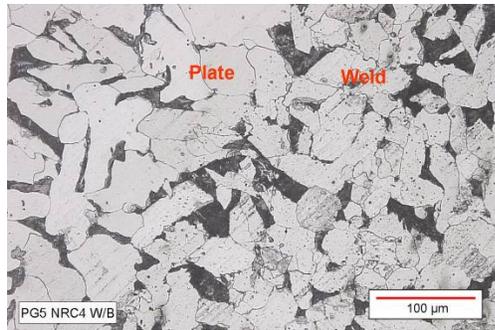
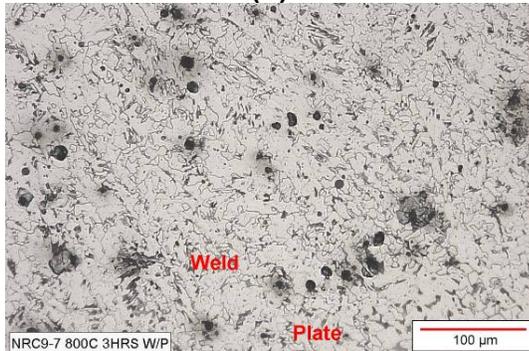
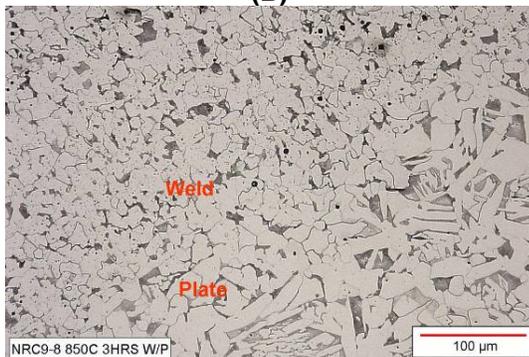
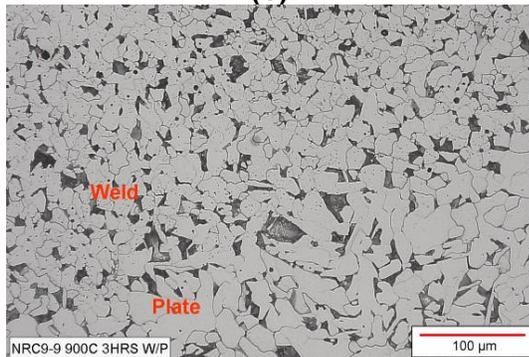
Figure 8 (B, C, and D) shows the microstructure of the plate and the weld after exposure to temperatures of 800 to 900°C [1,472 to 1,652°F], along with the microstructure of a specimen from Sample NRC 4 (A). The microstructural distinction between the weld and the plate is apparent at temperatures of 800°C [1,472°F] or less. At 900°C [1,652°F], the distinction between the weld and the plate is reduced and limited to the differences in grain size between the two regions. The microstructure of the welds in the specimens exposed to 850 or 900°C [1,562 or 1,652°F] appears to be similar to the microstructures observed in welds in specimens taken from Samples NRC 3 and NRC 4.

**Fig. 8. Weld and plate microstructures<sup>3</sup> for samples (A) NRC 4; (B) NRC 9-7, 800°C [1,472°F]; (C) NRC 9-8, 850°C [1,562°F]; and (D) NRC 9-9, 900°C [1,652°F]**

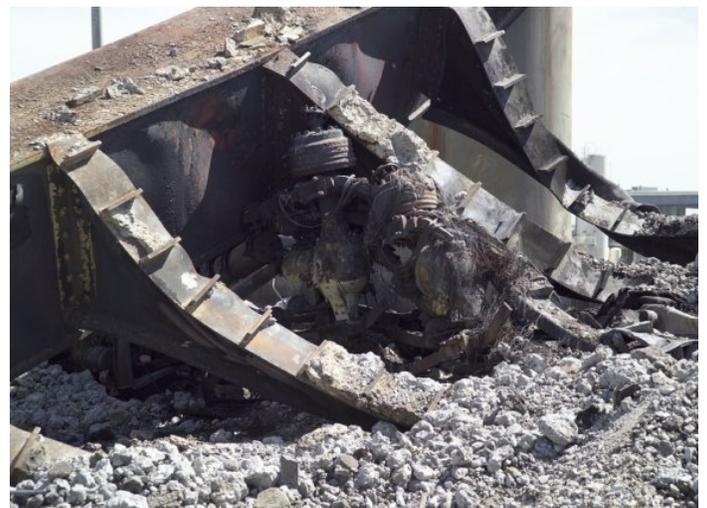
**Fig. 10. Photograph of the tanker truck remains under collapsed overpass**

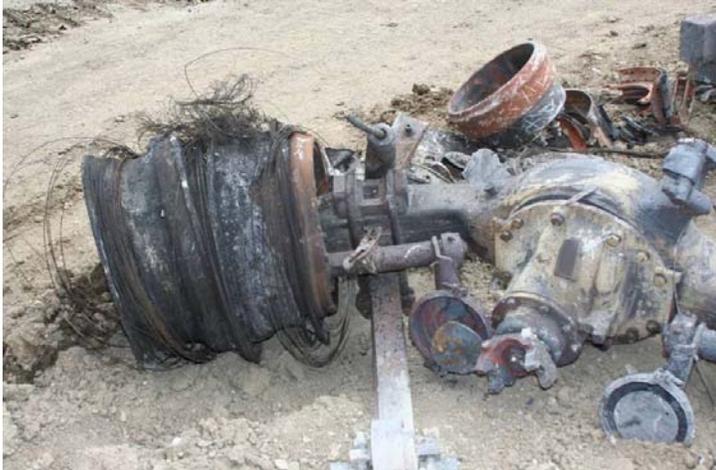
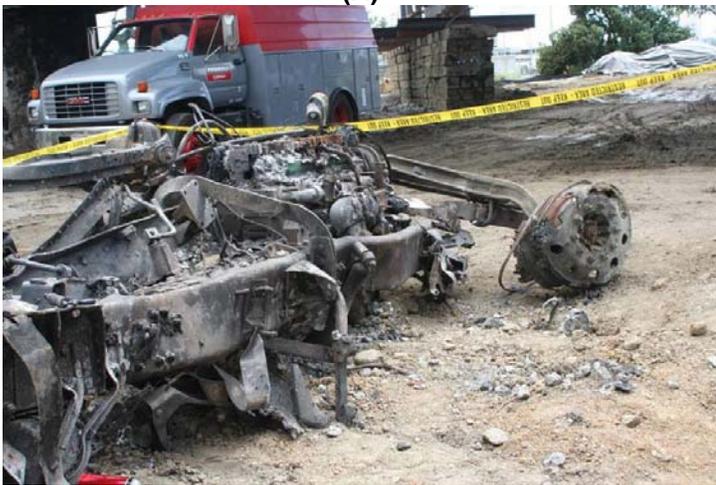
**Fig. 11. Photographs of the tanker truck remains at accident site; (A) truck axle; (B) engine and frame**

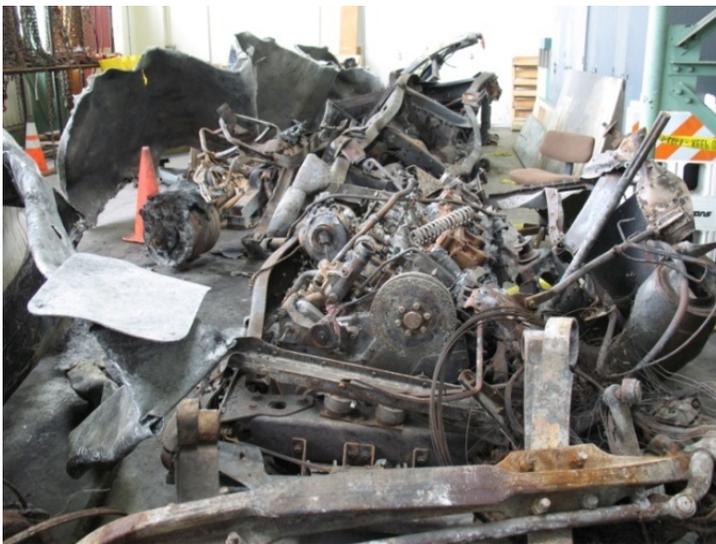
**Fig. 12. Photograph of the tanker truck remains at Caltrans storage yard**

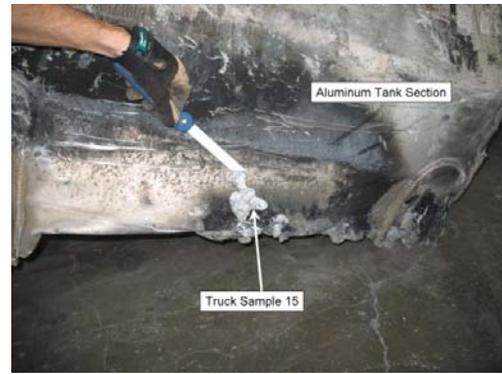
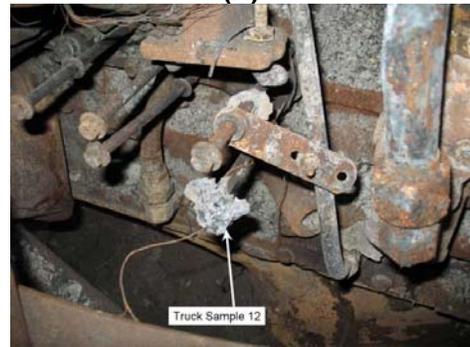
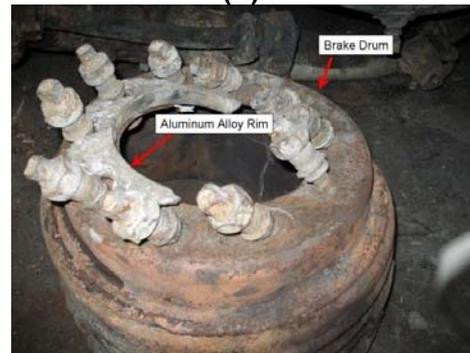
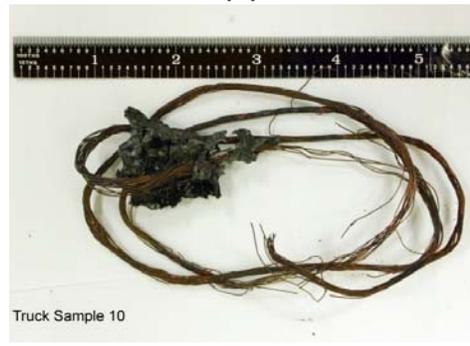
Truck Sample 12 was unique because it had multiple materials including a steel bolt, a strand of steel wire, and an aluminum alloy that may have been from a component or bracket that was attached to the engine. The composition of the aluminum sample is included in Table 6. Figure 13 shows that only the aluminum alloy melted. Similarly, Truck Sample 10, originally located on the truck frame, contained copper wire covered with aluminum that was melted and resolidified. The aluminum composition was determined to contain a significant amount of copper and thus has a low liquidus temperature of 590°C [1,094°F]. As shown in Figure 13, the small gauge copper wire showed no indication of melting.

Based on the compositional analysis, the liquidus temperature ranged from 590°C [1,094°F] to 720°C [1,330°F]. Melting was clearly apparent in all samples, indicating the temperature in some

locations reached values of 720°C [1,330°F]. Because very large portions of the thin-walled tank were not melted, the temperature in these areas was below 570°C [1,058°F].

**Fig. 13. Photographs of aluminum alloy truck samples; (A) Sample 15: portion of melted aluminum tank; (B) Sample 12: from passenger side of engine; (C) Sample 14: partially melted aluminum wheel; (D) Sample 10: copper wire partially covered with aluminum**

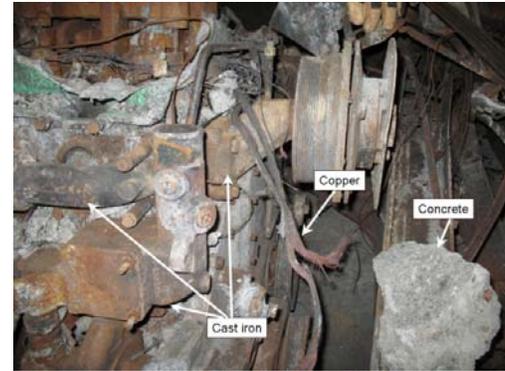
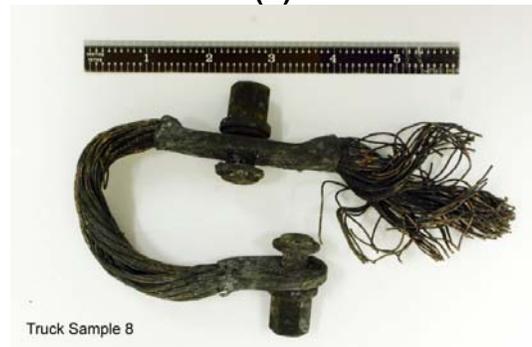
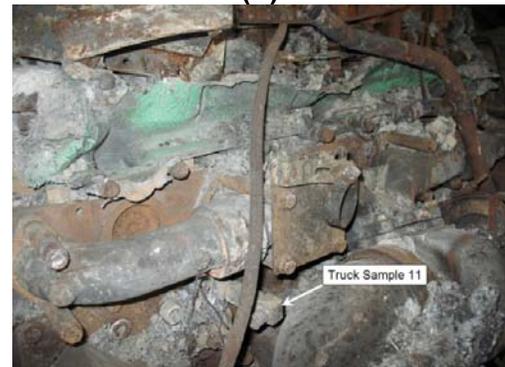
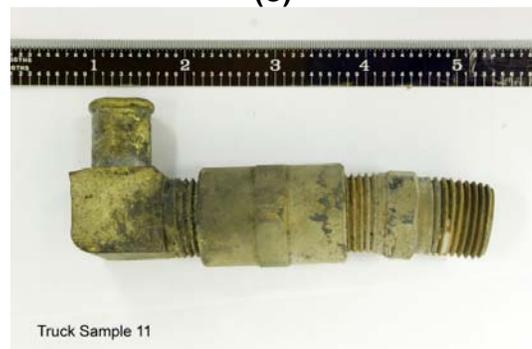
Copper used for electrical system wiring was found throughout the remains of the truck. Large sections of copper wiring, likely the battery cables, were observed in the engine compartment. Copper ground straps were found on the frame of the tanker truck. Smaller gauge wiring that would be expected for signal and marker lights was also found in many locations on the tanker truck frame. None of the copper wires examined displayed signs of melting. A brass fitting was also found attached to the engine block. The location of this sample was located approximately 10 cm [4 in] from Truck Sample 12 that had aluminum which melted during the fire. The brass sample did not display indications of melting. Photographs of the copper-based alloy samples are shown in Figure 14.

As expected, the copper wiring was pure copper, consistent with the compositional specifications for copper wire [10,11]. Some silicon contamination was noted on Truck Sample 11, which is believed to be from the pulverized concrete that covered the truck after the overpass collapse. The melting point of pure copper is 1,084 °C [1,983 °F]. As copper wiring was found on many locations along the truck frame, it is apparent that near the truck, the temperature during the fire did not exceed the melting point for copper. The solidus temperature for the brass fitting is 903 °C [1,657 °F], and the liquidus temperature is 930 °C [1,706 °F] based on the copper and zinc concentration. Small amounts of lead are typically added to improve machining but are not expected to significantly alter the solidus or liquidus temperature. As the brass fitting showed no indications of melting, the temperature near the engine compartment was estimated to be less than 903 °C [1,657 °F].

**Fig. 14. Photographs of copper alloy truck samples; (A) battery cable from engine compartment; (B) ground strap from tanker truck frame; (C) and (D) brass fitting from passenger side of the engine**
