PVP2009-77790

Severe Transportation Accidents: Impacts of Severe Fires on Radioactive Material Transportation

Christopher S. Bajwa, PE
U.S. Nuclear Regulatory Commission
301-492-3333
Chris.Bajwa@nrc.gov

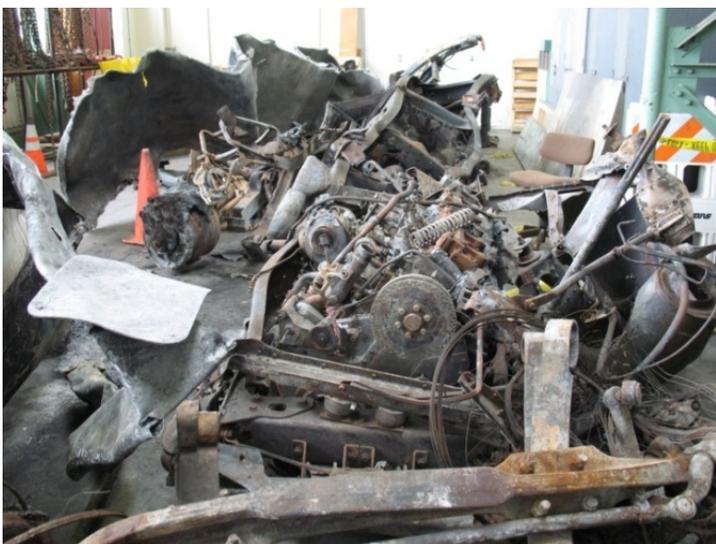
Fig. 12. Photograph of the tanker truck remains at Caltrans storage yard
