SUBJECT: NRC INSPECTION REPORT NO. 70-143/2009-007

Special Inspection Team Charter
NFS Glove Box Design Issues

Nuclear Fuel Services, Inc.
NRC Inspection Report 70-143/2009-007

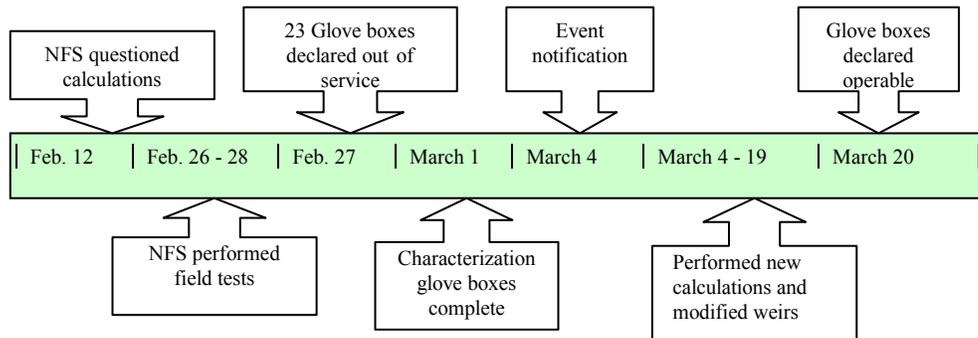
Following the completion of each review, the glove boxes were returned to service on a case-by-case basis using a well-defined and safety-focused management review process. All glove boxes were returned to service by March 20. The following flow chart presents the sequence of events with respect to the decision making process taken by the licensee.

The inspectors noted that the licensee demonstrated a questioning attitude and used a conservative approach in responding to the event. As an immediate corrective action, the licensee removed uranium-bearing materials from the affected glove boxes and declared them out of service to further evaluate the implications and extended condition of the event. The decision to declare the glove boxes out of service was based on a re-examination of set point calculations and field tests performed by licensee staff. The field tests revealed that during an overflow situation the drains installed on the glove boxes may not limit the height of liquid to less than or equal to one inch in certain localized areas of the glove boxes, as required by the credited items relied on for safety (IROFS). The licensee performed new set point calculations and modified drain weir heights to ensure appropriate discharge flow rates.

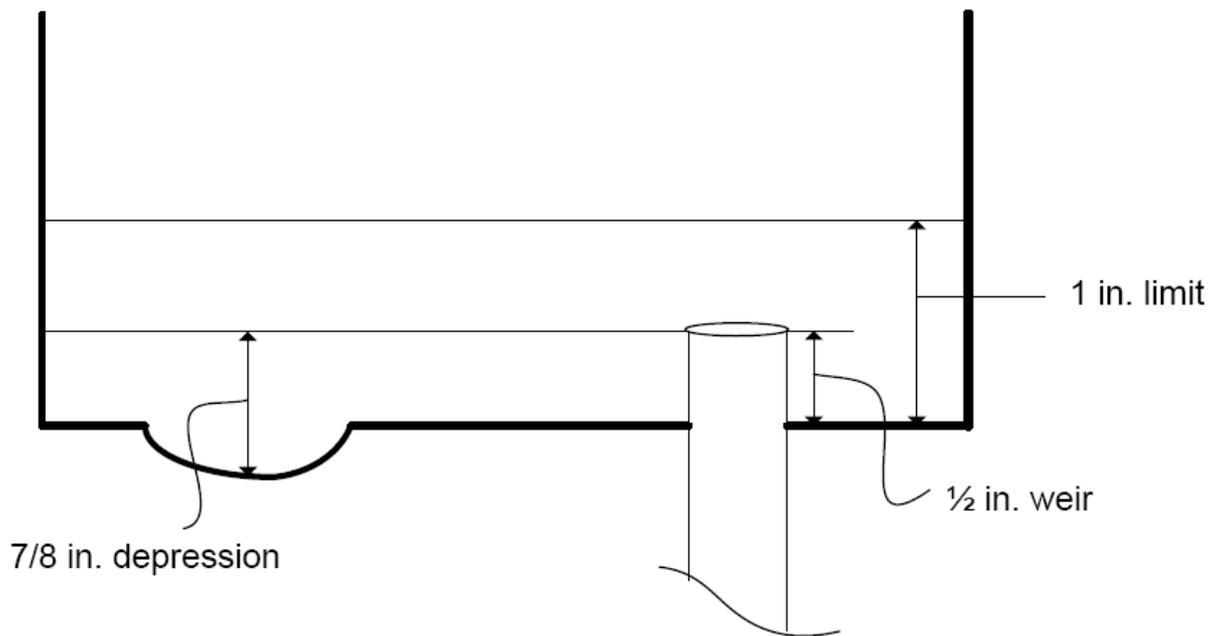
The inspectors noted that original (pre-event) calculations were based on an orifice type calculation that assumed that the glove box floor was flat and did not account for the existence of a drain weir in the glove box. During the field tests, the licensee discovered that discharge flow rates were sensitive to drain weir heights and glove box floor flatness. The licensee noted that the affected glove boxes had depressions on the floor. Furthermore, the licensee identified some glove boxes with floor depressions up to 7/8 inch measured from the top of the weir (nominally, the weir height was about 1/2 inch above the glove box floor). This condition is illustrated in the following diagram (not drawn to scale).

The inspectors determined that the solution level in several glove boxes could have exceeded the 1 inch limit in localized areas of the glove boxes where the floor was sufficiently depressed. However, the inspectors concluded that even if the 1 inch limit was exceeded in some of these localized areas the potential safety consequences would have been minimal due to safety factors used in the calculations and nuclear criticality safety analysis (NCSA). The NCSA assumed that the solution level was uniform (not localized) throughout the box, the glove box was fully reflected on all sides (i.e. the room is flooded), and that the uranium enrichment was 100%. Based on these conservative assumptions, the NCSA determined that the condition where a criticality event becomes credible occurs when the solution level exceeds about 3.5 inches. These assumptions, in addition to the drains, provide sufficient margin for safe operation of the glove boxes. The criticality safety aspects associated with the potential for exceeding the 1 inch limit will be further evaluated for significance during a future inspection by a NCS inspector and documented in a separate NRC inspection report.

The inspectors noted that the post-event calculations were based on a circular weir type calculation. The post-event calculations also used a weir height based on the lowest point (greatest depression of the glove box floor) measured in the glove box. The inspectors noted that by using the lowest point of the glove box, the calculation results would be more conservative. In addition, the licensee physically modified the weir height to ensure an adequate drainage rate. The inspectors reviewed a sample of the post-event calculations for technical completeness and accuracy. The inspectors also assessed the decision making process used for determining that glove boxes were safe to return to service. The inspectors noted that the licensee evaluated each glove box individually. The licensee performed new set point calculations for each glove box and performed an inspection of each drain. The inspectors walked down several glove boxes to independently check the weir height modifications. No findings of significance were identified with respect to the decision making process used by the licensee.
