III. Findings and Analysis from the 2006 Outage

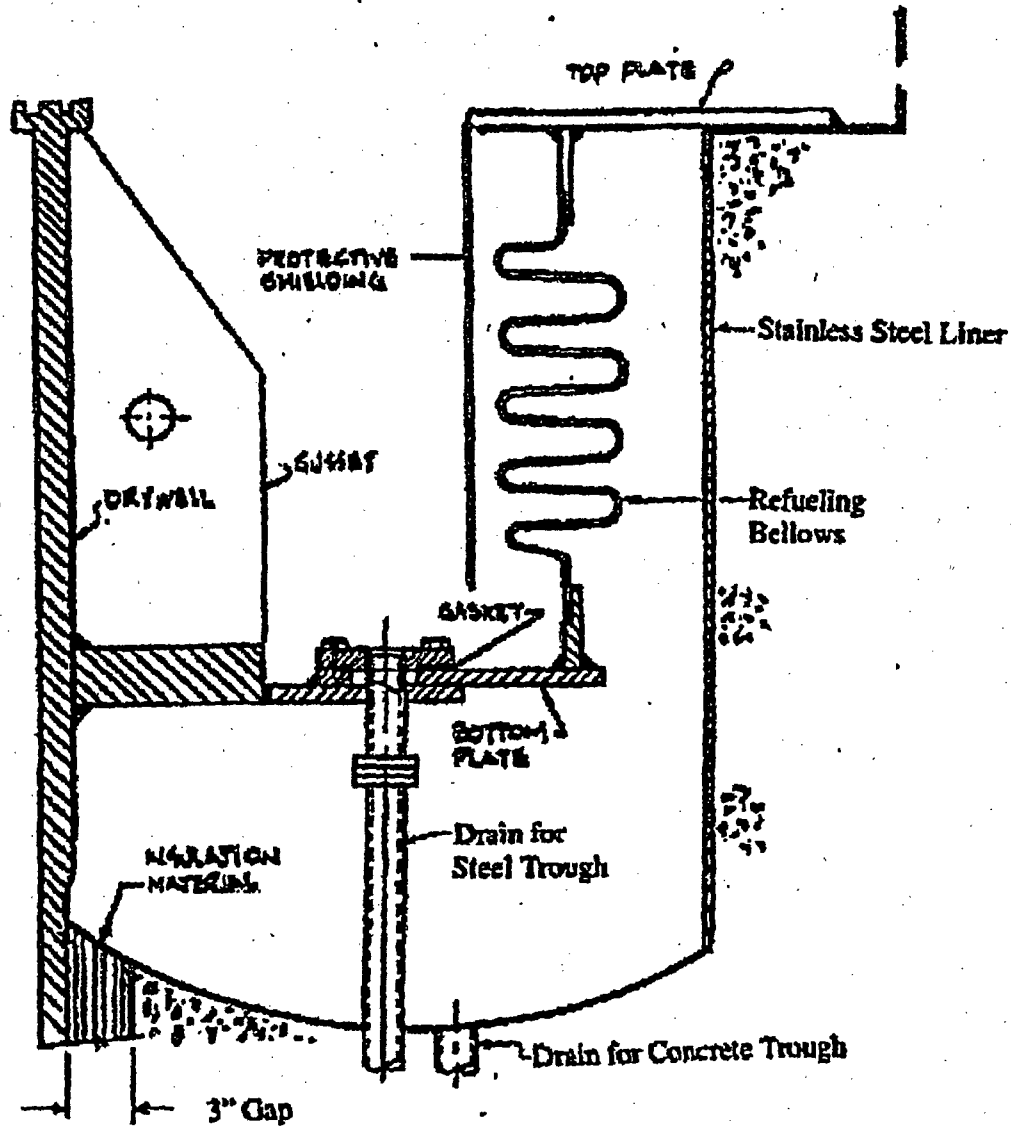
FIGURE 6 - REACTOR CAVITY TROUGH DRAIN

The reactor cavity was coated with a strippable coating prior to flooding the cavity for refueling activities. A small amount of leakage (approximately 1 gallon per minute (GPM)) was observed coming from the cavity trough drain line during the time period when the refueling cavity was flooded. Daily observations of the cavity trough drainage confirmed a steady stream of approximately 1 GPM during this period. Because this small amount of leakage did not exceed the drainage capacity of the trough, no water would have leaked onto the exterior surface of the drywell shell. The minor leakage was discharged to the plant's radwaste system as designed.
