Oyster Creek Generating Station
Facility Operating License No. DPR-16
NRC Docket No. 50-219

Subject: Submittal of Information to ACRS Plant License Renewal Subcommittee Related to AmerGen's Application for Renewed Operating License for Oyster Creek Generating Station (TAC No. MC7624)

**Oyster Creek
License Renewal Project
Drywell Monitoring Program**

Information for ACRS Subcommittee

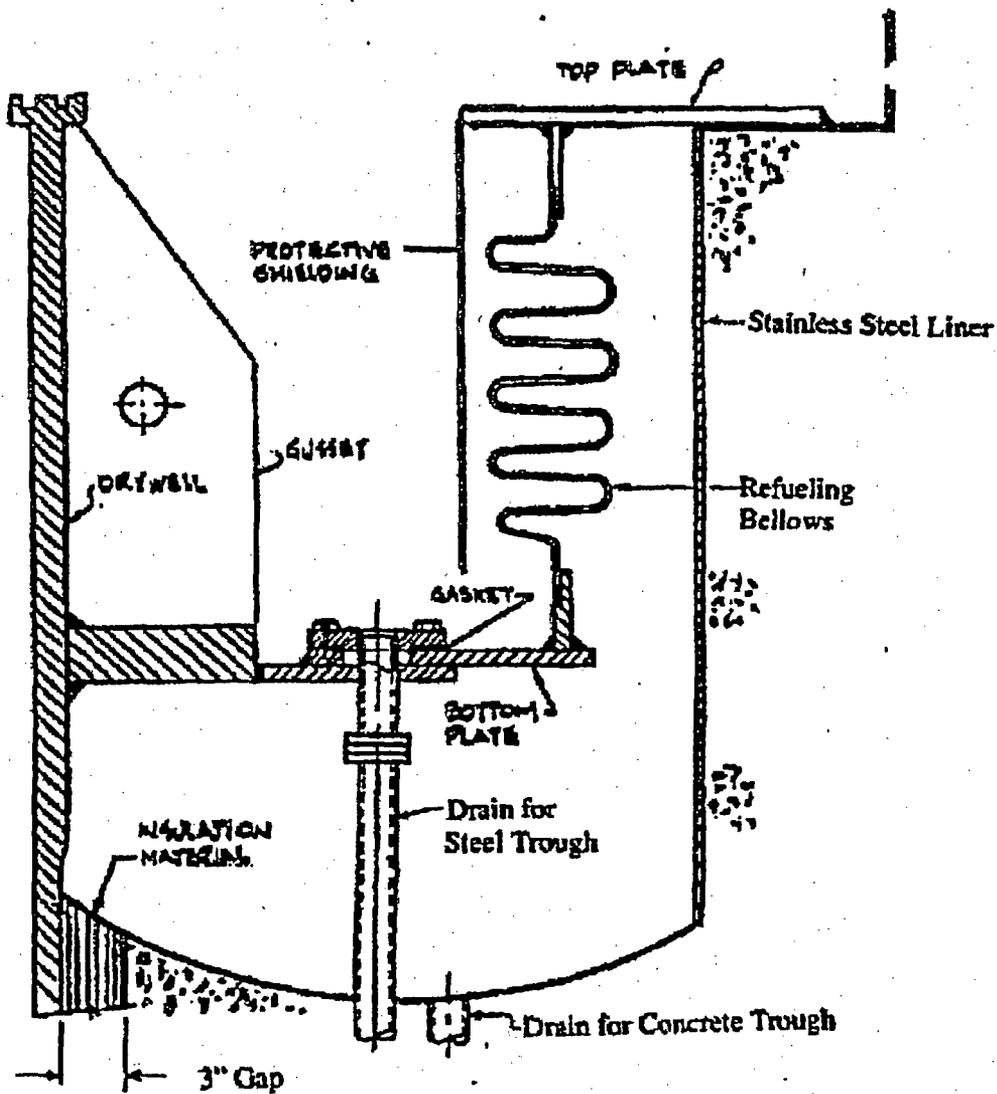
FIGURE 6 - REACTOR CAVITY TROUGH DRAIN

At the top of the Reactor Building concrete shield wall, a concrete trough is located below the reactor cavity seal to collect any water that might leak from the reactor cavity during refueling outages. This trough is equipped with a drain line designed to direct any leakage to the Reactor Building equipment drain tank and prevent it from entering the gap between the drywell shell and the Reactor Building concrete shield wall (See Figure 6).

- The leakage path was from the reactor cavity, to the concrete trough (later found to have been degraded – see Section C below) and through the drywell expansion gap down to the sandbed region within the reactor building (See Figure 6 of Section 3 of this Enclosure).

- Replaced reactor cavity metal trough drain gasket, which was found to be leaking (See Figure 6 of Section 3 of this Enclosure).
 - Removed water from the sand bed region.

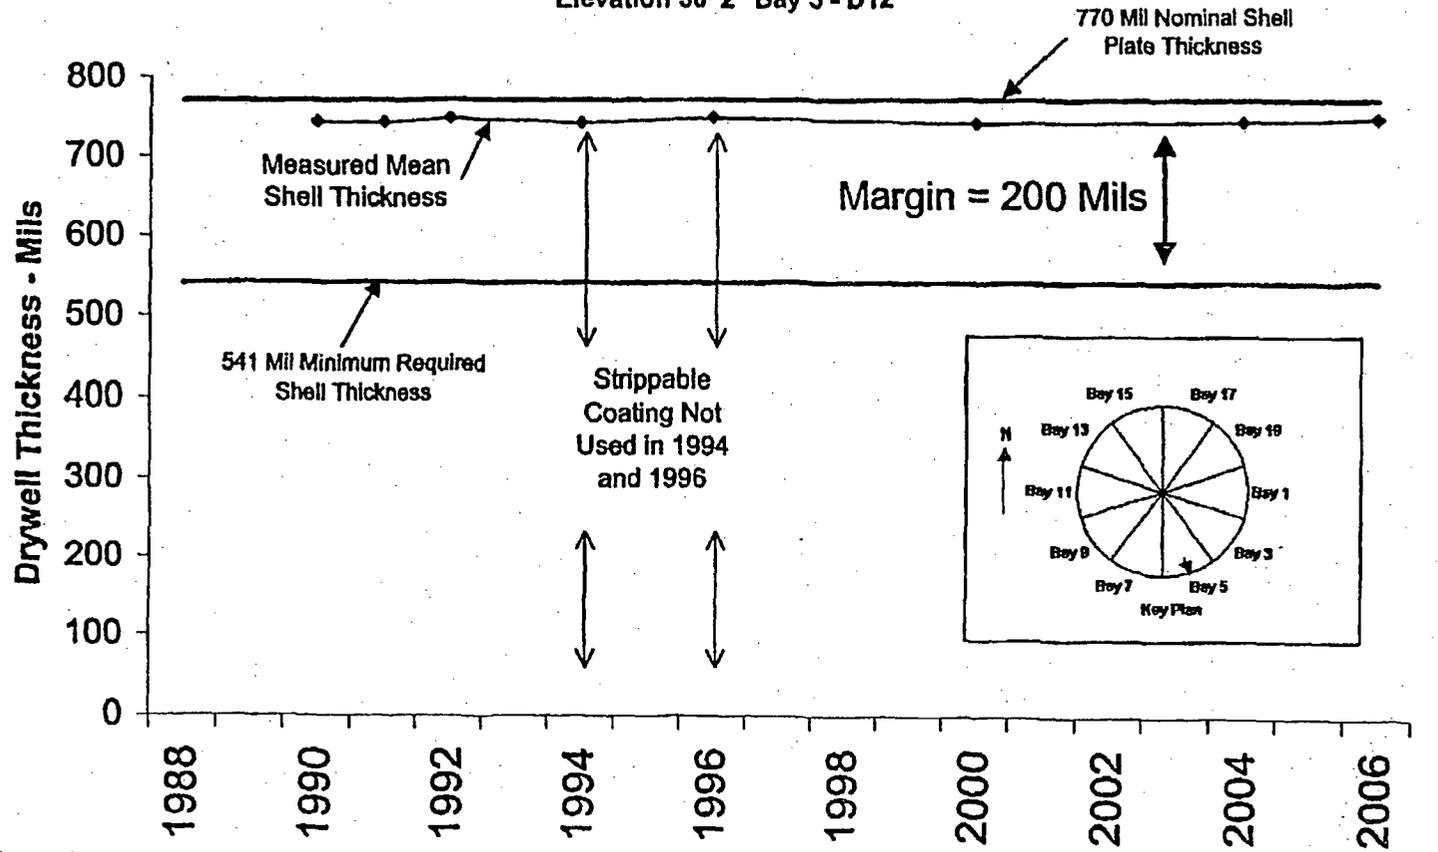
Elevation 50' 2" Bay 5 - D12

1. Upper Drywell Corrosion Trend and Margin

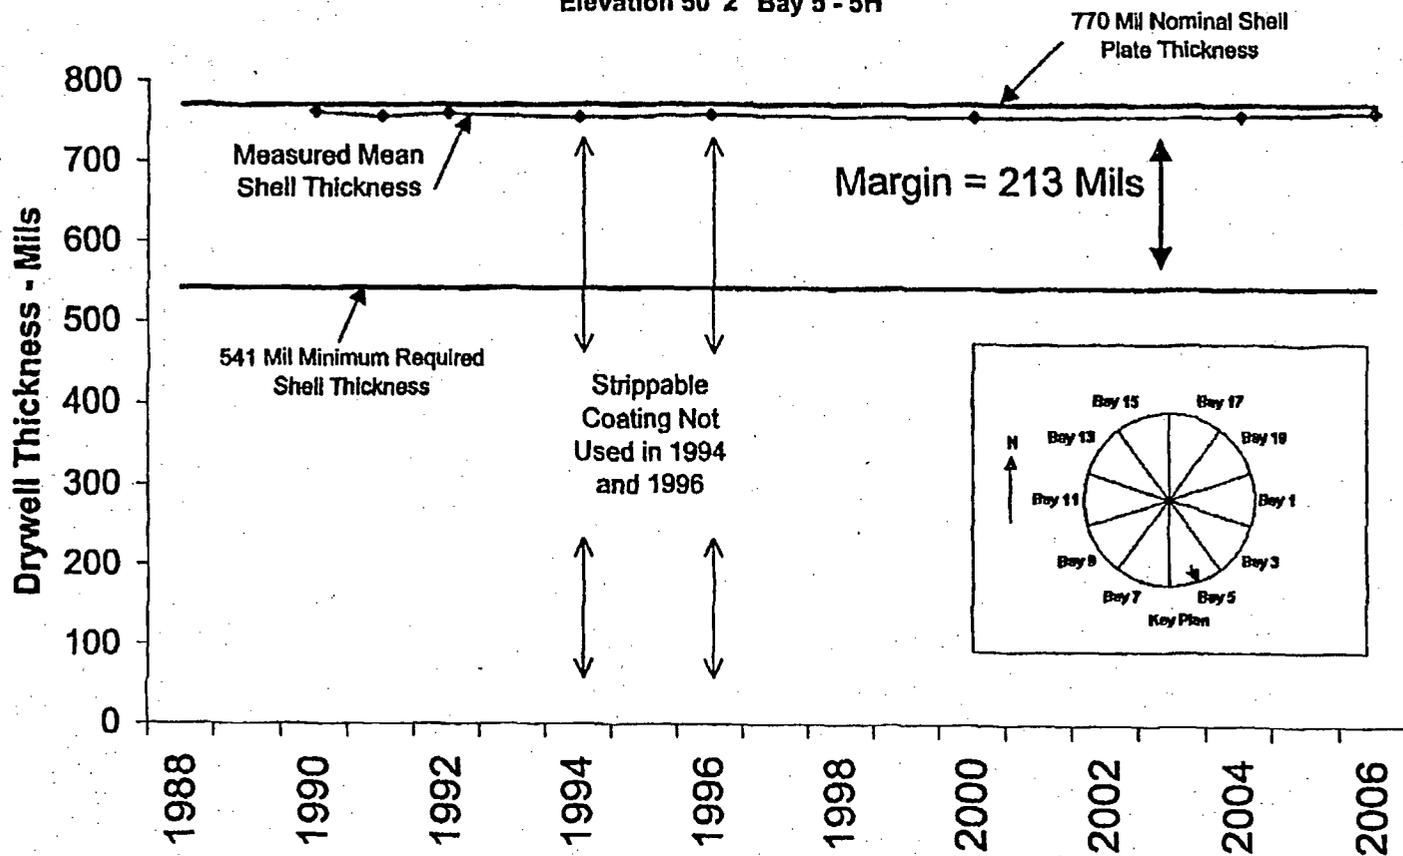
Elevation 50' 2" Bay 5 - 5H

2. Upper Drywell Corrosion Trend and Margin

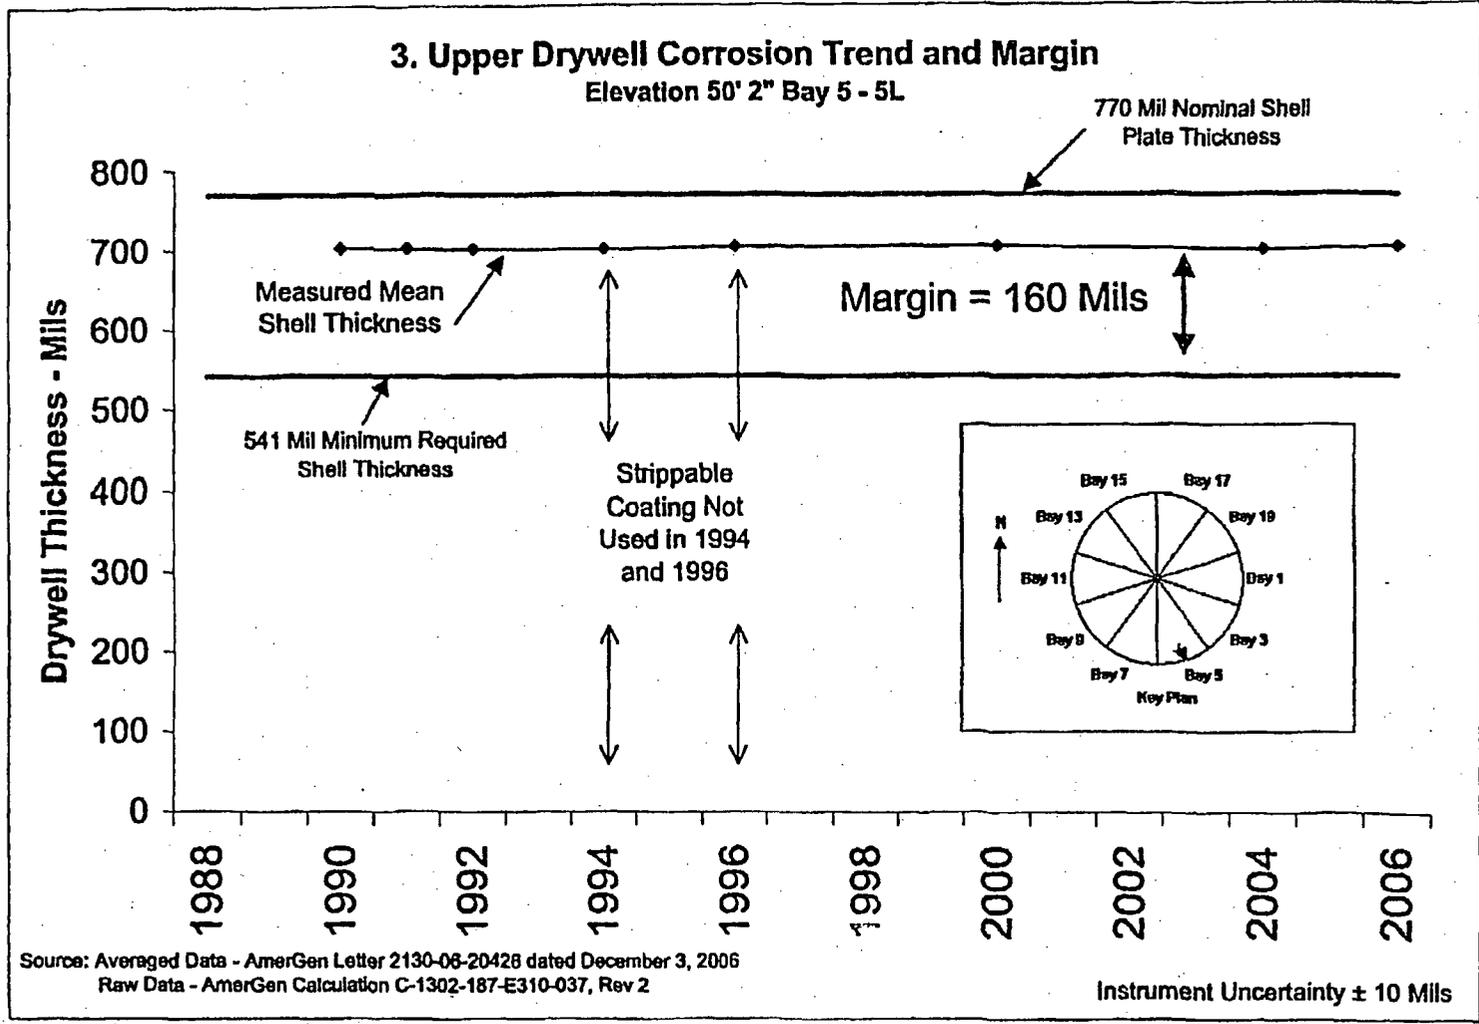
Elevation 50' 2" Bay 5 - 5L

3. Upper Drywell Corrosion Trend and Margin

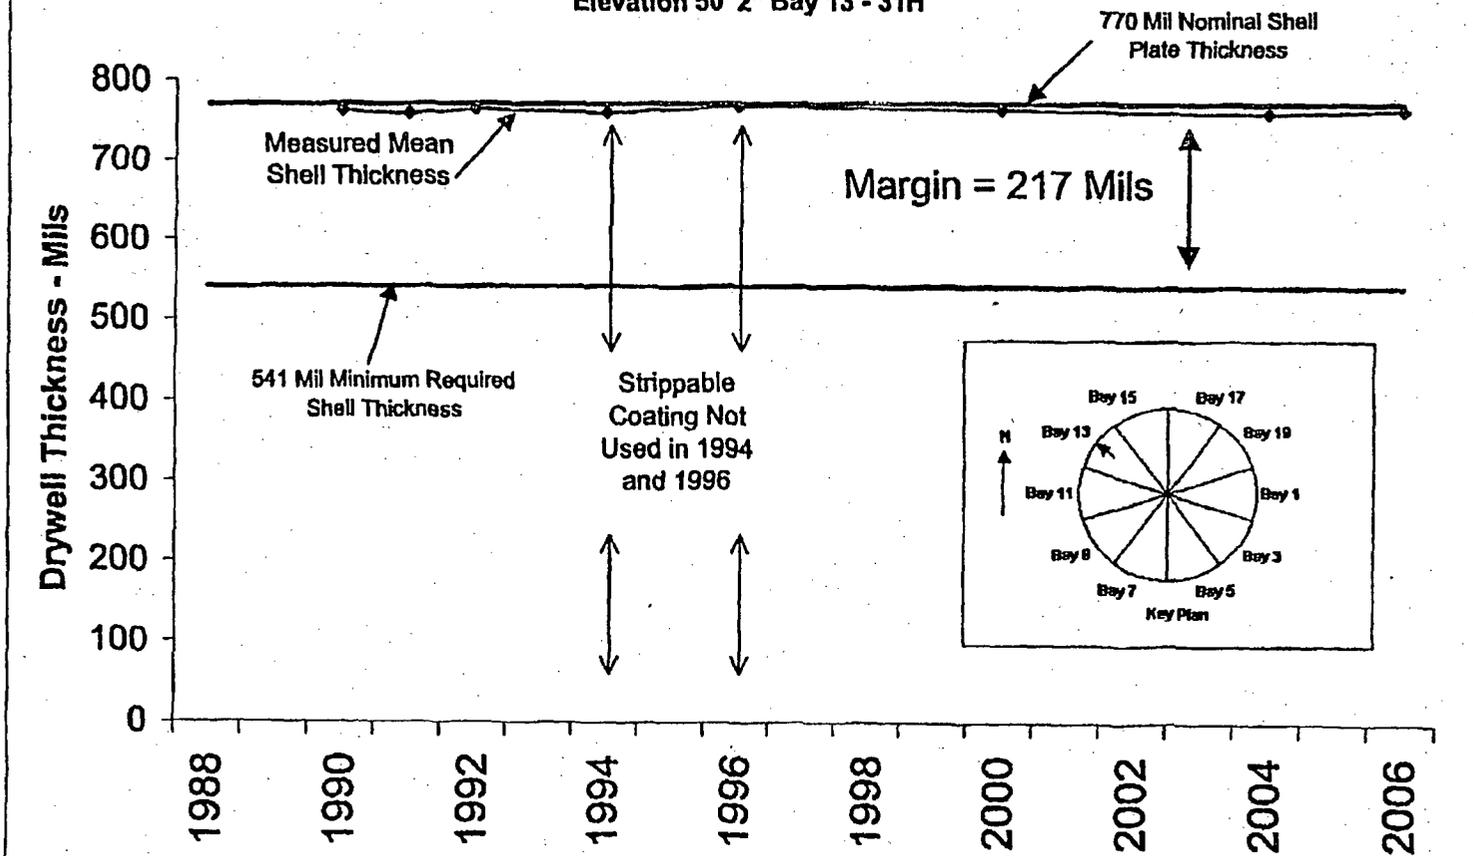
Elevation 50' 2" Bay 13 - 31H

4. Upper Drywell Corrosion Trend and Margin

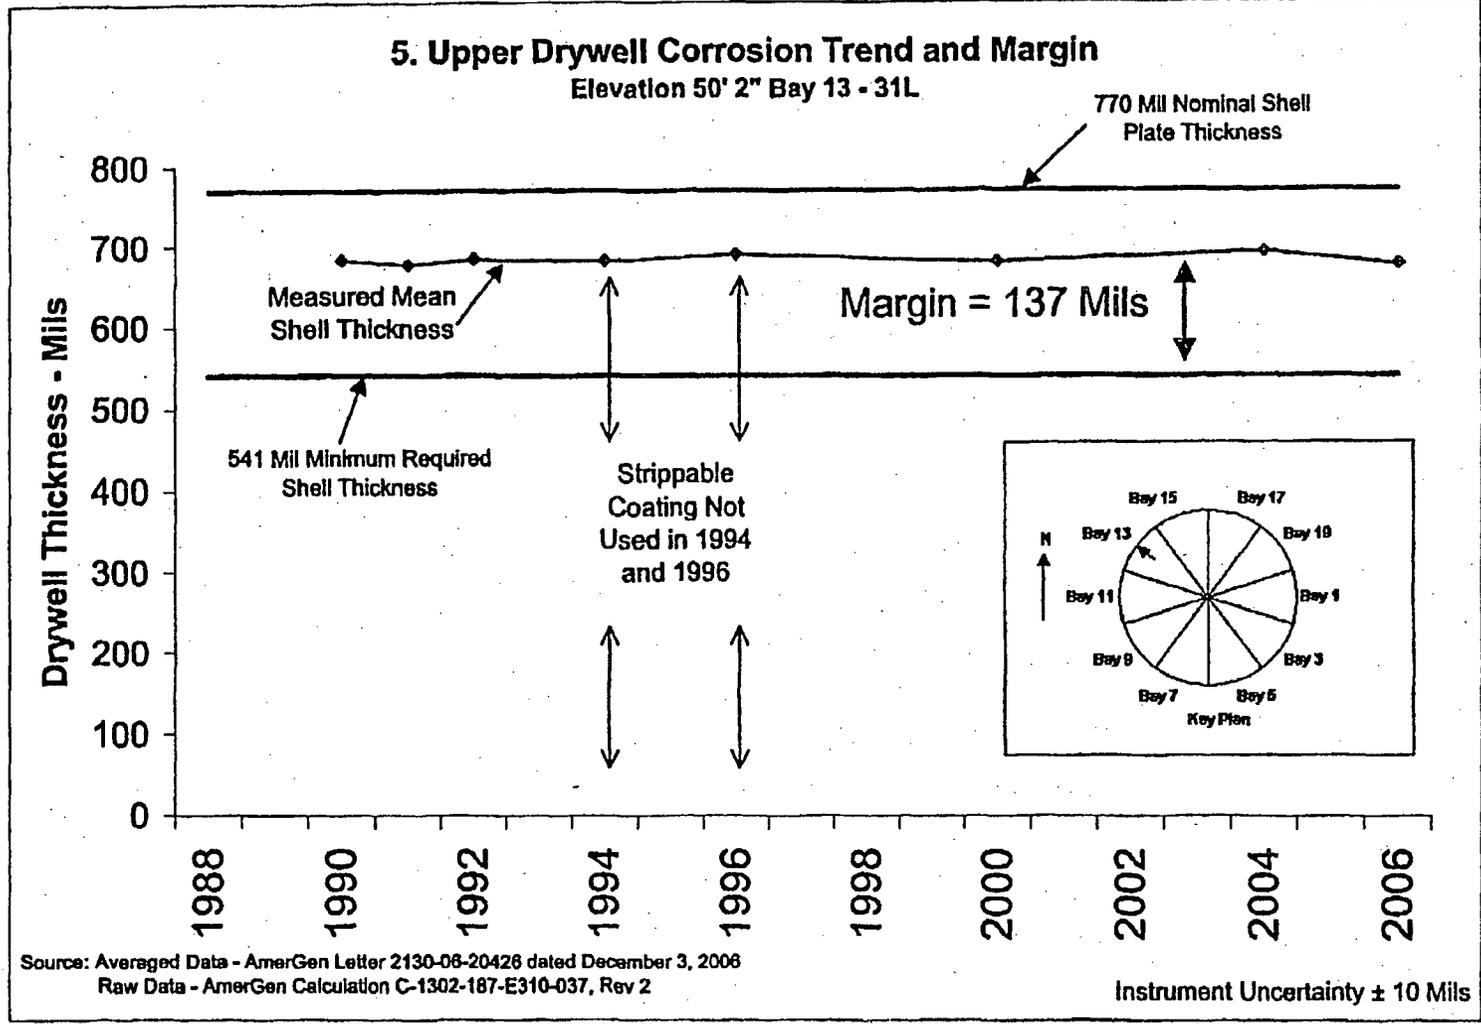
Elevation 50' 2" Bay 13 - 31L

5. Upper Drywell Corrosion Trend and Margin

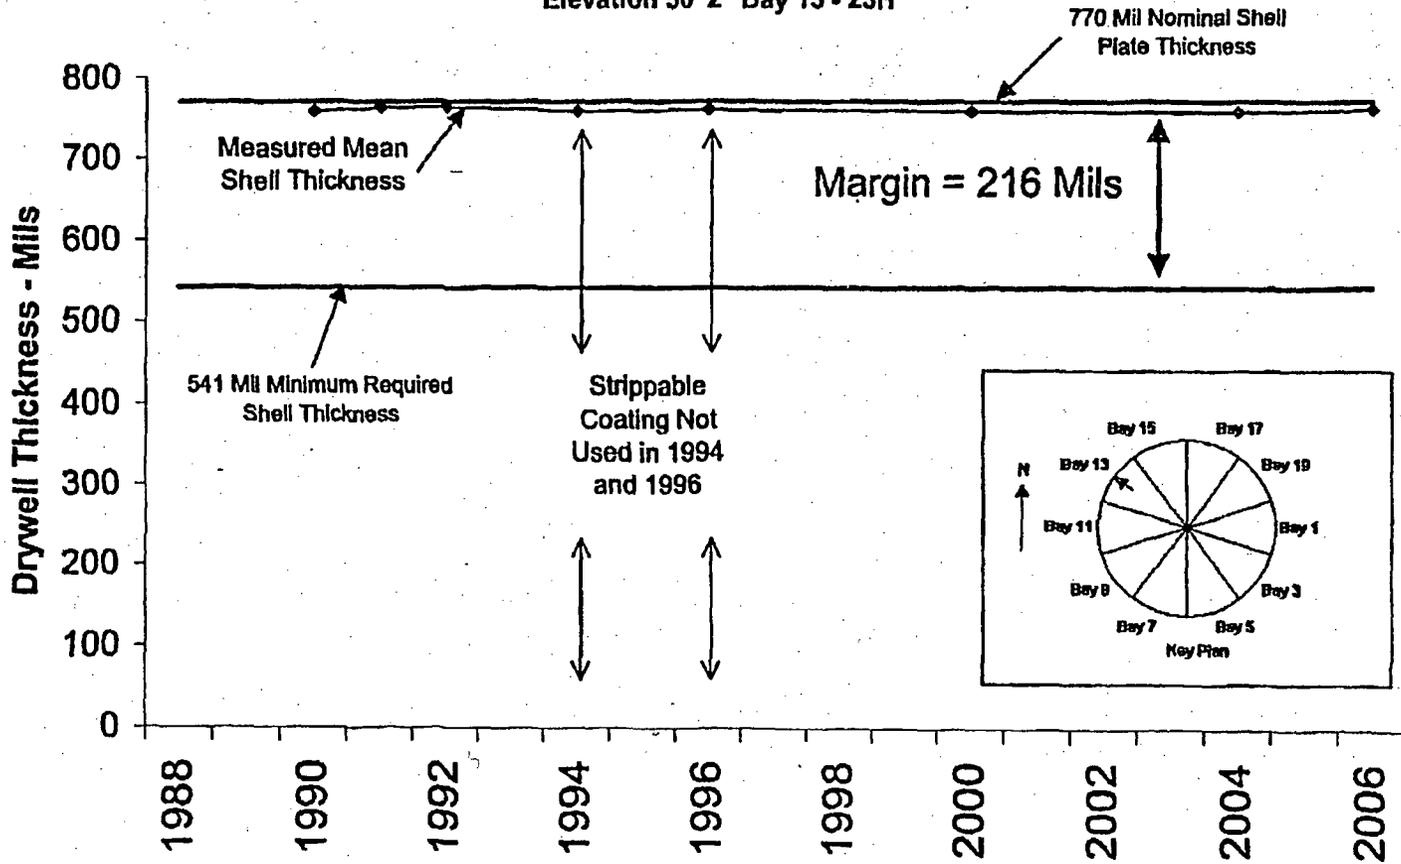
Elevation 50' 2" Bay 15 - 23H

6. Upper Drywell Corrosion Trend and Margin

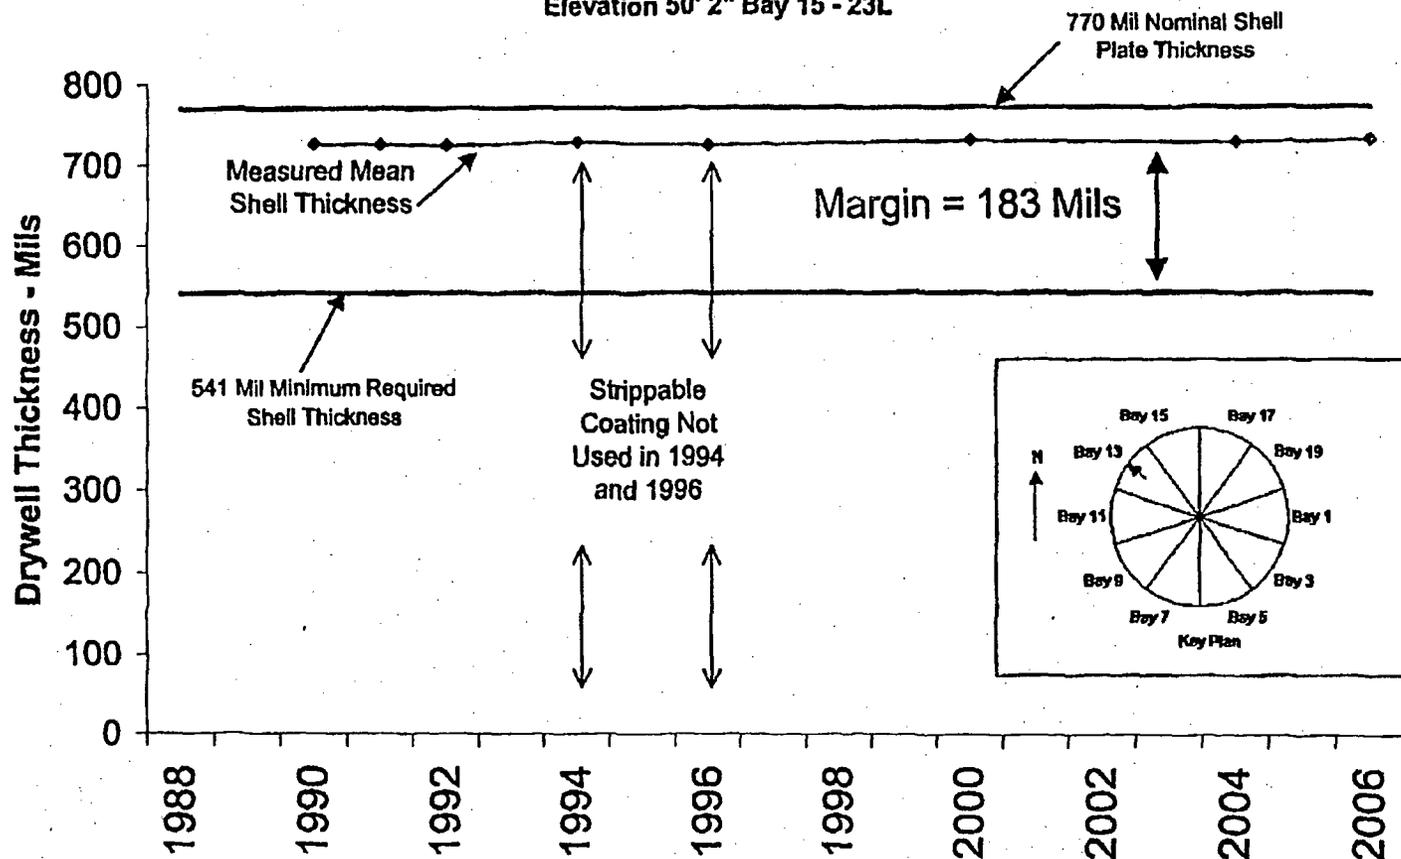
Elevation 50' 2" Bay 15 - 23L

7. Upper Drywell Corrosion Trend and Margin

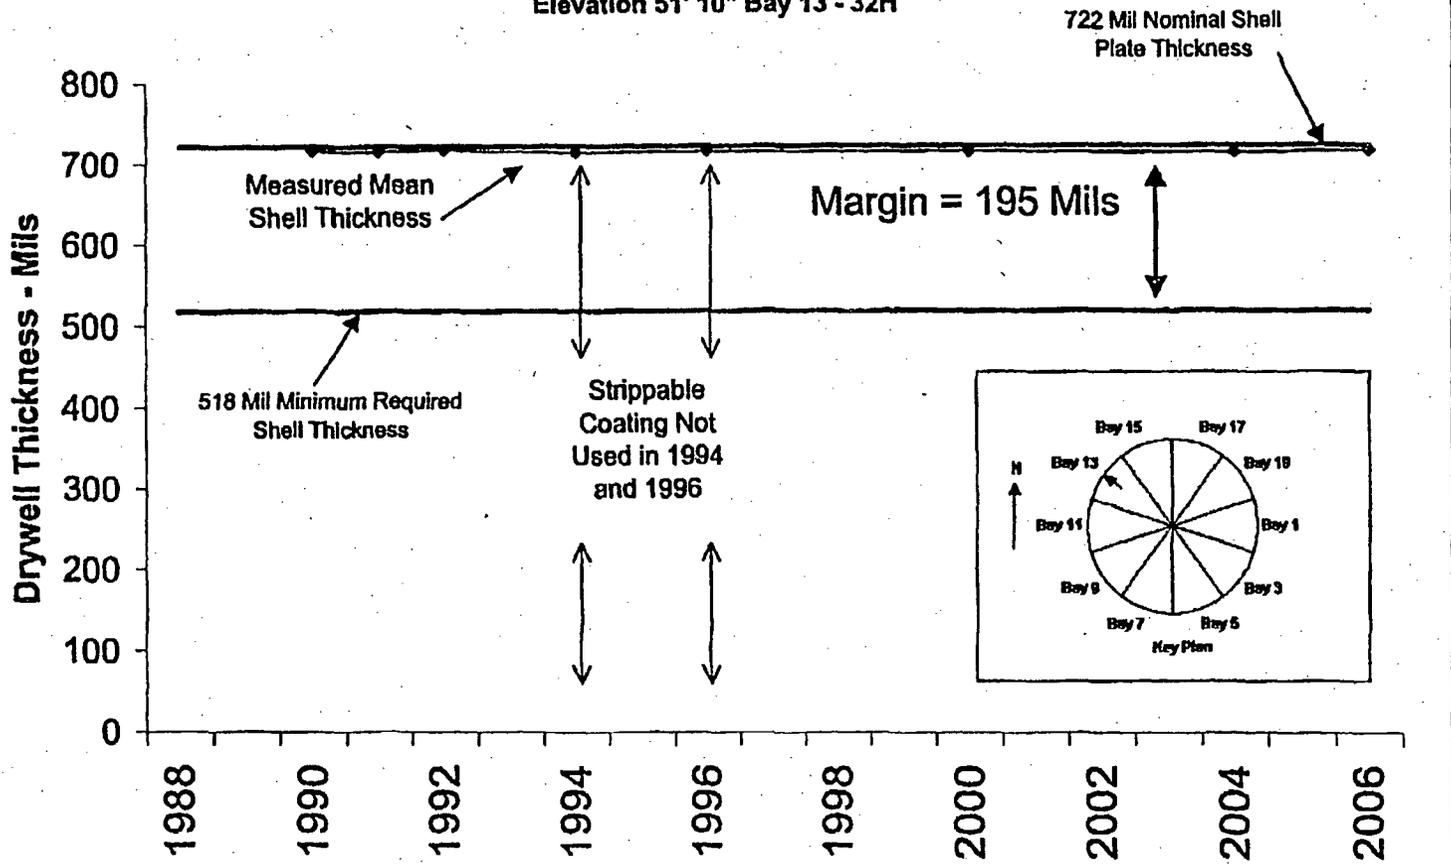
Elevation 51' 10" Bay 13 - 32H

8. Upper Drywell Corrosion Trend and Margin

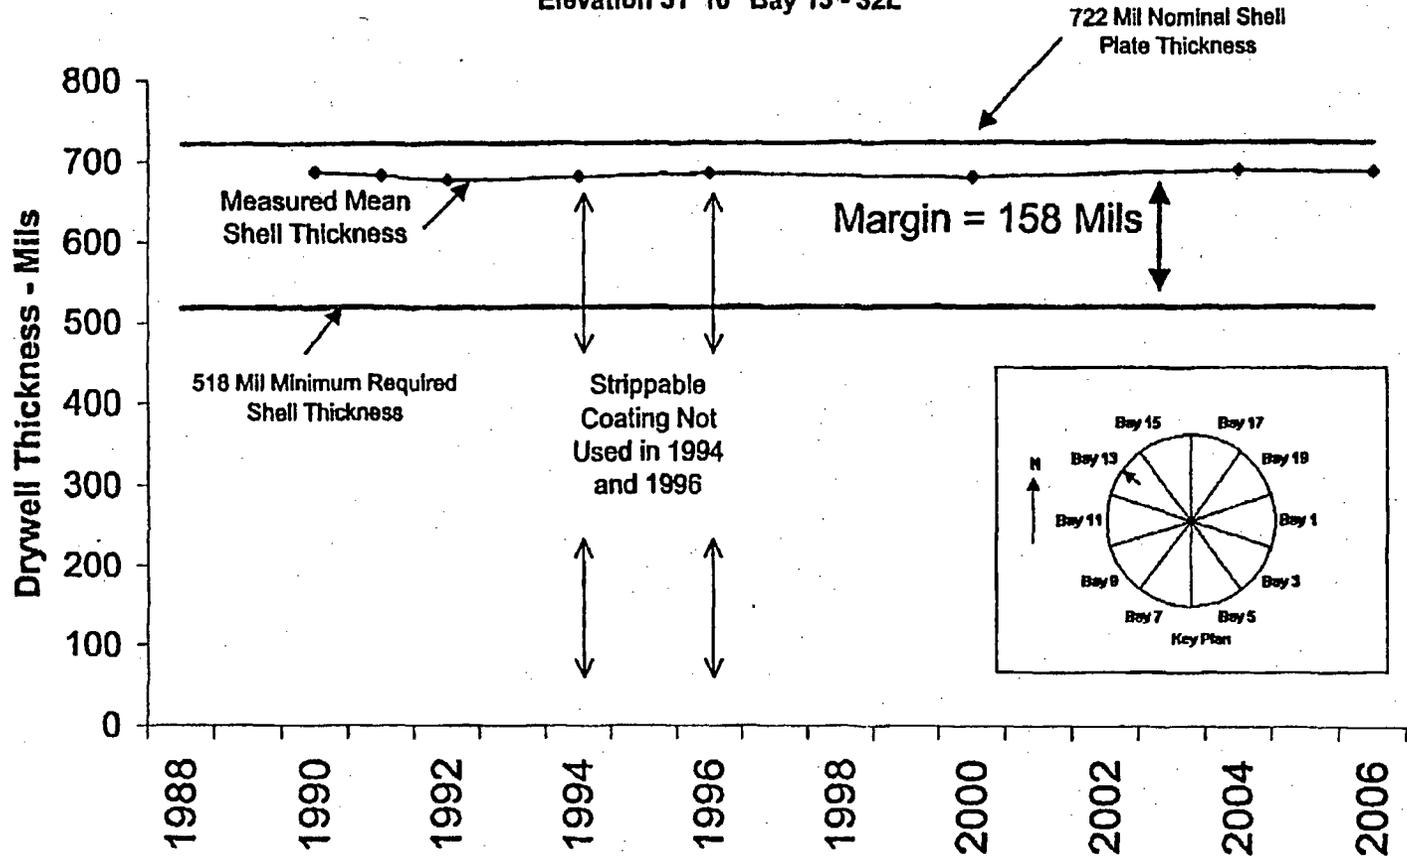
Elevation 51' 10" Bay 13 - 32L

9. Upper Drywell Corrosion Trend and Margin

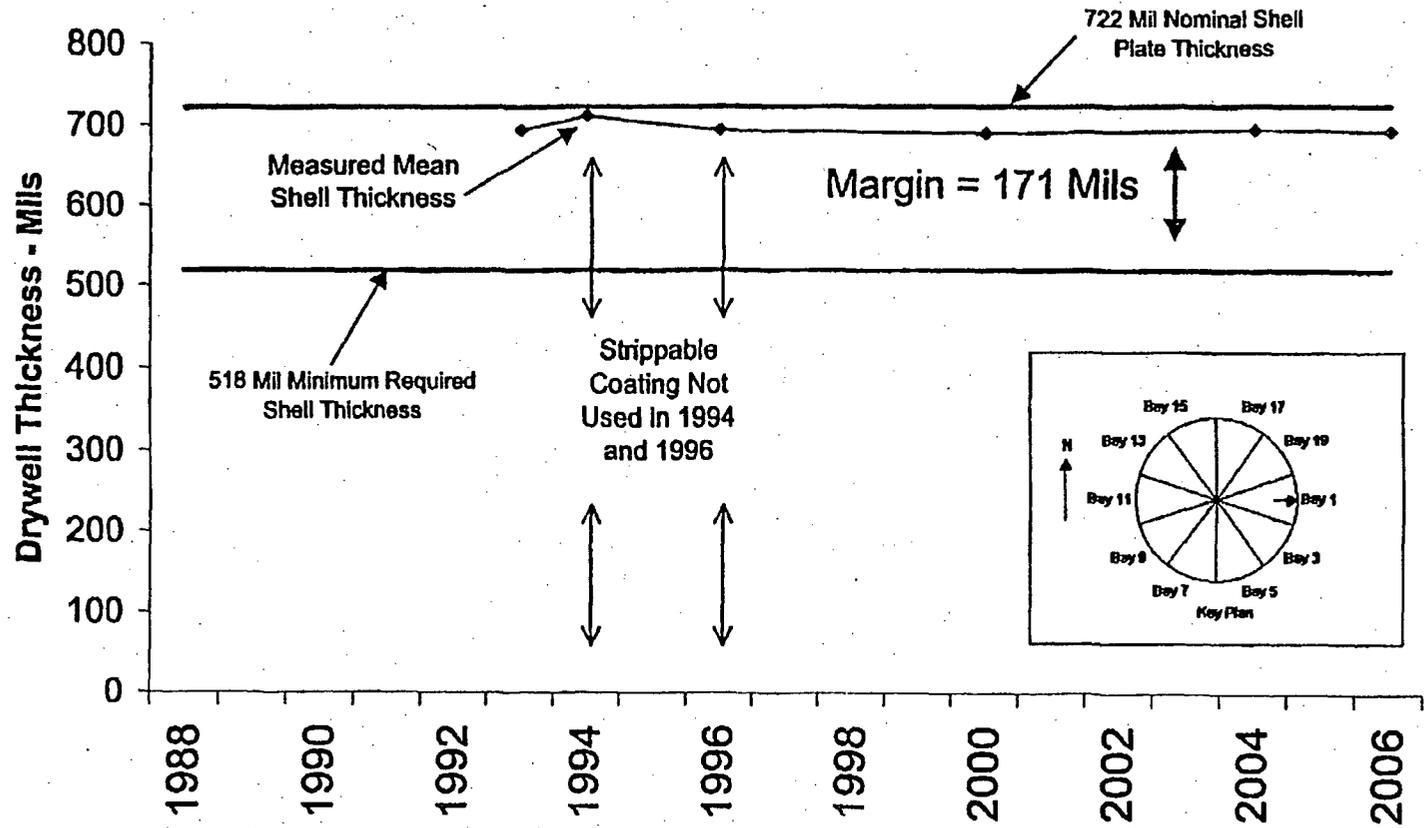
10. Upper Drywell Corrosion Trend and Margin Elevation 60' 10" Bay 1 - 50 - 22

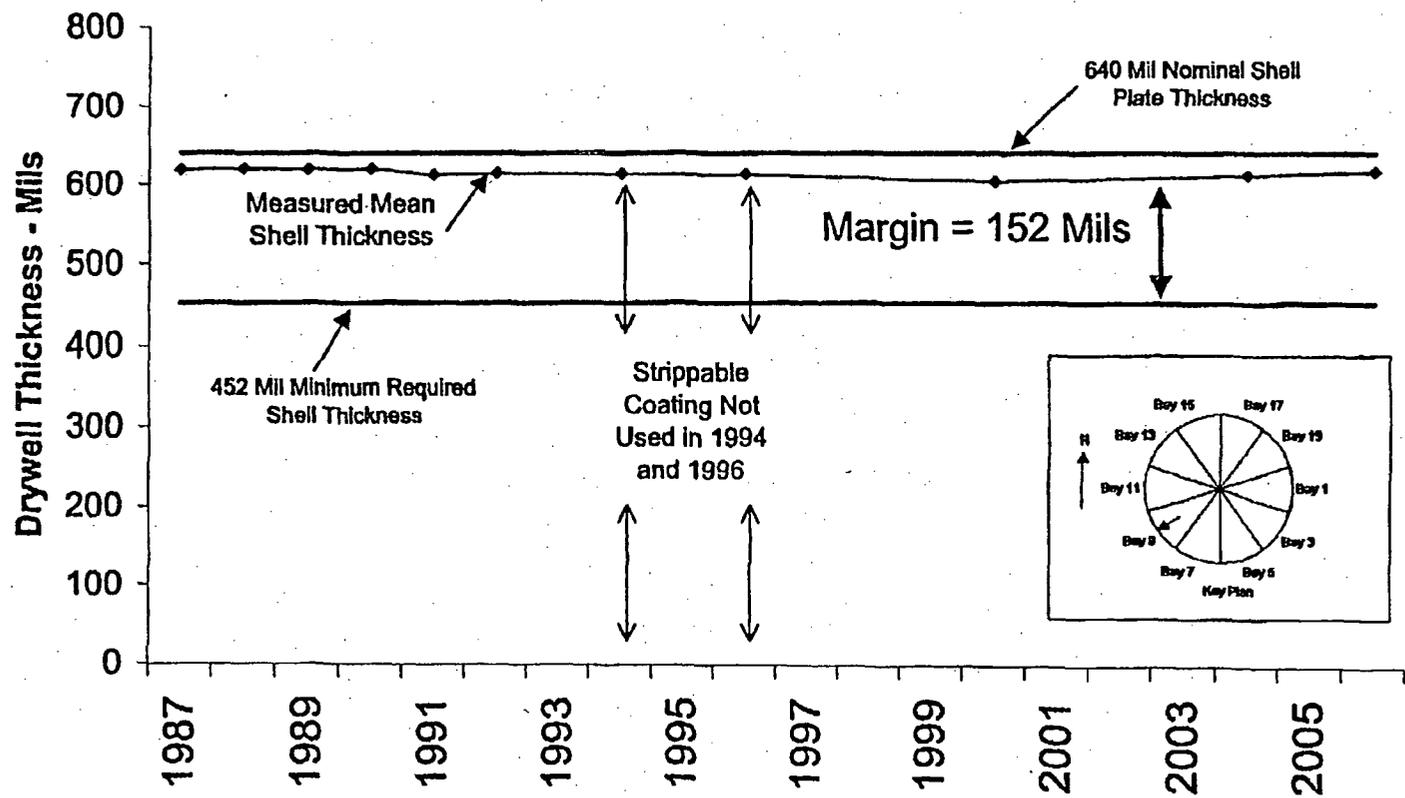
11. Upper Drywell Corrosion Trend and Margin Elevation 87' 5" Bay 9 - 20

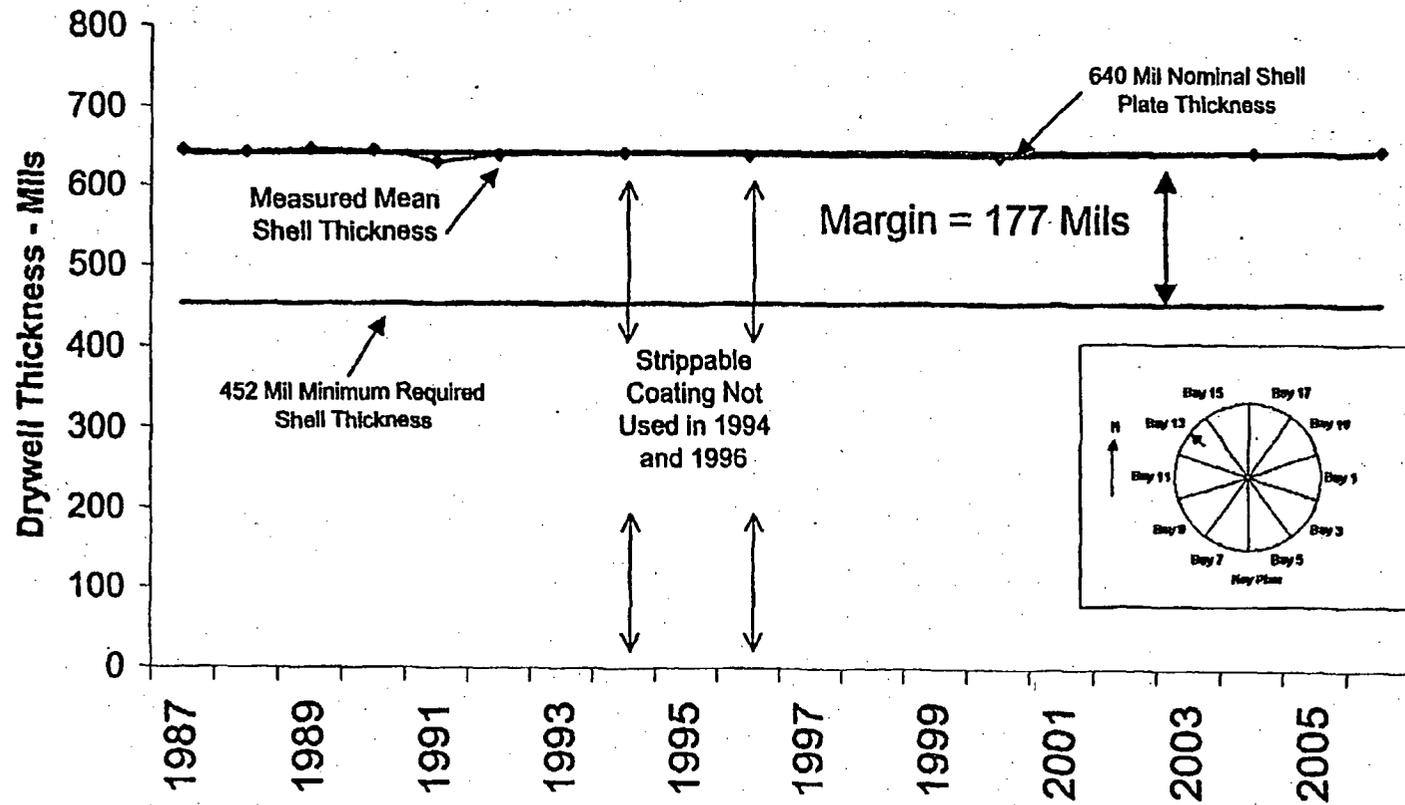
Elevation 87' 5" Bay 13 - 28

12. Upper Drywell Corrosion Trend and Margin

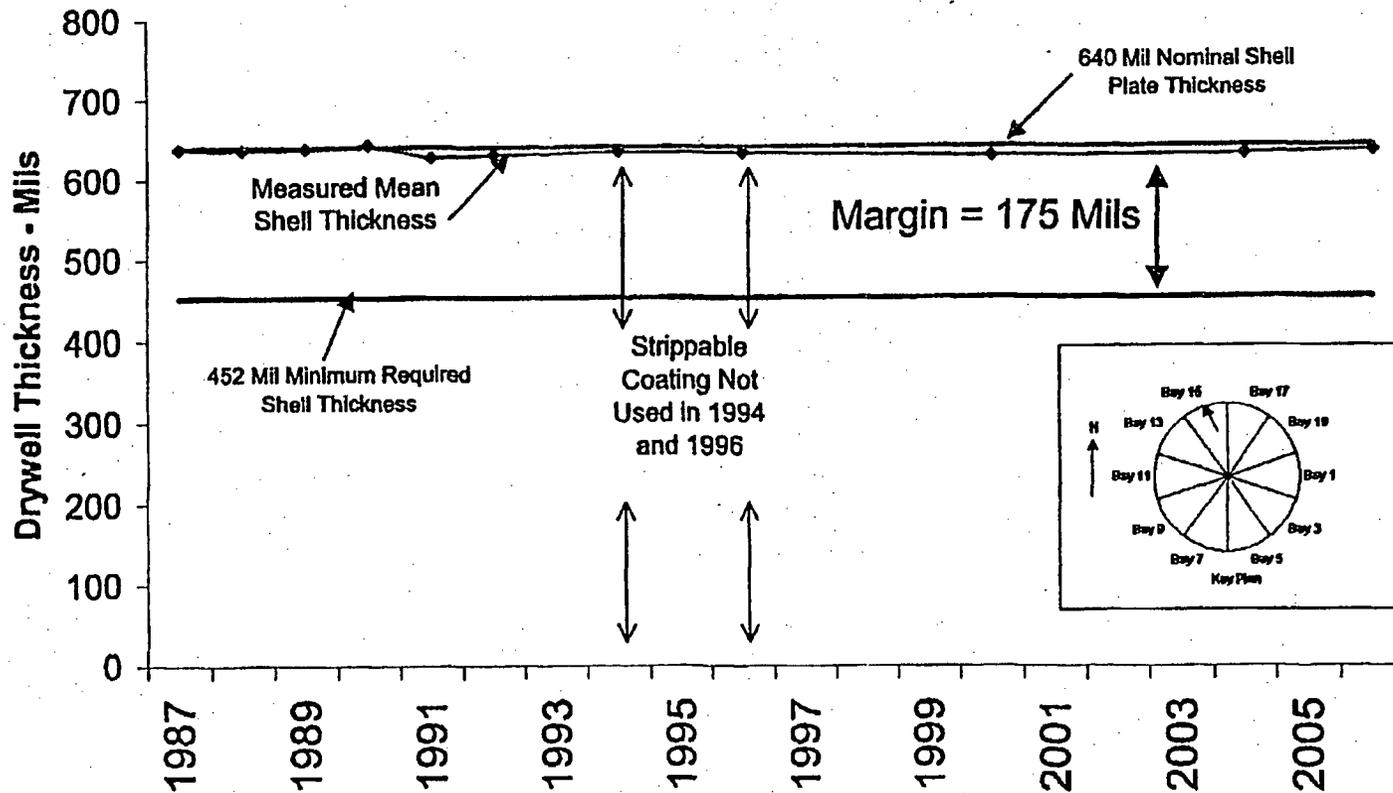
13. Upper Drywell Corrosion Trend and Margin Elevation 87' 5" Bay 15 - 31
