Oyster Creek Generating Station
Facility Operating License No. DPR-16
NRC Docket No. 50-219

Subject: Submittal of Information to ACRS Plant License Renewal Subcommittee Related to AmerGen's Application for Renewed Operating License for Oyster Creek Generating Station (TAC No. MC7624)

**Oyster Creek
License Renewal Project
Drywell Monitoring Program**

Information for ACRS Subcommittee

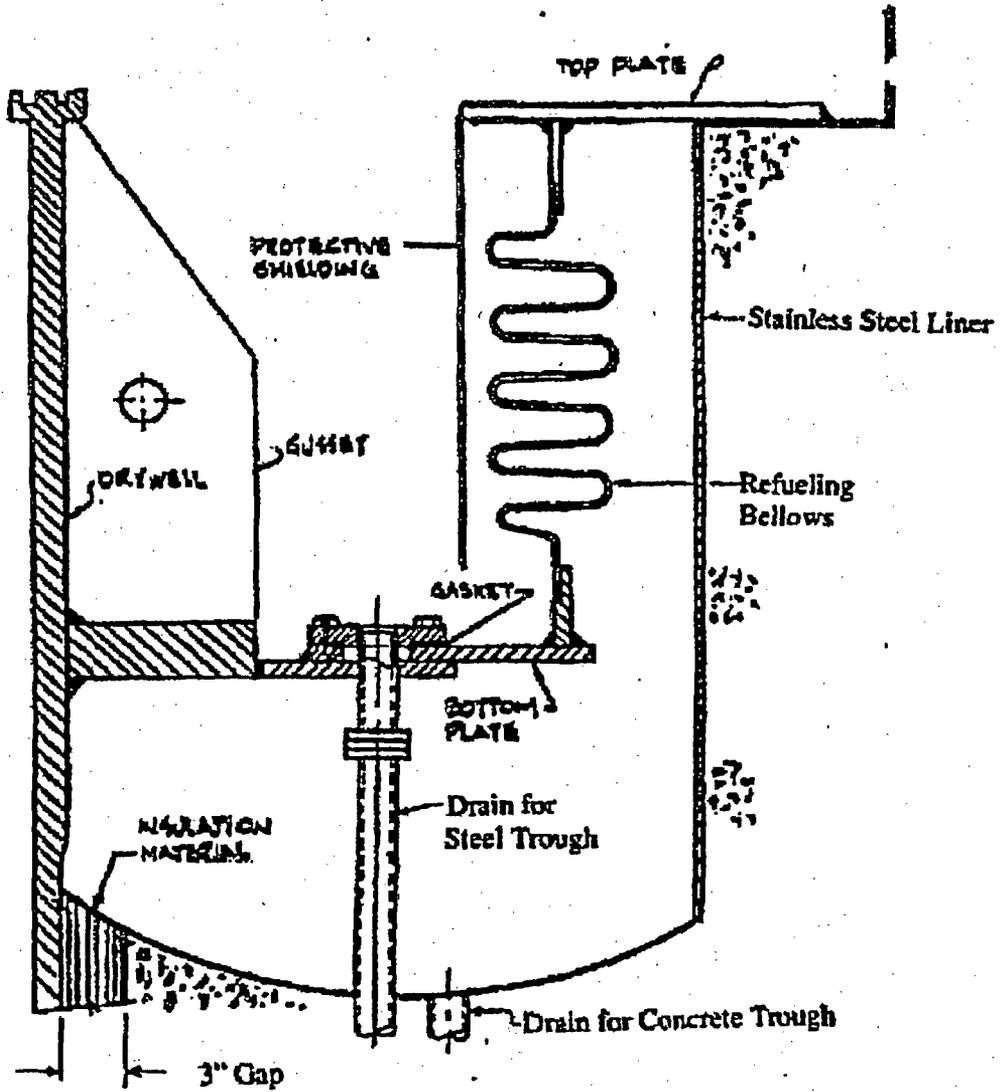
FIGURE 6 - REACTOR CAVITY TROUGH DRAIN

- Leakage was not attributed to the reactor cavity metal trough drain line gasket or the refueling bellows seal (See Figure 6 of Section 3 of this Enclosure).

- The leakage path was from the reactor cavity, to the concrete trough (later found to have been degraded – see Section C below) and through the drywell expansion gap down to the sandbed region within the reactor building (See Figure 6 of Section 3 of this Enclosure).

- Replaced reactor cavity metal trough drain gasket, which was found to be leaking (See Figure 6 of Section 3 of this Enclosure).
 - Removed water from the sand bed region.

During the 1986 refueling outage, camera inspections identified that the lip of the reactor cavity concrete trough was not sufficient to assure that water would not enter the area between the concrete shield wall and drywell shell. (Ref [5], page 3). Prior to reactor cavity flooding for the 1988 refueling outage, repairs were made to the concrete trough to rectify the condition. These repairs were determined to be effective based on visual inspections for leakage during the 1988 outage.

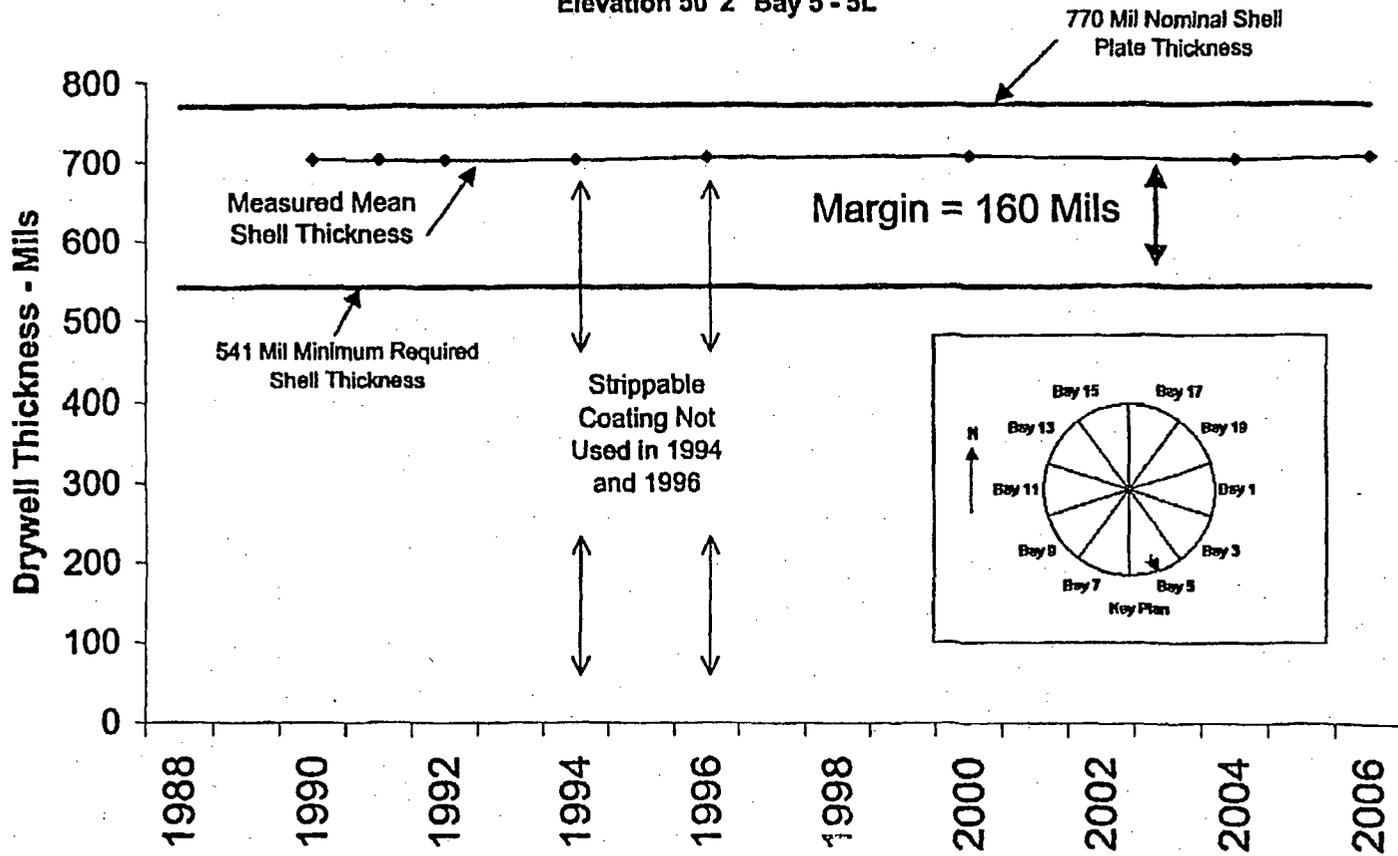
3. Upper Drywell Corrosion Trend and Margin

Elevation 50' 2" Bay 5 - 5L

Instrument Uncertainty \pm 10 Mils

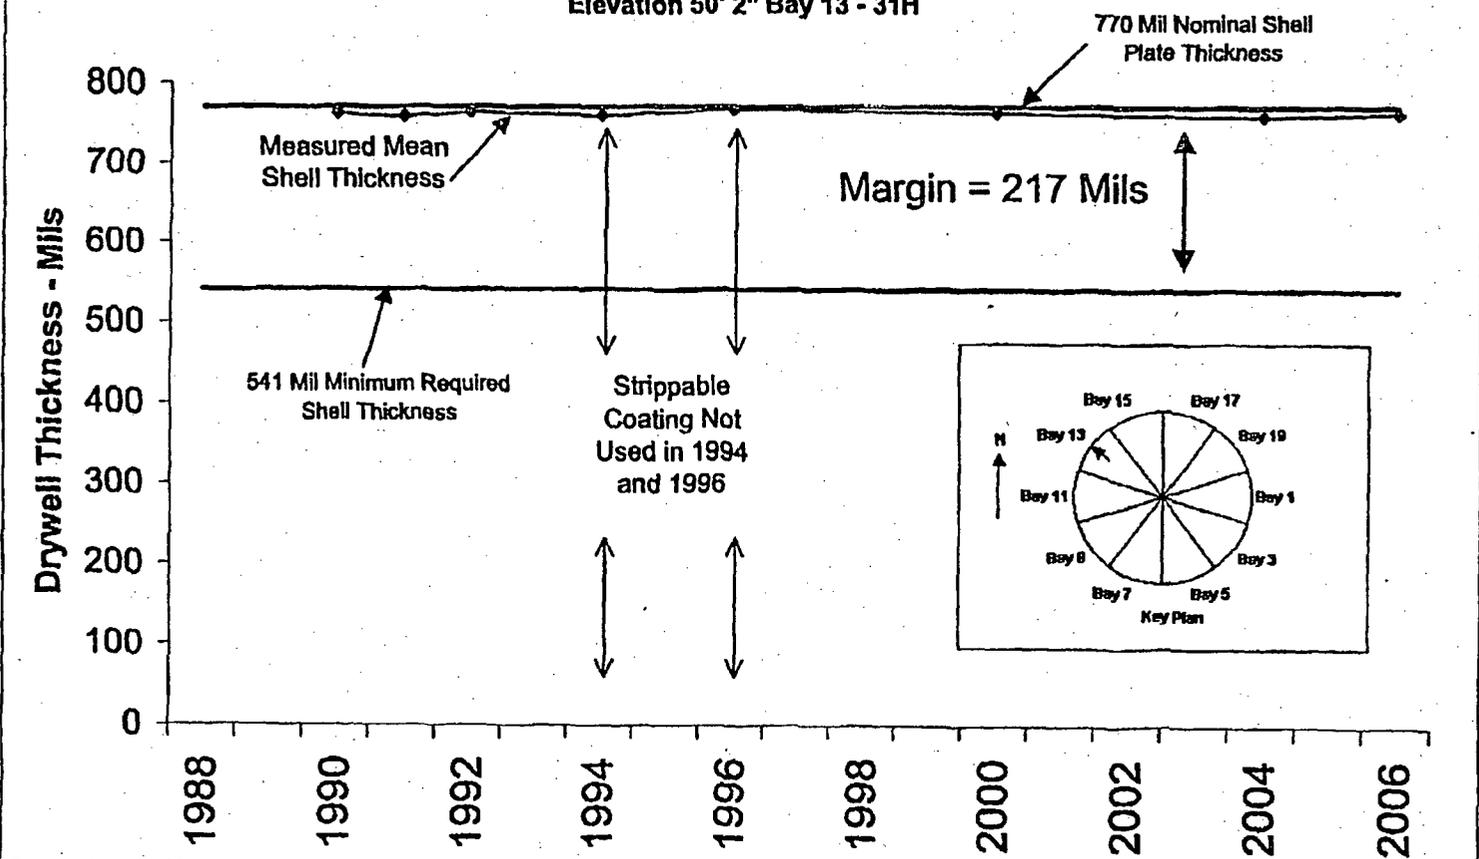
4. Upper Drywell Corrosion Trend and Margin

Elevation 50' 2" Bay 13 - 31H

Instrument Uncertainty ± 10 Mils

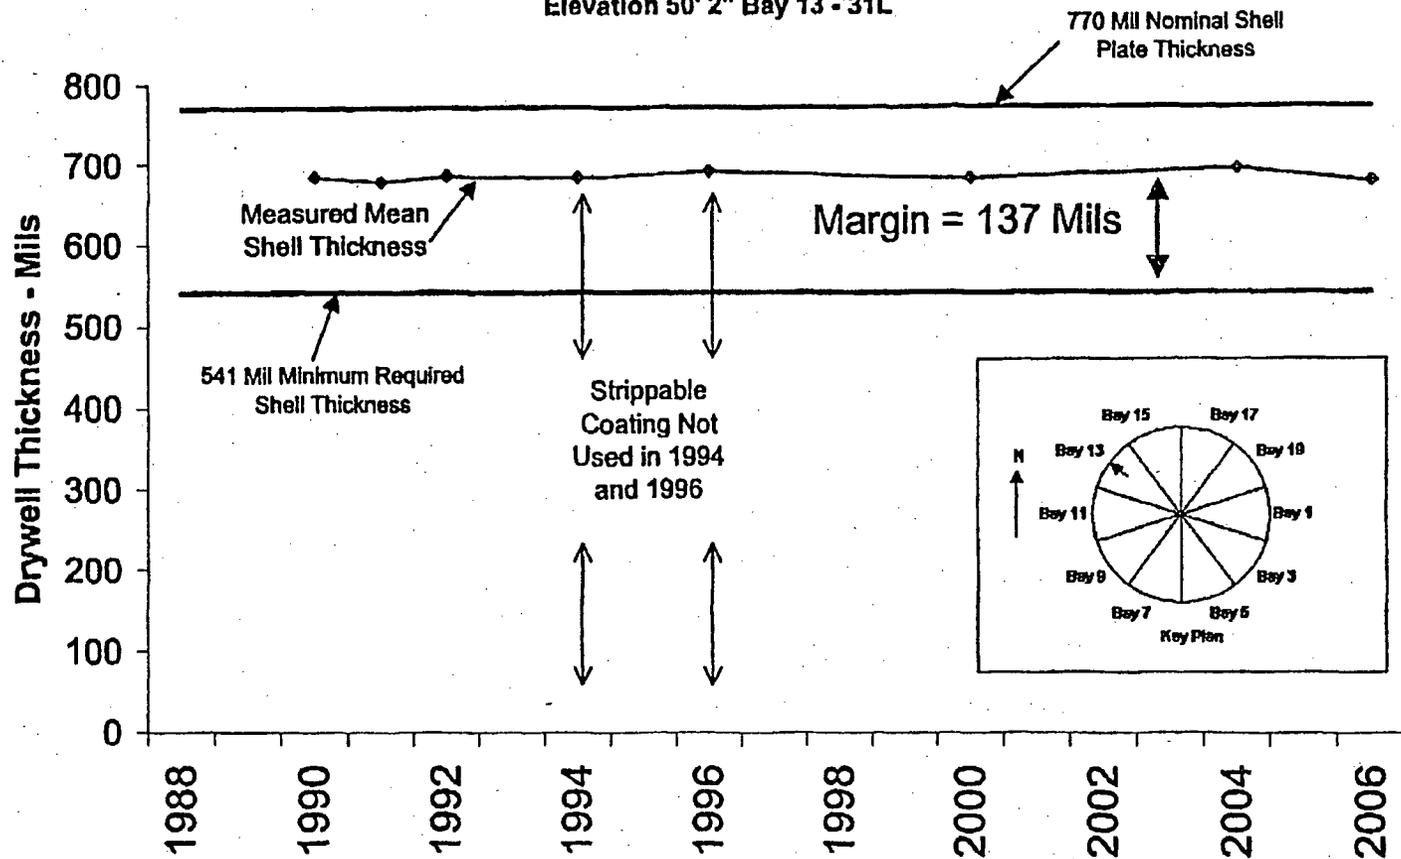
5. Upper Drywell Corrosion Trend and Margin

Elevation 50' 2" Bay 13 - 31L

Instrument Uncertainty ± 10 Mils

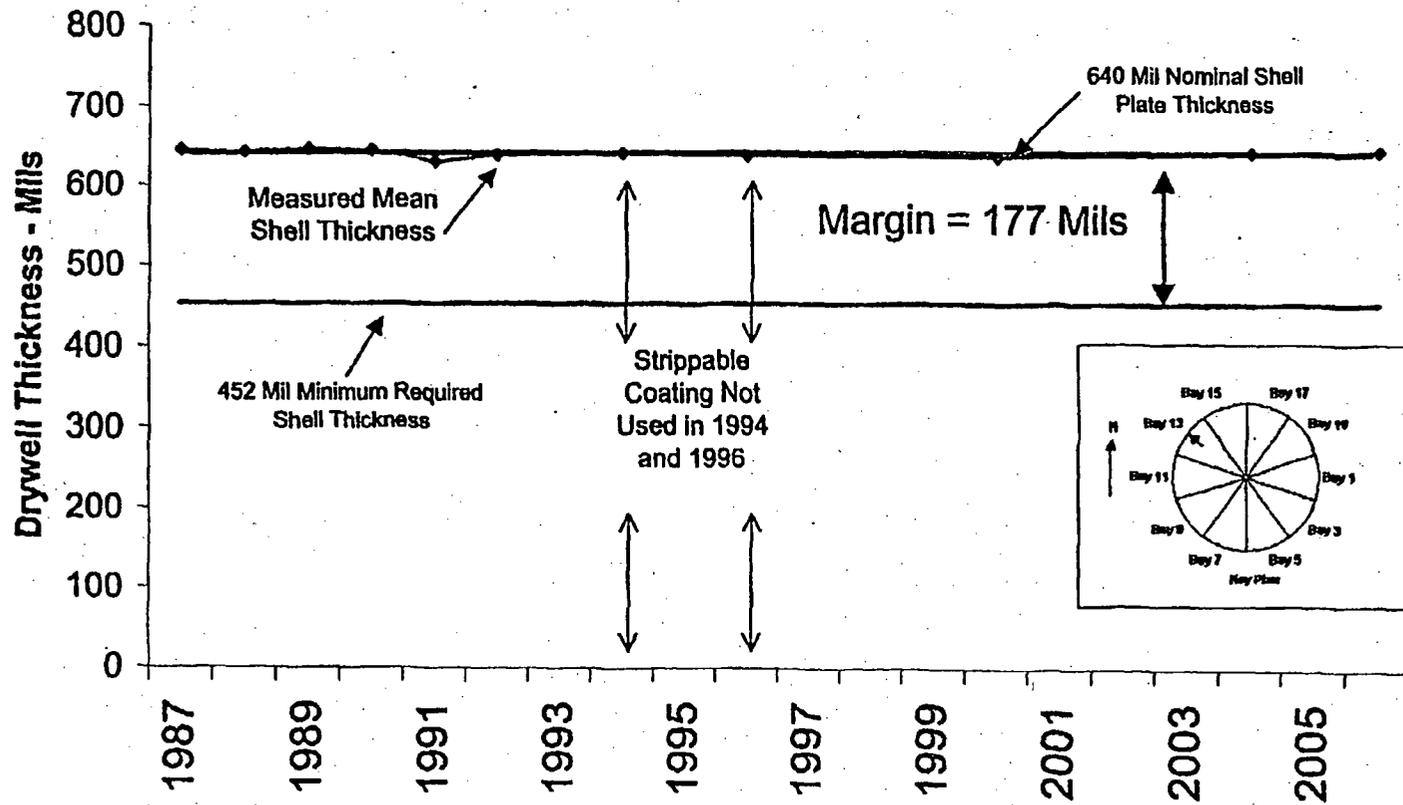
12. Upper Drywell Corrosion Trend and Margin

Elevation 87' 5" Bay 13 - 28

Instrument Uncertainty \pm 10 Mils

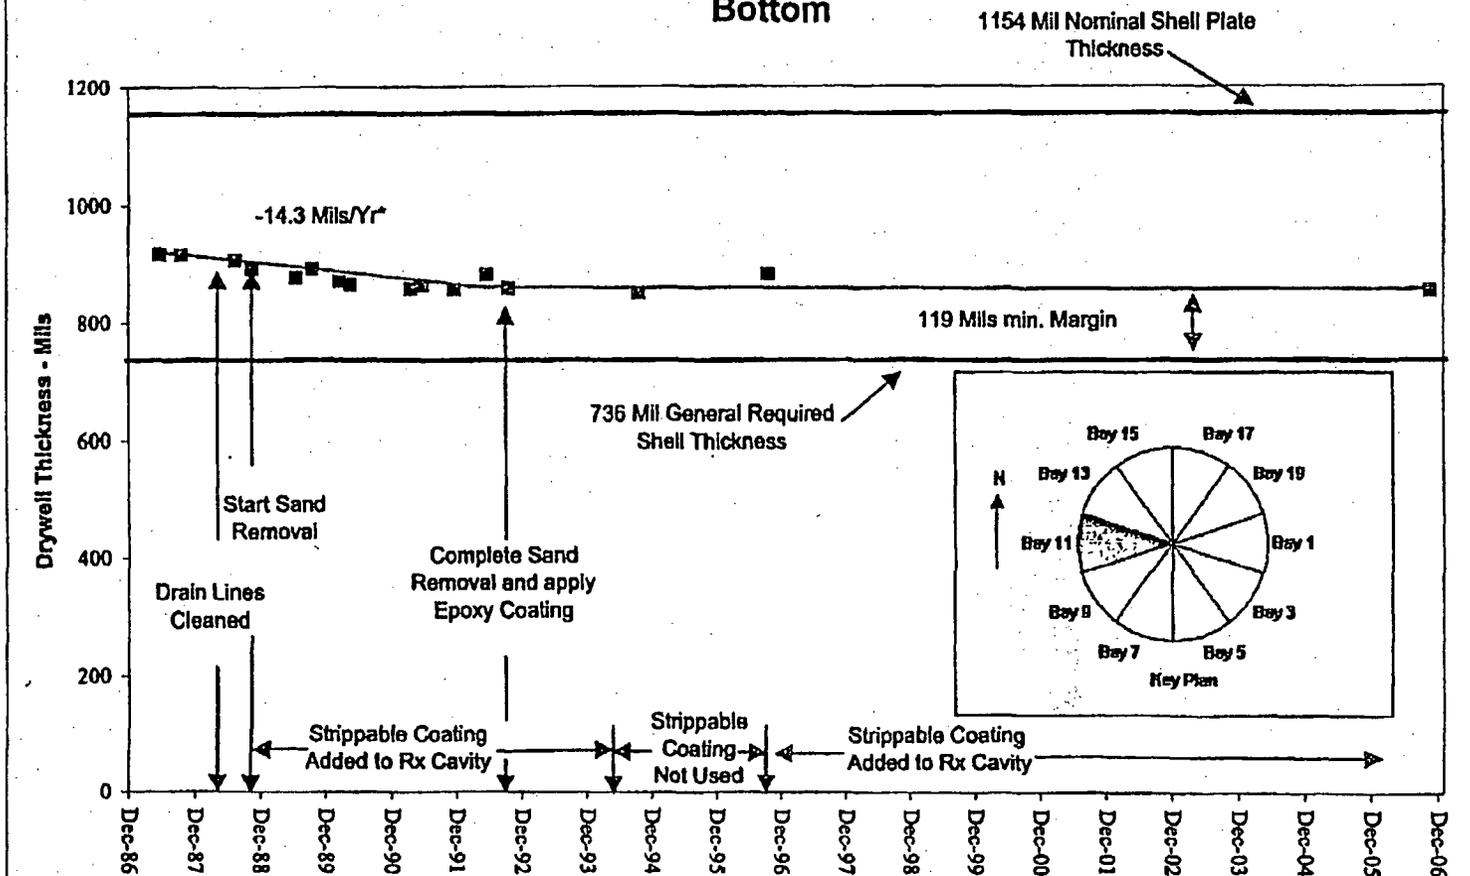
**Figure 9. Sandbed Bay #11C
Bottom**

Source: Raw Data - Amergen Calculation C-1302-187-5300-021, C-1302-187-5300-028, C-1302-187-8610-030 Date (*Maximum calculated rate -22.4mils/yr 4/91,C-1302-187-5300-011 Rev.1)
