**RE: Irigaray-Christensen Operations Annual Inspection Report, Permit No. 478**

## ANNUAL INSPECTION REPORT

**Subject:** Cogema Mining Inc.'s Irigaray and Christensen In Situ Uranium Operations

**Permit No.:** 478

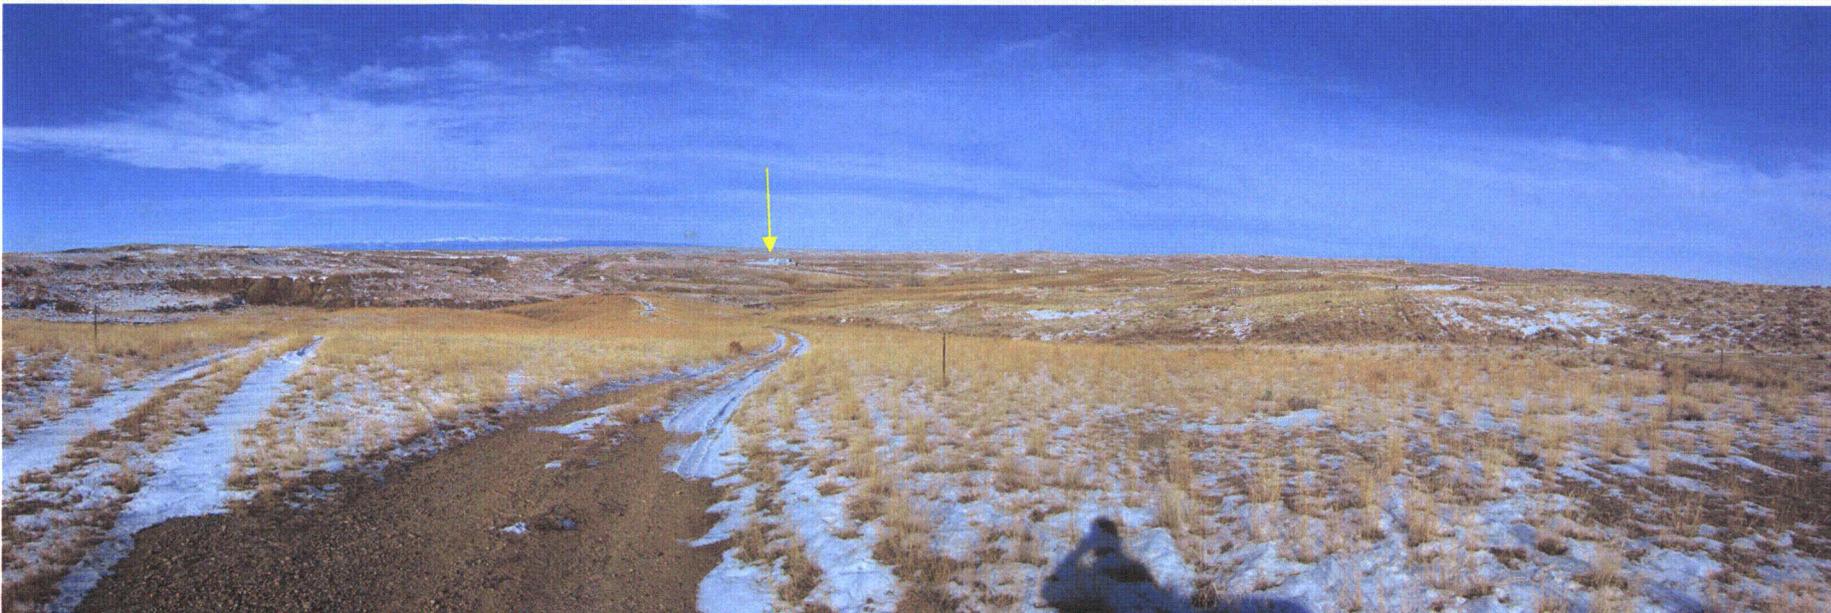
In Units 7, 8 and 9, the well field buildings, buried trunklines and manholes leading to the buried trunklines have been removed. A few wellheads remain to mark the locations of the buried piping which still remains in the ground (Photo No. 1).

**Photo No. 1** Looking northwest to north across former Wellfields 6-9 where nearly all surface equipment and wellheads have been removed. The arrow points to the Irigaray plant building. Topsoil in this area was removed and stockpiled decades ago so all vegetation here has been growing in subsoil.

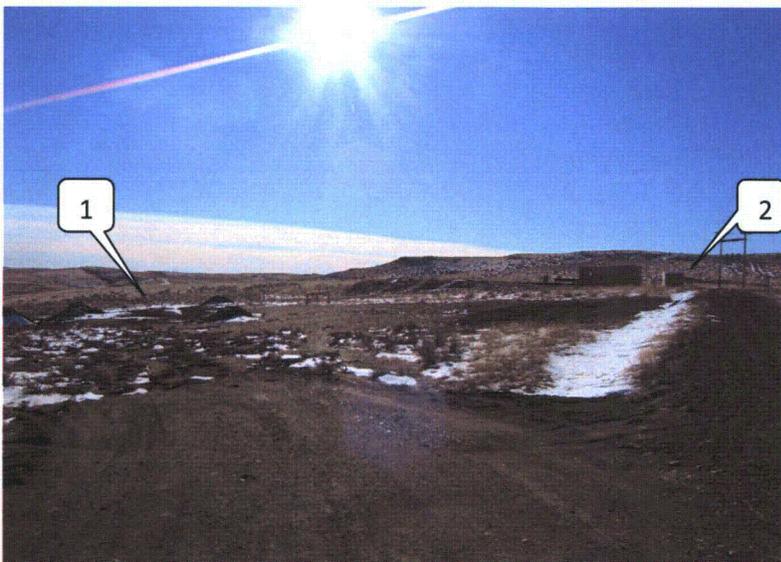
**Photo No. 2**

Mr. Arbogast said Anadarko had the gas leases for much of the Christensen Ranch area. He said they had been good to work with. They had constructed an access road through Wellfield Unit 5 running off to the south. Anadarko has drilled a gas well just to the southwest of deep disposal well DDW 18-3 (Photo No. 2).

Looking west at coal bed methane well (No. 1) drilled near Deep Disposal Well No. DDW 18-3 (No. 2).
