**RE: Irigaray-Christensen Operations Annual Inspection Report, Permit No. 478**

## ANNUAL INSPECTION REPORT

**Subject:** Cogema Mining Inc.'s Irigaray and Christensen In Situ Uranium Operations

**Permit No.:** 478

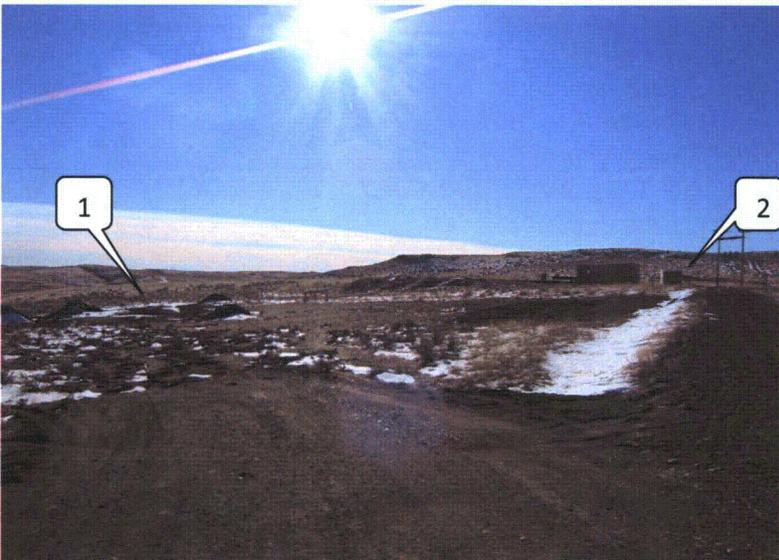
**Photo No. 2**

Mr. Arbogast said Anadarko had the gas leases for much of the Christensen Ranch area. He said they had been good to work with. They had constructed an access road through Wellfield Unit 5 running off to the south. Anadarko has drilled a gas well just to the southwest of deep disposal well DDW 18-3 (Photo No. 2).

Looking west at coal bed methane well (No. 1) drilled near Deep Disposal Well No. DDW 18-3 (No. 2).
