A Destructive Validation of NDE Responses of Service-Induced PWSCC Found in North Anna 2 Control Rod Drive Nozzle 31¹

S. E. Cumblidge, S. R. Doctor, G. J. Schuster, R. V. Harris,
S. Crawford, Rob Seffens, Mychailo Toloczko, Steve Bruemmer
Pacific Northwest National Laboratory
P.O. Box 999
Richland, WA 99352

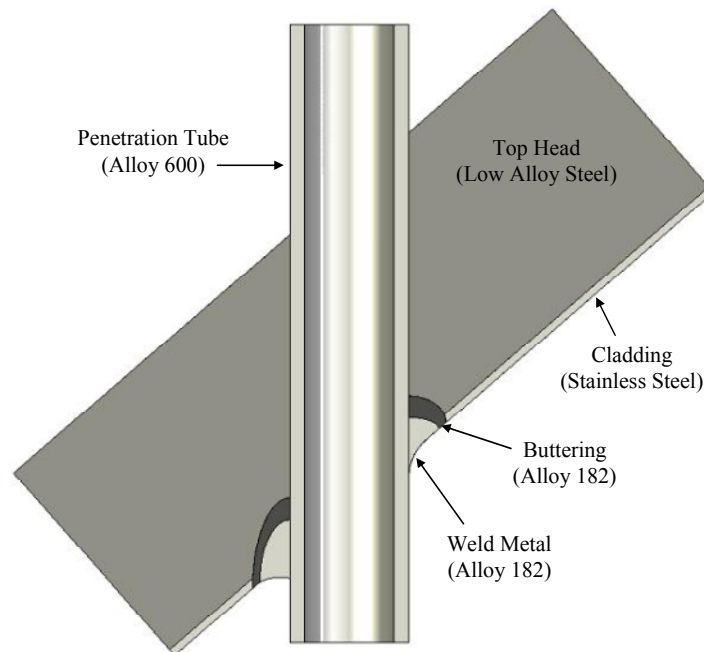
Figure 1: Control rod drive mechanism penetration-nozzle assembly

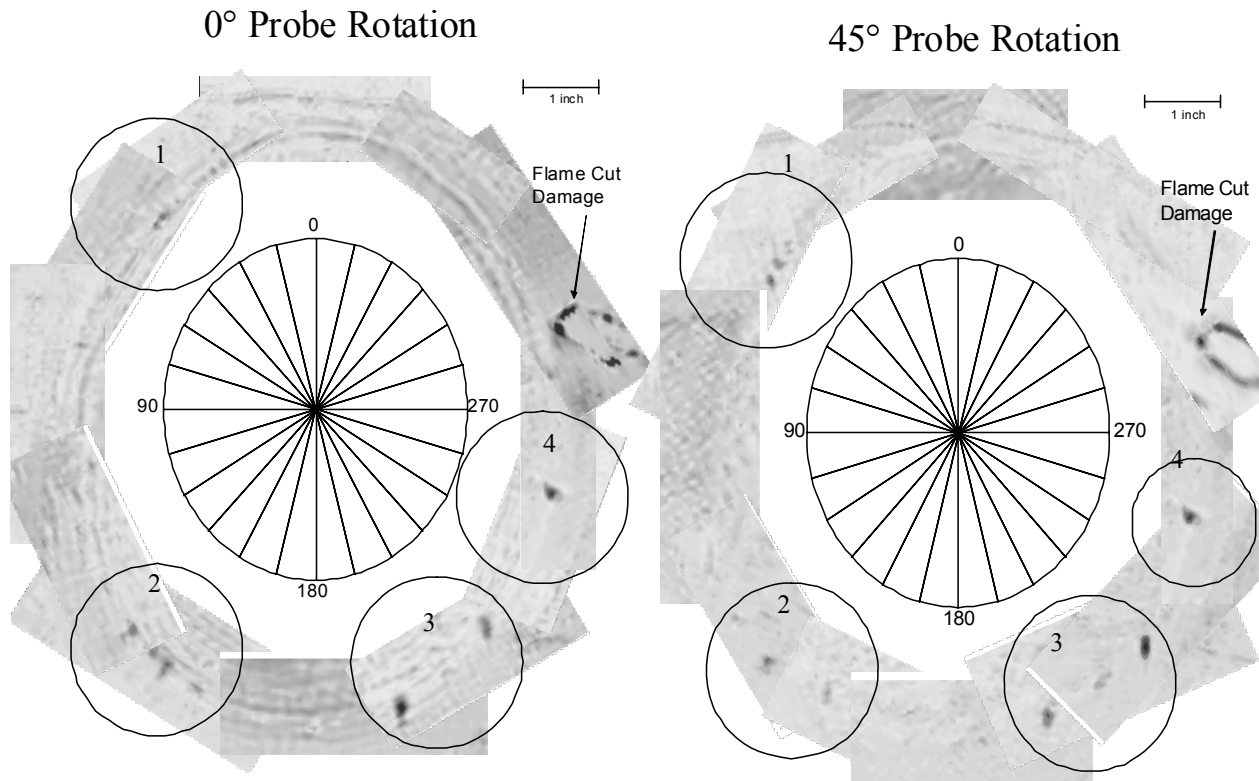
Figure 2: Eddy Current results for zero degree scan of the J-groove weld of Nozzle 31. Four areas of interest were found at close to 60 degrees, 150 degrees, 215 degrees, and 270 degrees.

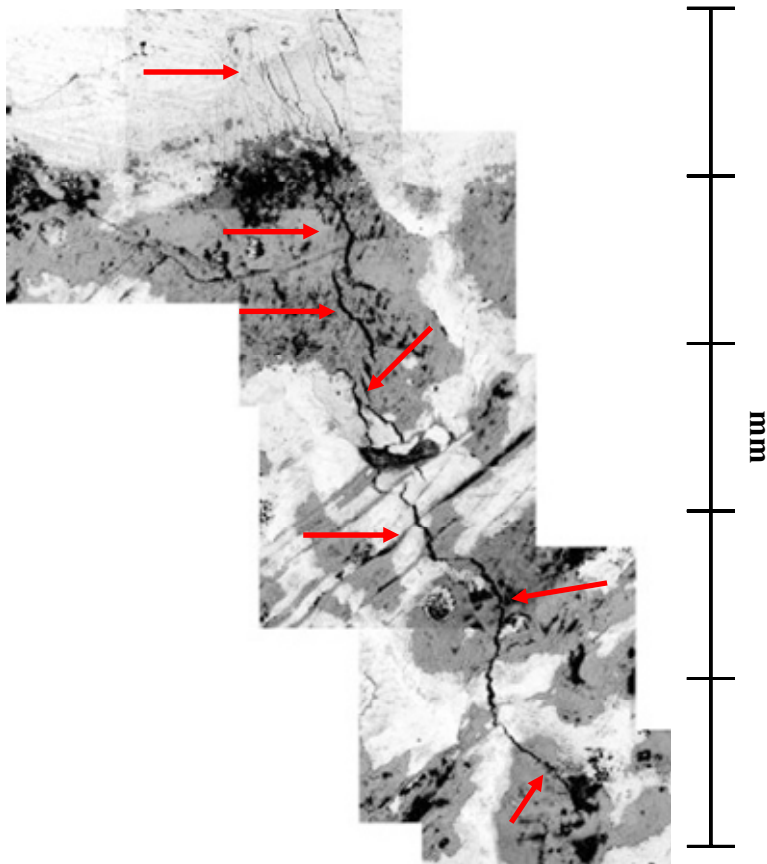
Figure 3: SEM micrographs showing the observed crack on the PWR water surface. The rough as-welded surface and relatively thick corrosion-product oxide is places (white contrast) made imaging of fine secondary cracks difficult. However, the main crack is seen to extend ~6 mm on this surface.

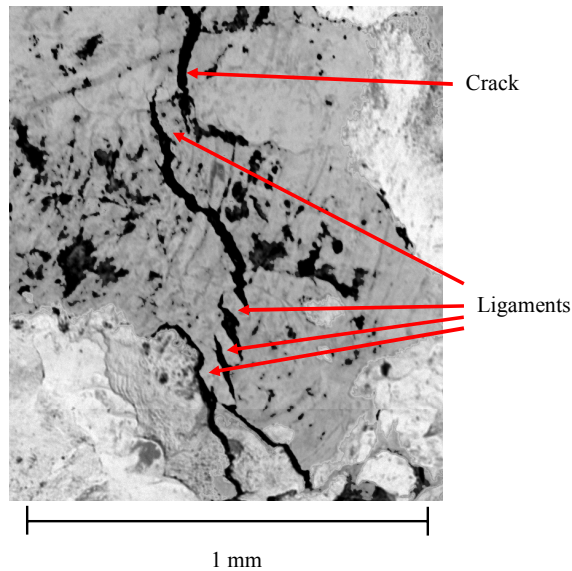
Figure 4: Expanded section of the crack showing ligaments bridging the two sides of the crack.

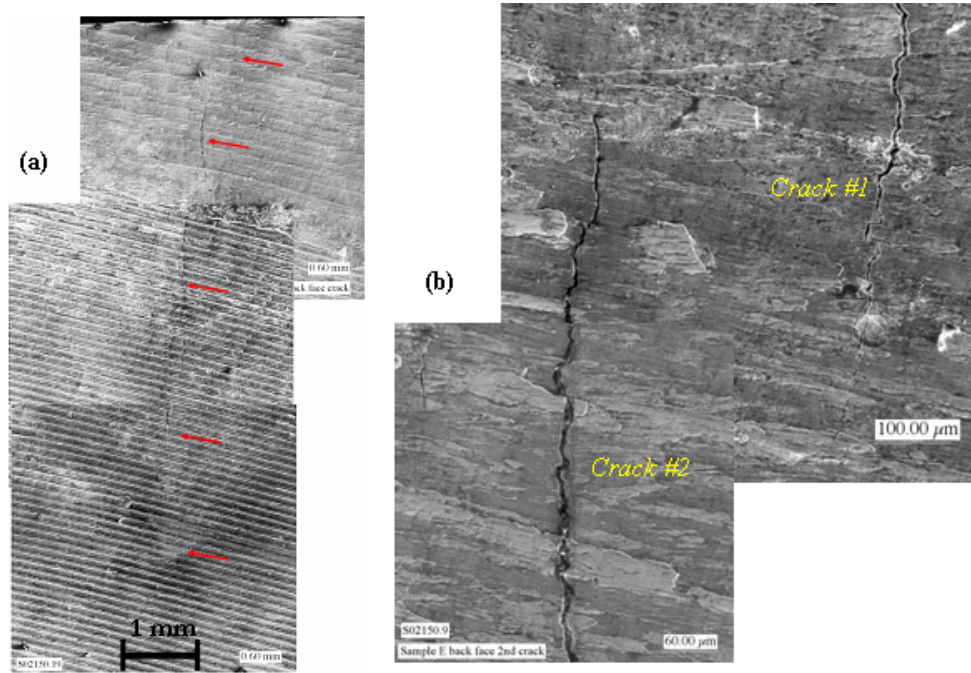
Figure 5: Machined surface and exit location for through-wall cracks from 182 weld metal into interference-fit gap between alloy 182 butter and alloy 600 tube.

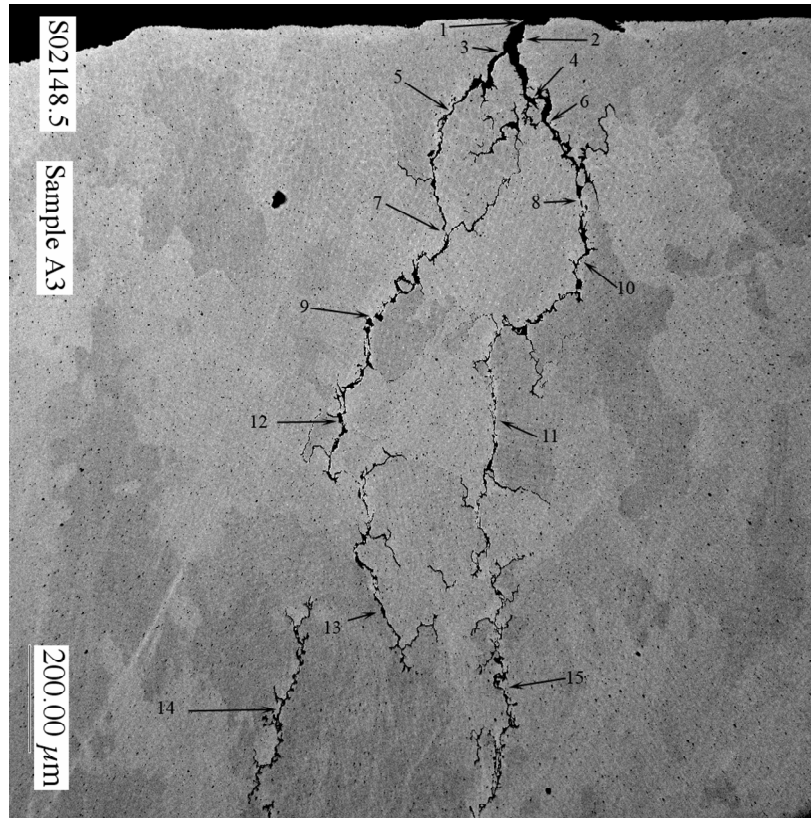
Figure 6: CODs at several points close to the surface.

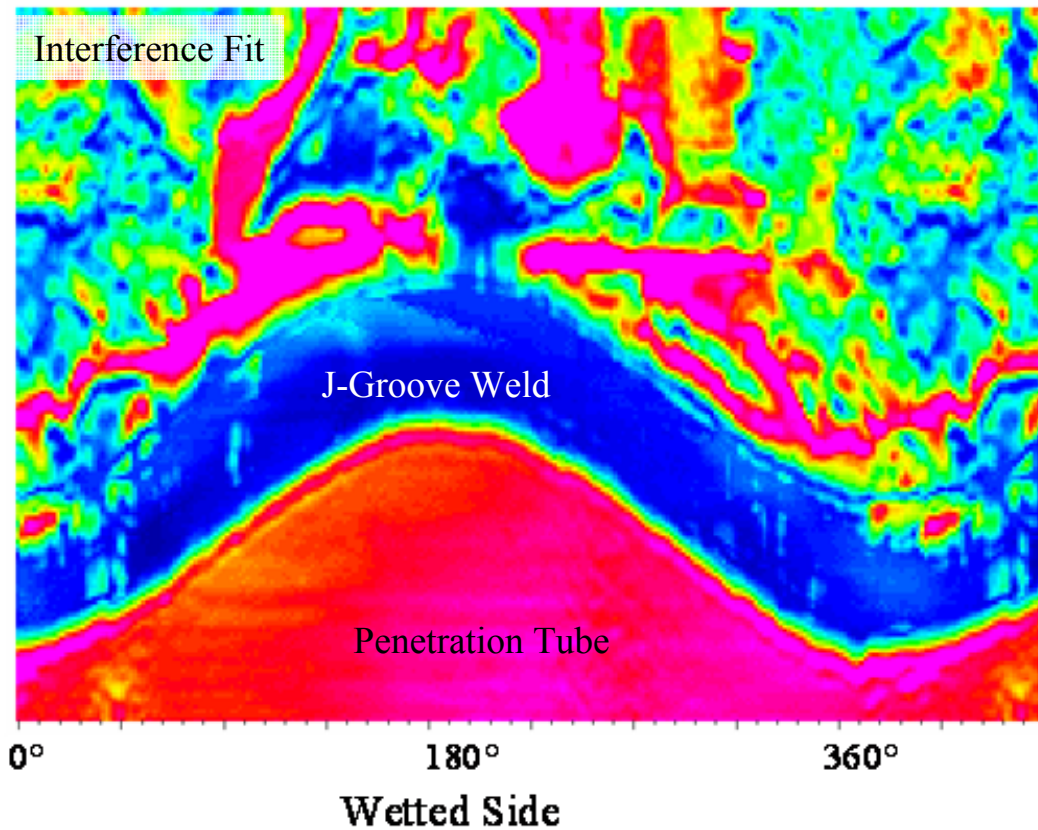
Figure 7 PNNL-Acquired 2.25 MHz Ultrasonic Data on the J-Groove Weld and Part of the Interference Fit of Nozzle 31 After the Nozzle Had Been Removed from the Head

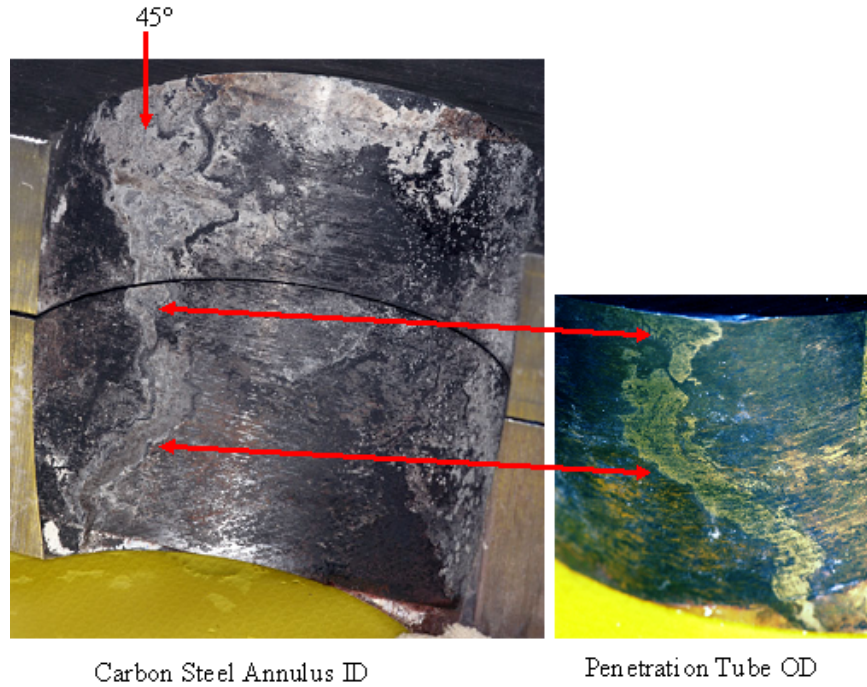
Figure 8 Mirror-Image Damage to the Carbon Steel Annulus and a Section of the Alloy 600 Penetration Tube. The wetted surface is toward the top of the samples.

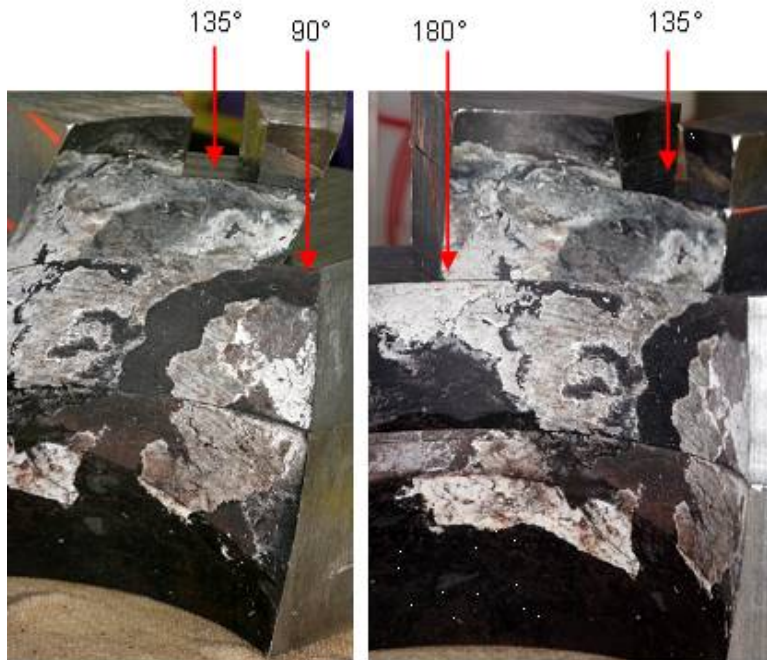
Figure 9 Boric Acid Deposits on the Carbon Steel from 90–180 Degrees. The wetted surface is toward the top of the samples.

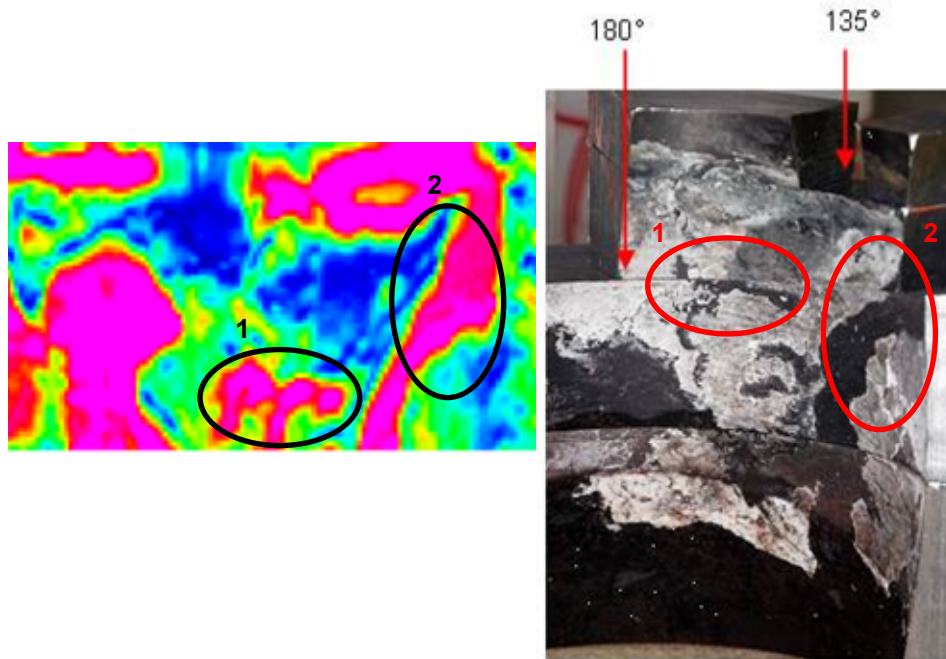
Figure 11 Comparison of Boric Acid Patterns on the Carbon Steel Annulus and UT Patterns on the Left

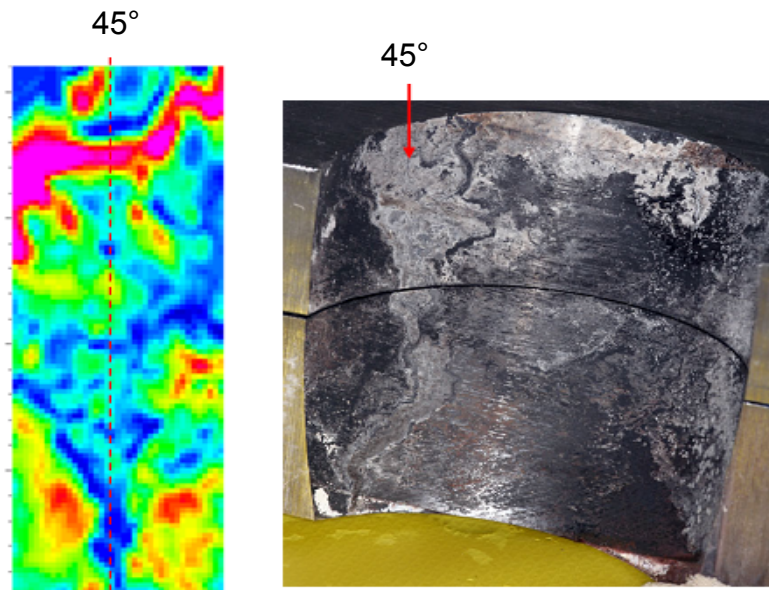
Figure 12 Comparison of the UT Data and the Apparent Corrosion of the Carbon Steel Near 45 Degrees
