**VIRGINIA ELECTRIC AND POWER COMPANY**  
**SURRY POWER STATION UNIT 1**  
**ASME SECTION XI INSERVICE INSPECTION PROGRAM**  
**PROPOSED ALTERNATIVE TO CODE REQUIREMENTS - SPT-008**

**Alternative Request SPT-008  
Surry Unit 1**

**Surry Power Station (SPS) Unit 1 Alternative Request**  
**SPT-008**

<b>Dominion</b>	NUCLEAR ENGINEERING RICHMOND, VIRGINIA	
			<b>30" PIPE WELD REPAIR</b>	
DSGN	CAD NO: 111843 MIDER.DGN	DRAWING NO:	SH 1 OF 1	REV B

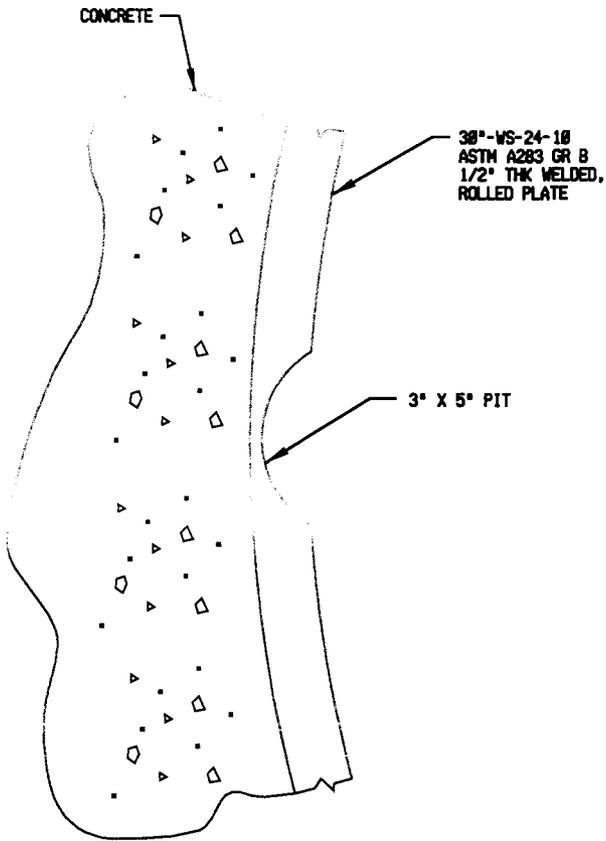
**SECTION**  
BEFORE PIPE WALL REPAIR

Originally, a 3x5 inch pit was identified on the interior of the 30 inch diameter piping for the SW system. The depth of the pit was measured to be 3/16 of an inch. The failure mechanism was general corrosion caused by localized coating failure. The remaining portion of this piping was inspected by a qualified coating inspector according to the Preventive Maintenance Program. Other areas were repaired and coated appropriately.

The subject piping material is carbon steel with nominal wall thickness of 0.5 inch (minimum acceptable wall thickness is 0.25 inch). The operating pressure for this piping section is based upon the height of the canal water level (i.e., approximately 15 psig).
