## IR 0553792-02, Drywell Structural Integrity Basis from 1R21 Inspections

The purpose of this Technical Evaluation is to present current and projected (until 1R22) margin in Drywell Vessel Thicknesses and the bases to further confirm that the drywell structural integrity continues to maintain design basis requirements as established in references 1 through 3. The intent of this evaluation is to demonstrate that the Drywell Vessel thicknesses are adequate to satisfy current licensing and design bases requirements.

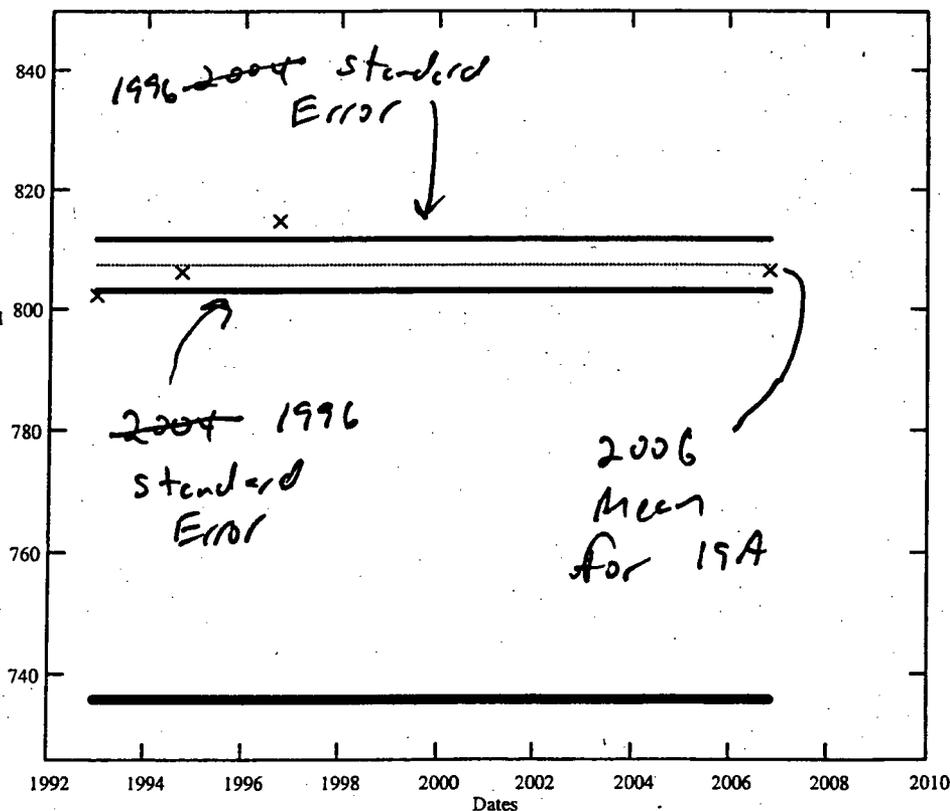
Calculation C-1302-187-5300-030 identified location 19A as the most critical since it was the thinnest area in the sandbed. However the calculation concluded with 95% confidence that this location and the other sandbed region locations were not experiencing corrosion. Figure 1 provides a trend of the mean values for this location. Figure 1 also provides curves showing the calculated standard error of plus or minus 0.0034 inches for the means. The 2006 mean is also plotted on figure 1 and shows that this value is well within the standard error band.

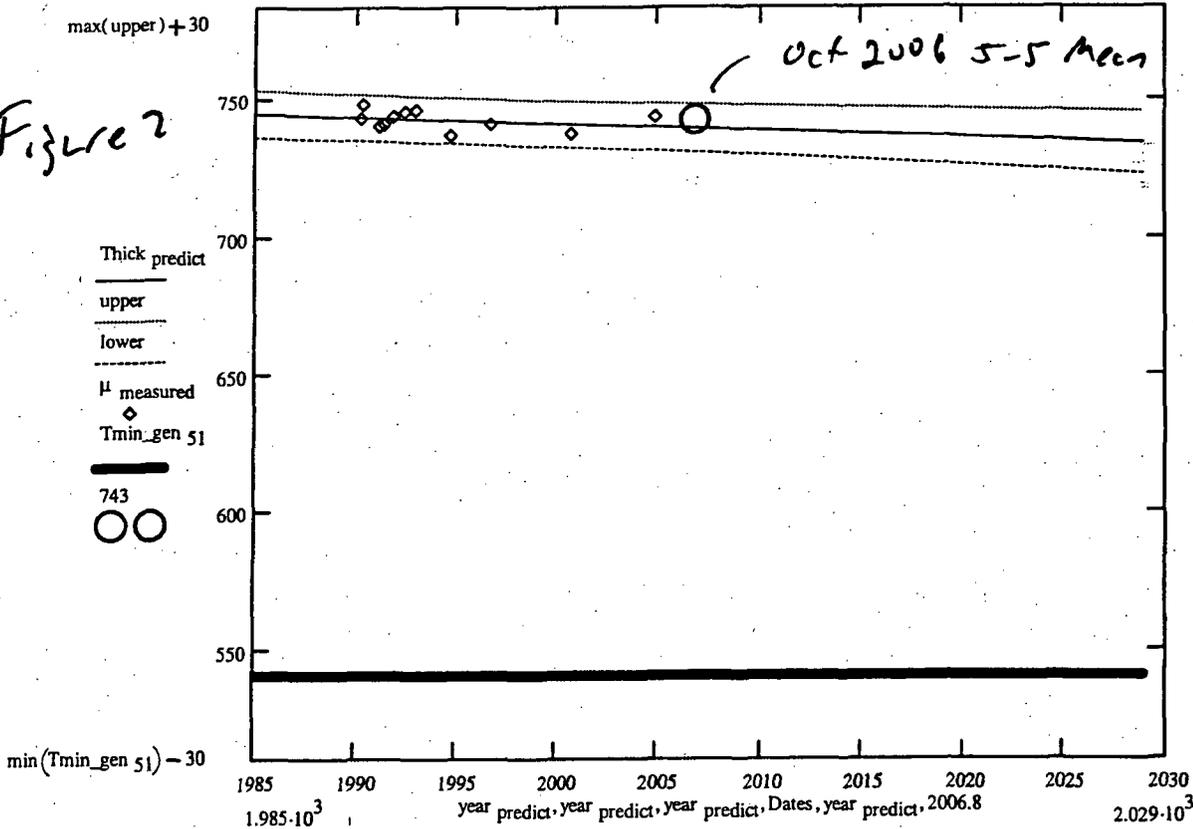
The 2004 calculation identified locations 5-5HI and 15-23HI as the most critical since they were the thinnest at this elevation. The calculation concluded that these locations are experiencing corrosion rates of 0.0003 and 0.0004 inches per year with 95% confidence. Figure 2 and Figure 3 provide trends of the means of data collected from 1987 through 2004 for these locations taken from calculation C-1302-187-E310-037 Revision 2. The 2006 means for each location are plotted on these figures. These show that the 2006 means are consistent with and are bounded by the 2004 projections. Therefore the margins and projections from 2004 remain valid and bounding. Table 1 provides the means and margin calculated in 2004.

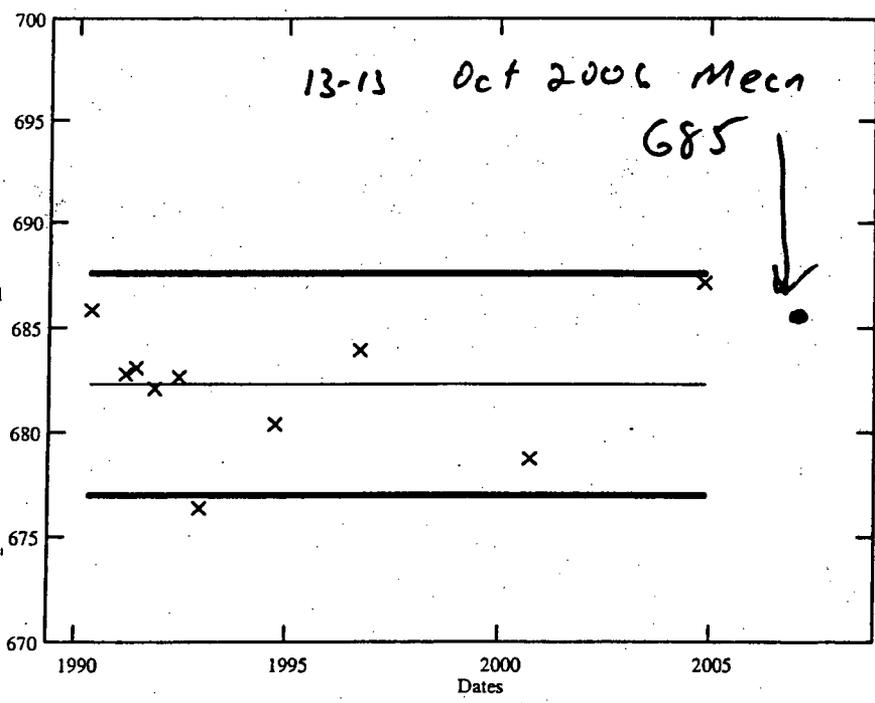
The 2004 calculation identified location 13-32 as the most critical since it was the thinnest at this elevation. However the calculation concluded with 95% confidence that the location was not experiencing corrosion. Figure 4 provides a trend of the means of data collected from 1987 through 2004 for this location taken from calculation C-1302-187-E310-037 Revision 2. The 2006 mean for this location is plotted on this figure. Figure 4 also provides curves showing the 2004 calculated standard error of  $\pm 0.0053$  inches for the data from 1987 to 2004. The 2006 mean is well within the 2004 standard error band.

This shows that the 2006 mean is consistent with and bounded by the 2004 projection, which concluded that this location is not corroding. Therefore the margin and projection from 2004 remains valid and bounding. Table 1 provides the means and margin calculated in 2004.

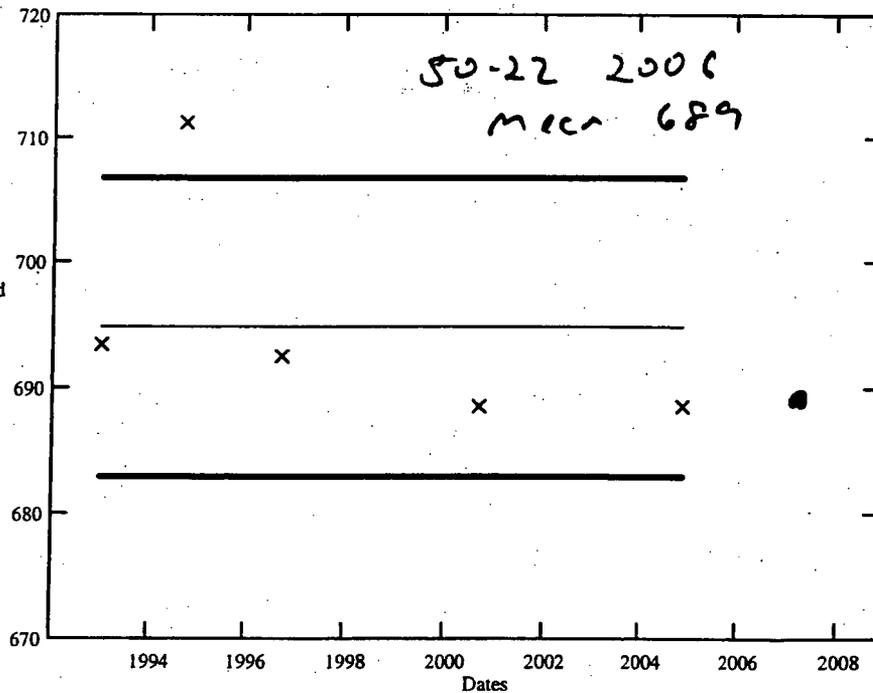
The 2004 calculation identified location 5-22 as the most critical since it was the thinnest at this elevation. However the calculation concluded with 95% confidence that the location was not experiencing corrosion. Figure 5 provides a trend of the means of data collected from 1992 through 2004 for these locations taken from calculation C-1302-187-E310-037 Revision 2. The

2006 mean for this location is plotted on this figure and shows that this value has virtually not changed since 2004.

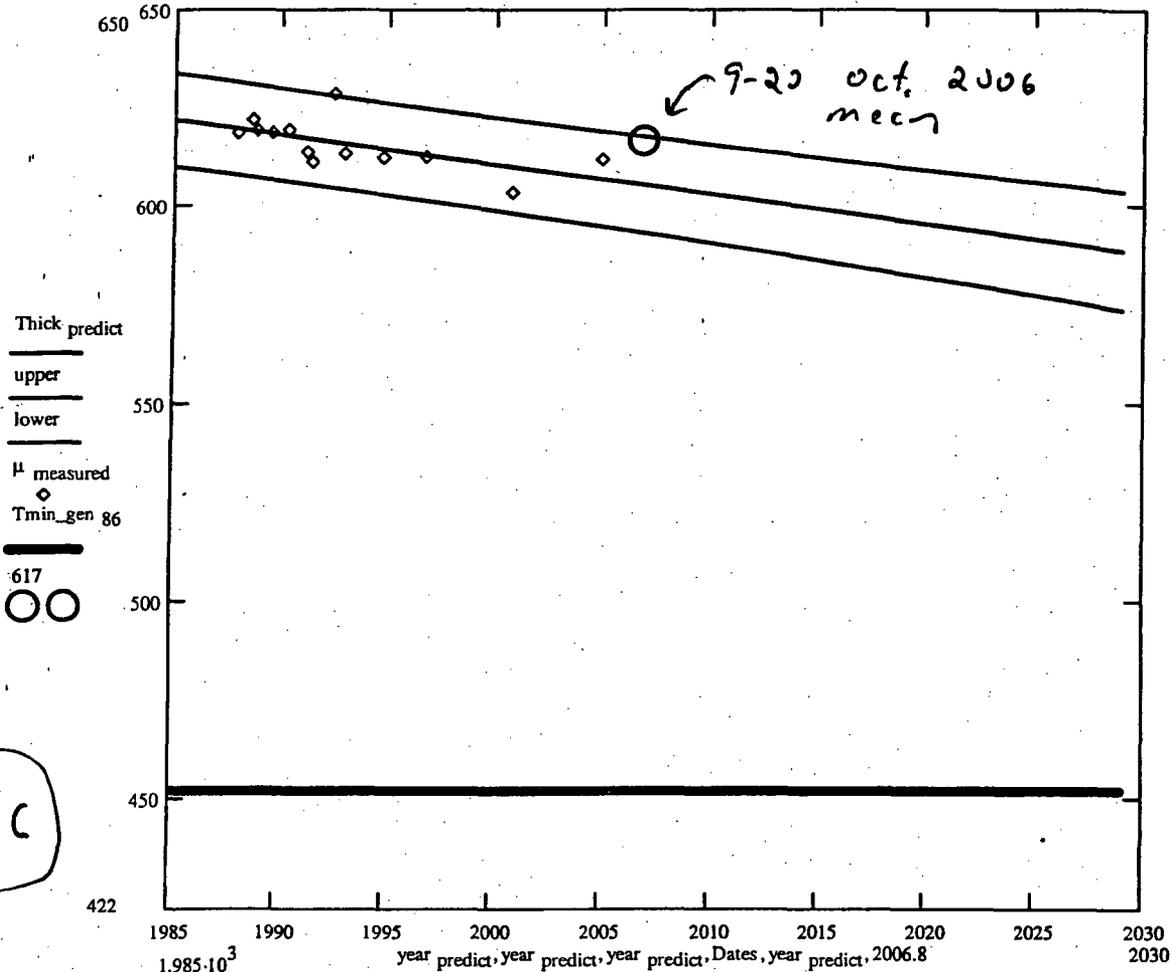
Figure C

The 2004 calculation identified location 9-20 as the most critical since it was the thinnest at this elevation. The calculation concluded that this location was experiencing a corrosion rate of 0.00075 inches per year with 95% confidence. Figure 6 provides the trend of the means of data collected from 1987 through 2004 for these locations taken from calculation C-1302-187-E310-037 Revision 2. The 2006 mean for this location is plotted on this figure. This shows that the 2006 mean is consistent with and is bounded by the 2004 projection. Therefore the margin and projection from 2004 remain valid and bounding. Table 1 provides the means and margin calculated in 2004.

Therefore the regression model shows that even at the lower 95% confidence band this location will not corrode to below Drywell Vessel Minimum required thickness by the plant end of life.
