RE: Reply to a Notice of Violation; EA-09-069  
License No. 15-27070-01

Response to Notice of Violation  
License No. 15-27070-01, Docket No. 030-32176  
May 11, 2009  
Page 2

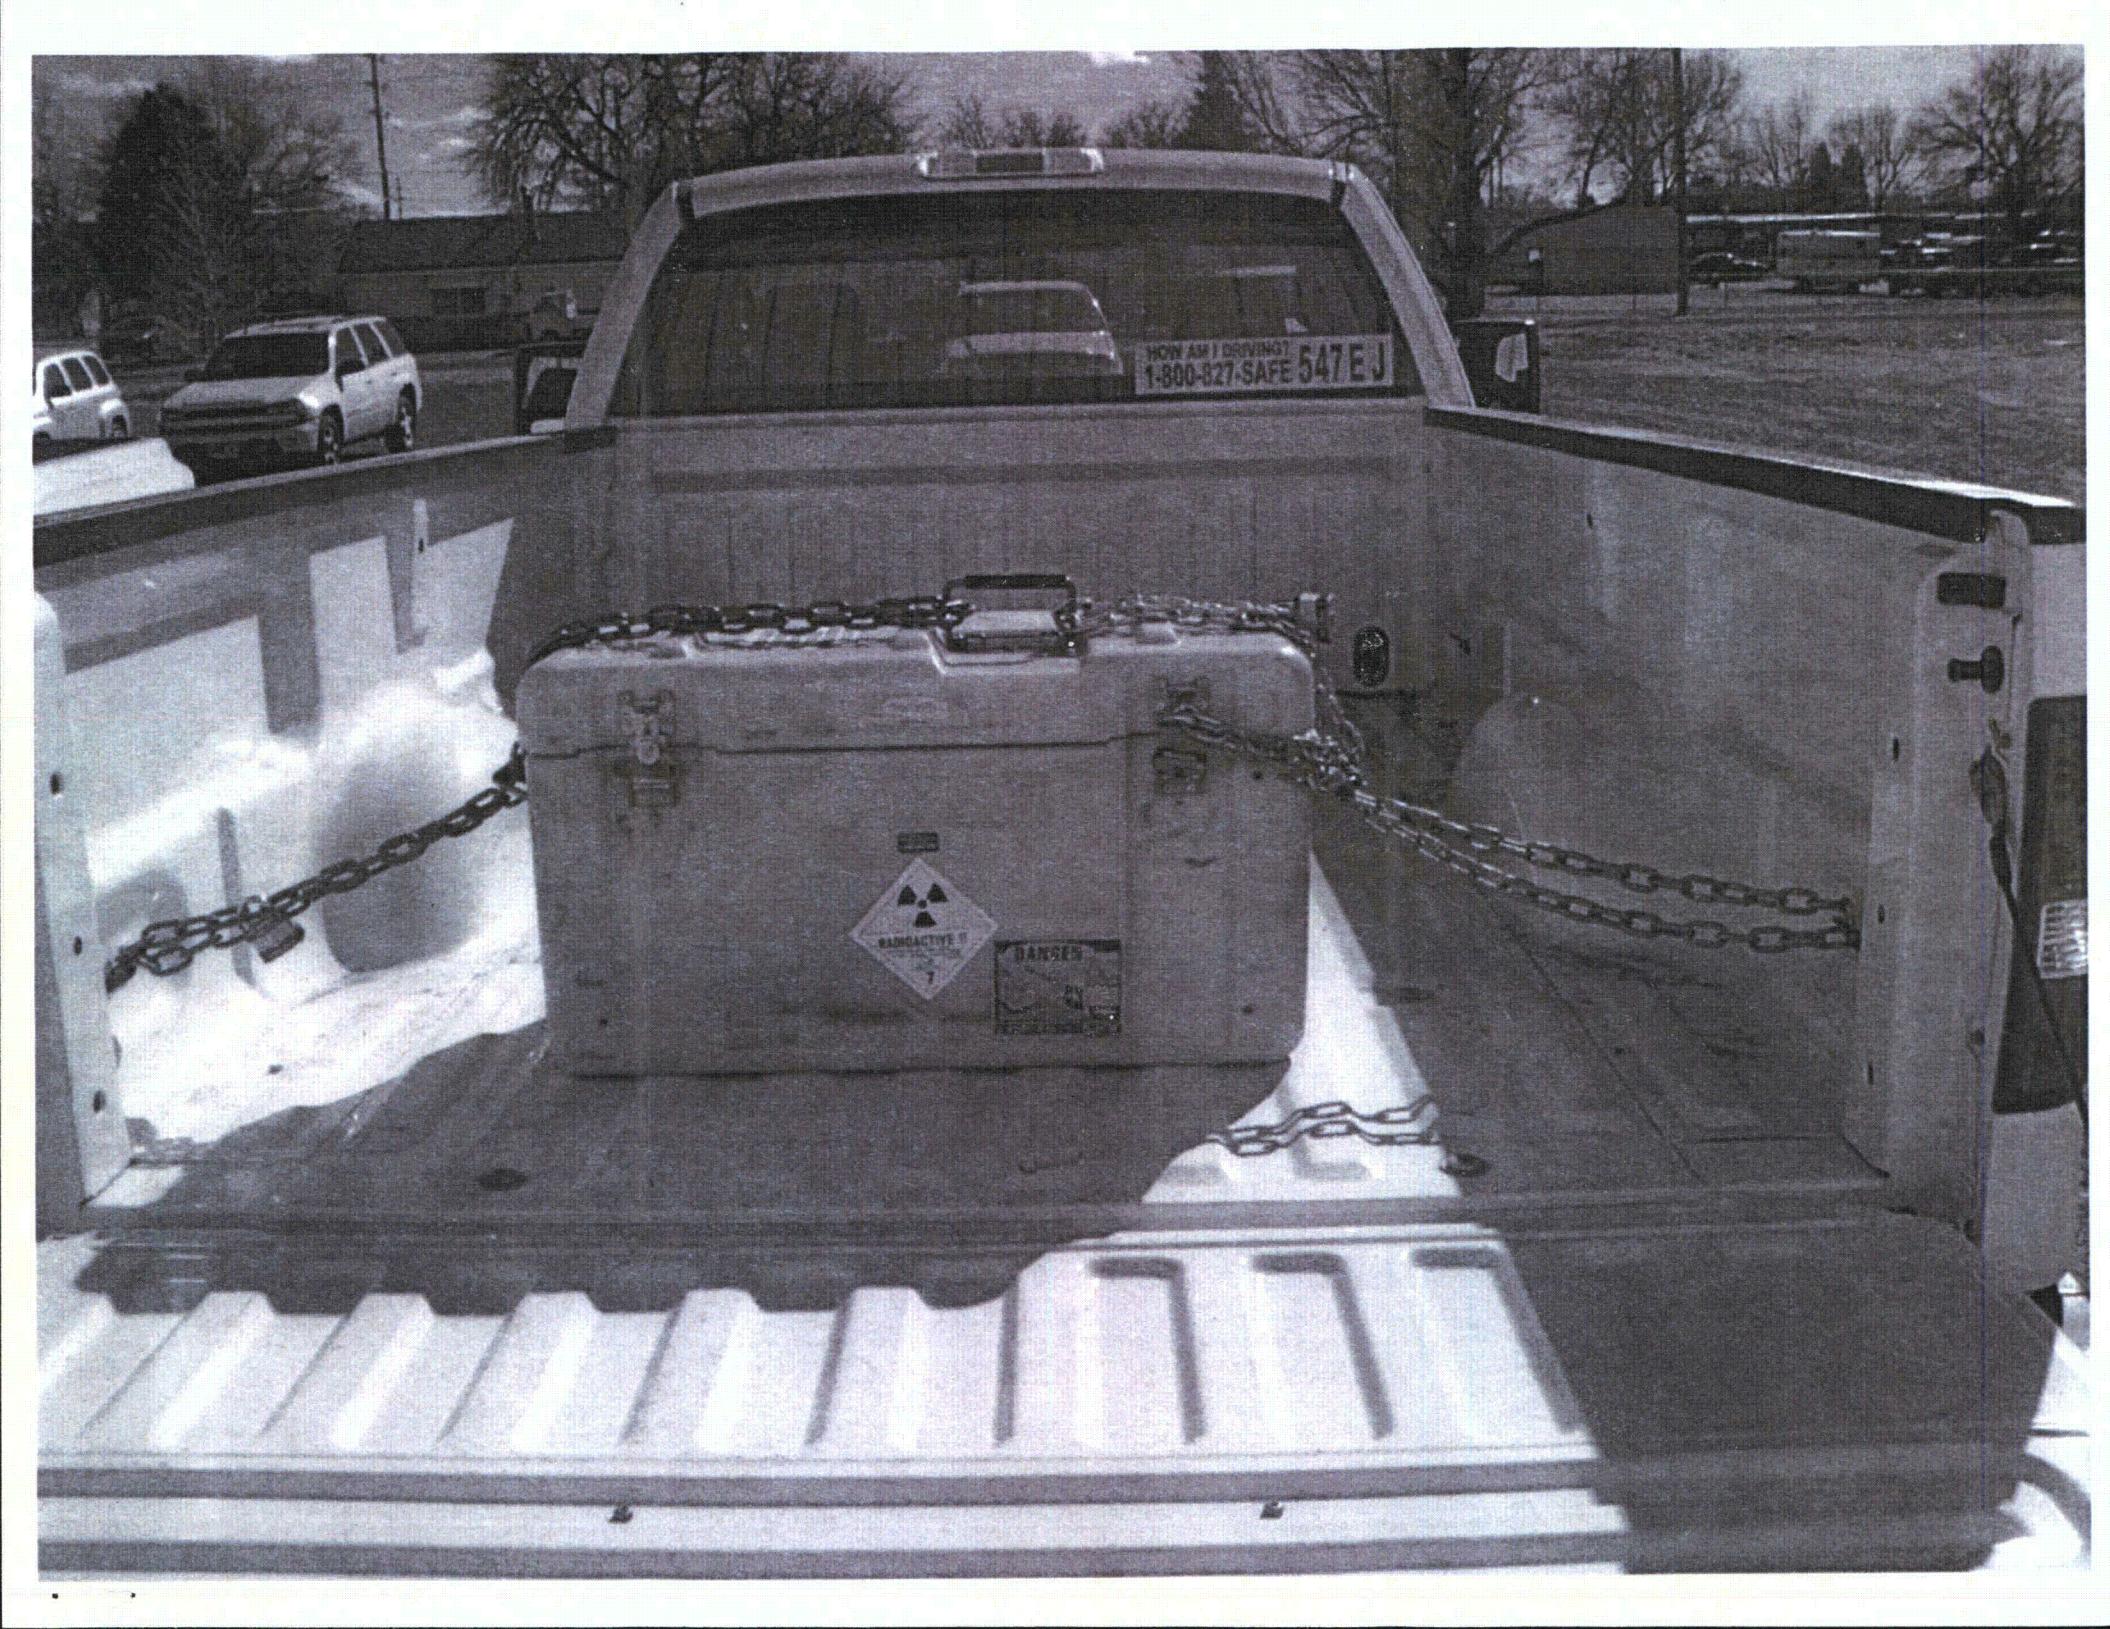
Nuclear Gauge  
Security 001.jpg...

Unfortunately, the inspector found storage of the gauge observed on our project site storage location in violation of the "dual security" rule. Although the gauge case was secured to the vehicle with two separate chains and padlocks...there was only one lock keeping the gauge itself from being stolen. We'll be cited for "escalated enforcement" based on this finding. To correct this in advance...We need to make sure that we are securing gauges such that there are always TWO independent barriers against theft. That means we either have a padlock on each hasp thru a length of suitably strong

chain securing the gauge to the vehicle...or...we have the gauge case LOCKED, and have two chains and independent locks fished thru both side handles and across the top of the gauge case. These should be just short enough to go from one side of the pickup bed to the other so that someone can't open the gauge case with the chains in place over the top of the case. Here are some pictures with acceptable DUAL SECURITY chains in place to prevent theft of the gauge and case. If you have two locking hasps on your gauge case, a padlock and chain thru each the vehicle structure will serve. Your cooperation in re-instruction your technicians on the requirements of the dual security rule will be greatly appreciated.
