**Inspection of Motor Operated Valve Limitorque AC Motors with  
Magnesium Rotors**

BWROG-TP-09-005  
Revision 0  
March 05, 2009

A Technical Product of the BWR Owners Group  
Valve Technical Resolution Group

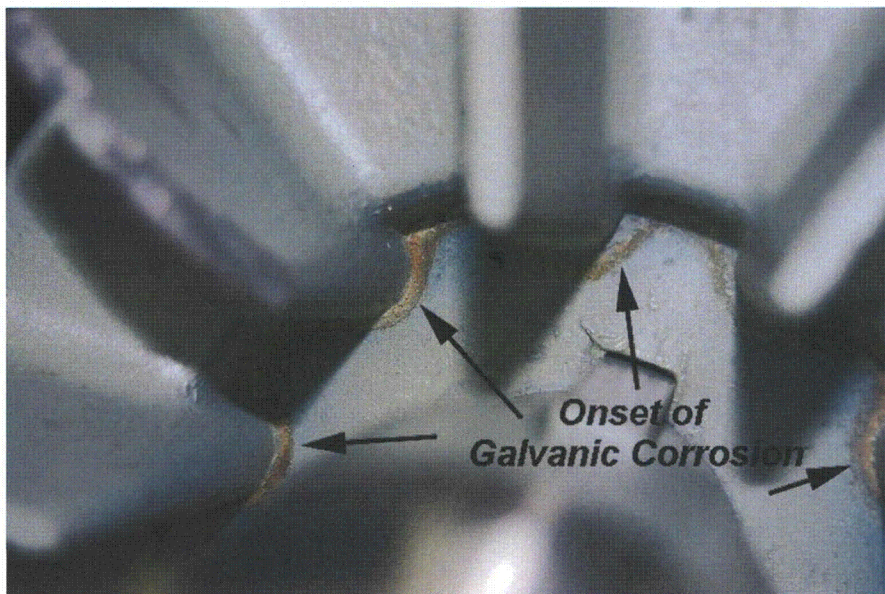
Figure 2 – Onset of galvanic corrosion between magnesium end ring and end lamination.

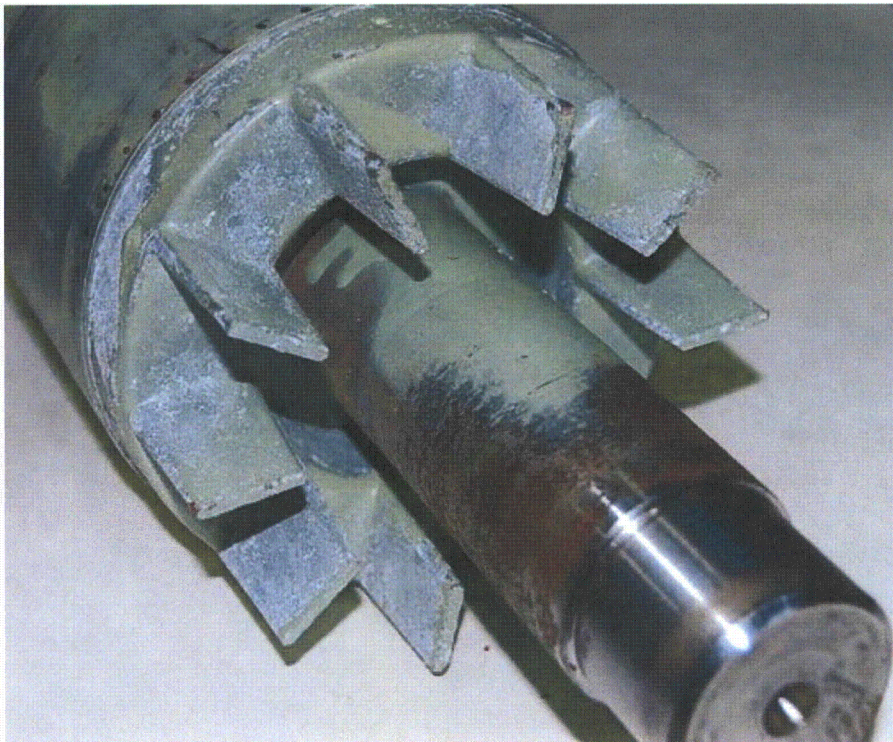
Figure 3 – General corrosion on magnesium end ring.

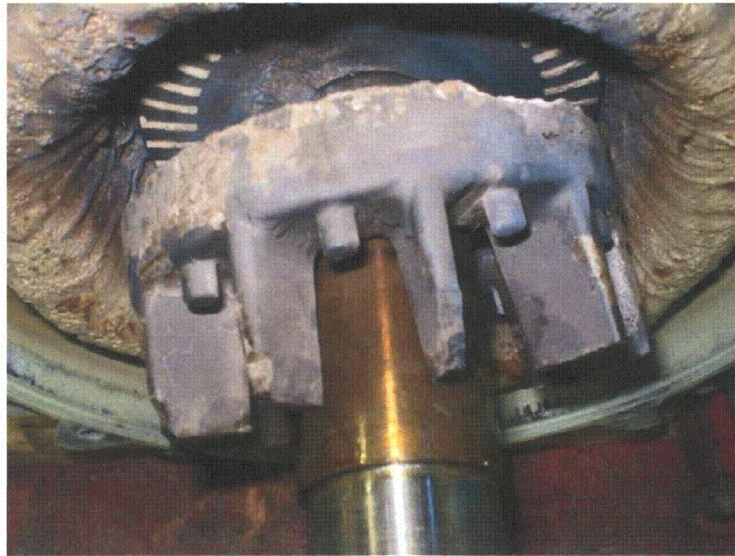
*Figure 4 - Thermally induced stress failure of 150 lb-ft magnesium rotor. This motor was automatically energized by the control system at locked rotor conditions for approximately 0.4 seconds followed by six seconds of not being energized. This continued for approximately 90 minutes. The valve was bound in place so the motor rotor did not turn (operated at locked rotor condition). After approximately 90 minutes, the motor stator winding failed and a ground fault indication tripped the motor control center supply breaker.*

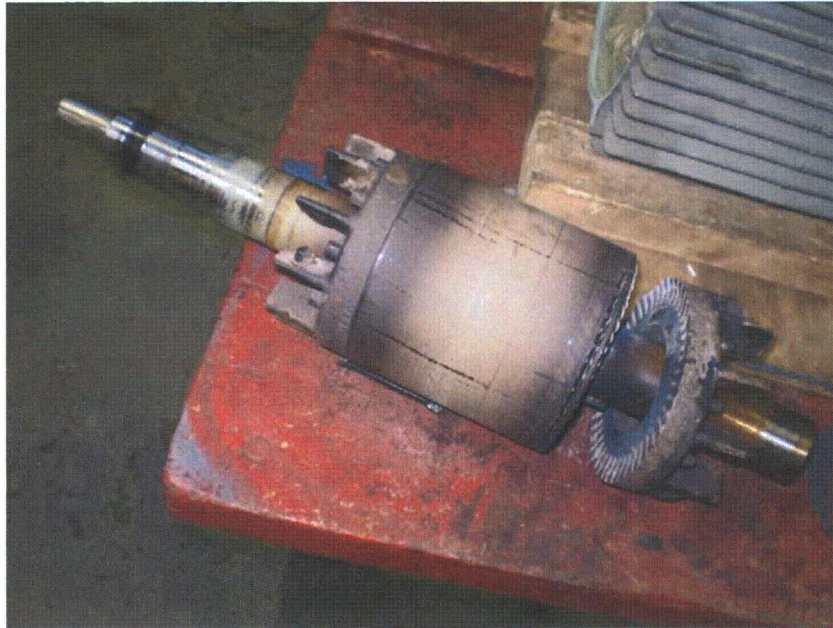
*Figure 5 – 150 lb-ft magnesium rotor after removal from stator frame. Note the heavy heat damage on the magnesium rotor end rings as compared to that apparent on the center body of the rotor.*

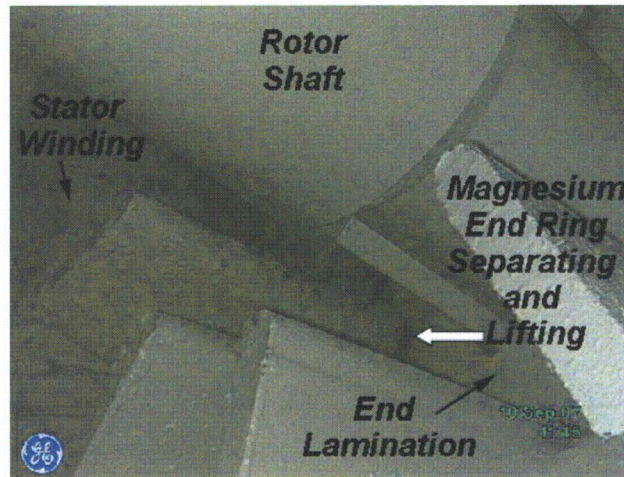
Figure 6 - Onset of magnesium end ring separating from rotor end lamination. The cooling fin has deflected outwards towards the stator winding but has not yet come in contact with the stator winding. This motor would not meet borescope inspection acceptance criteria.

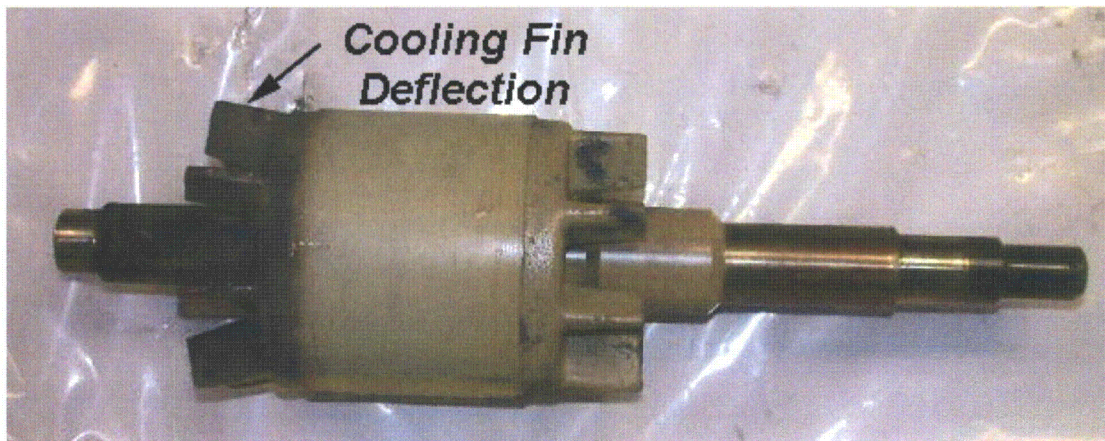
Figure 7 - Magnesium rotor with cooling fins deflected due to the growth of corrosion products between the end lamination and magnesium end ring. The rotor cooling fin came in contact with the stator winding and caused the motor to fail.

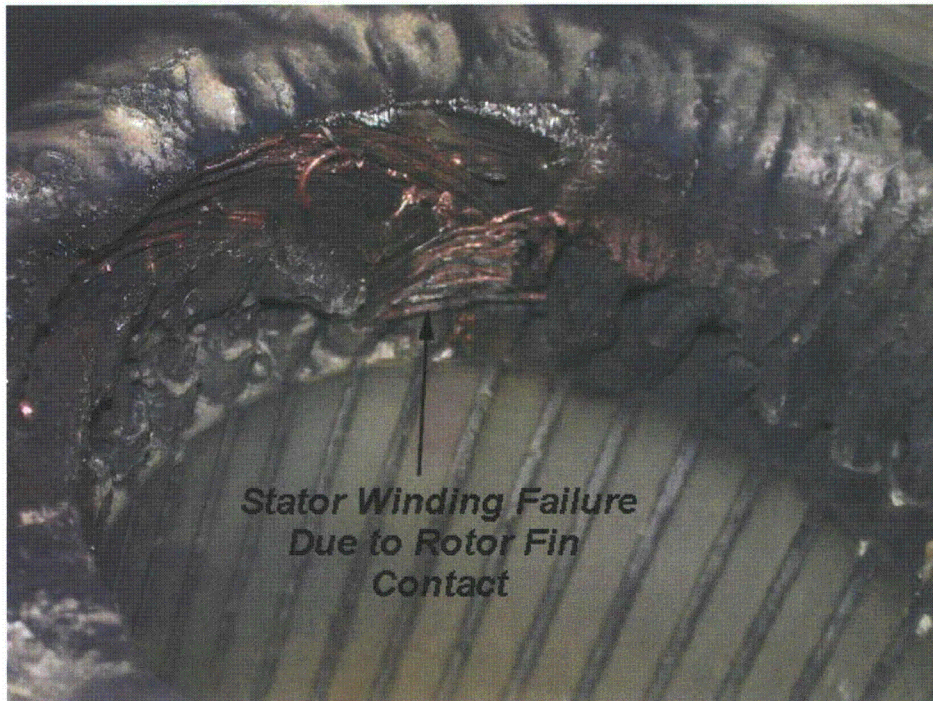
*Figure 8 - Motor stator winding failure due to motor rotor cooling fins contacting the stator winding during operation. The cooling fins were deflected due to corrosion products between the end lamination and magnesium end ring.*

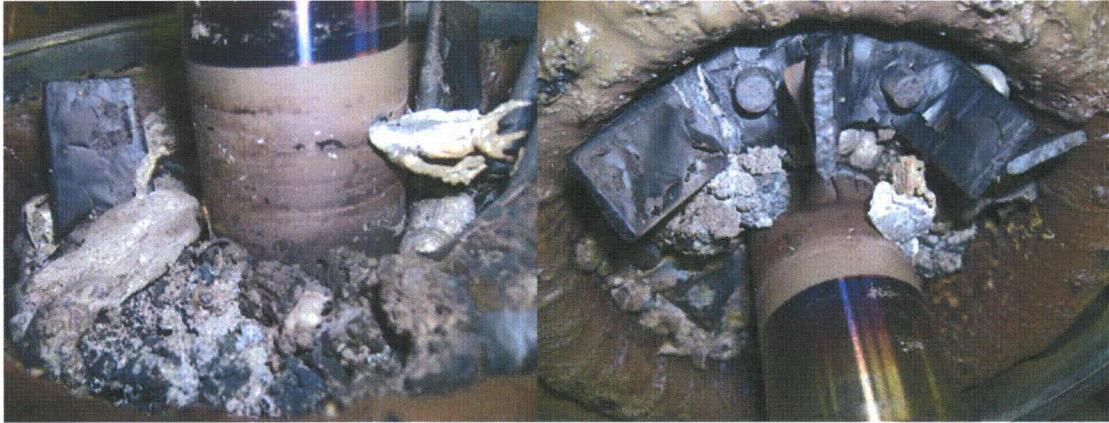
*Figure 9 - Catastrophic failure of magnesium rotor where the magnesium casting melted during a locked rotor condition.*

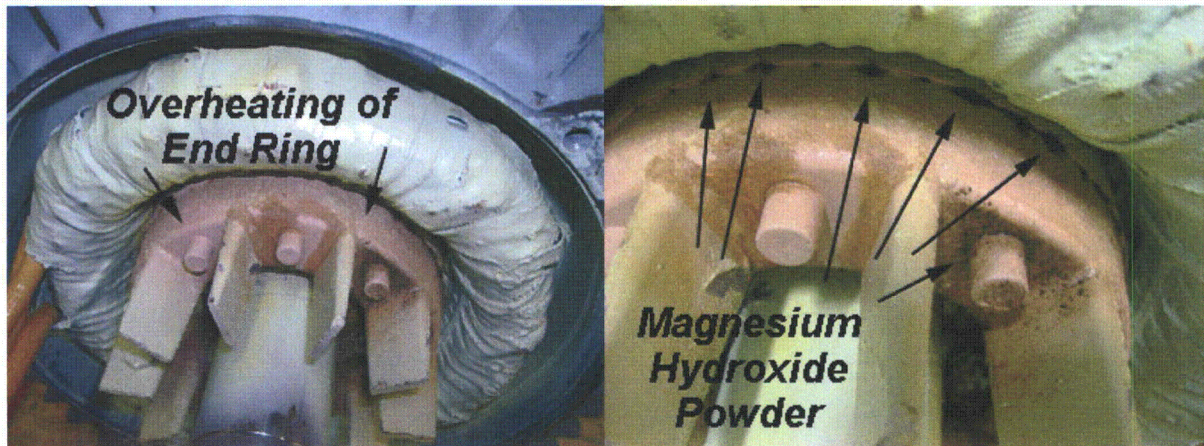
Figure 20 - Rotor still installed in motor stator. The magnesium hydroxide powder can be seen at the O.D. of the rotor and at the balance nub at the 1 o'clock position. The magnesium end ring is overheated and discolored from the original insulating paint color of light green. The formation of magnesium hydroxide powder in this example is most likely due to thermally induced stress.

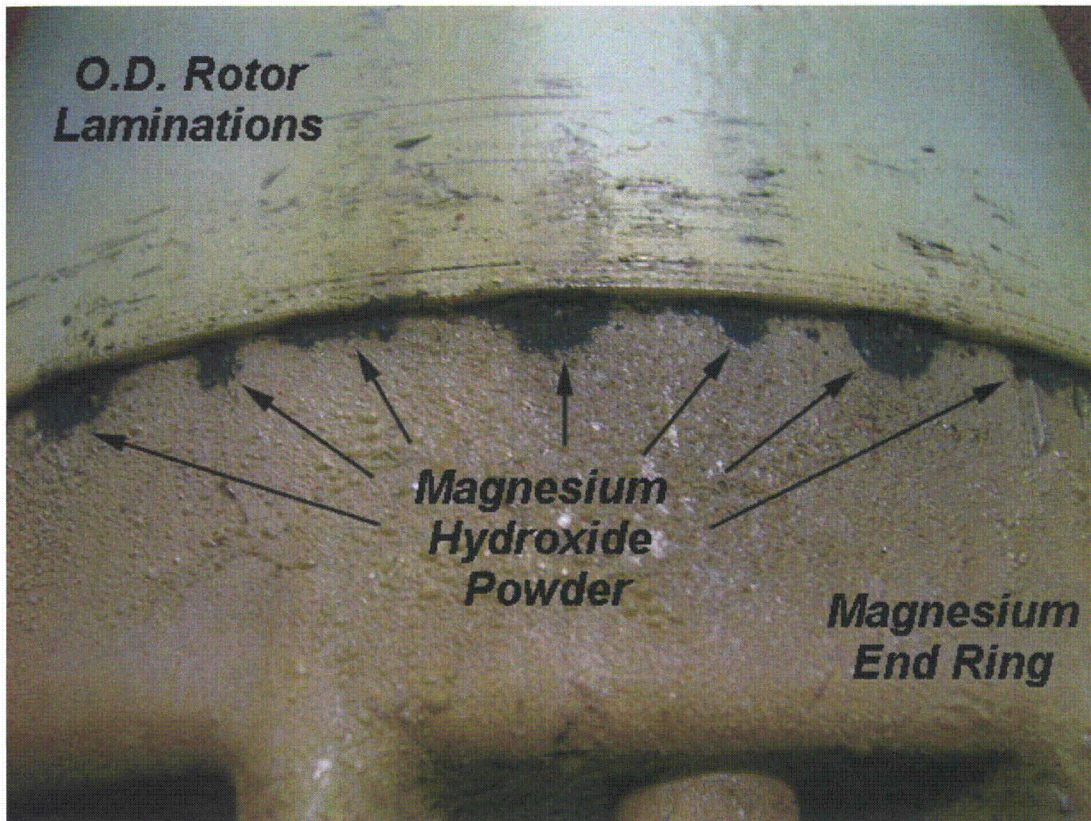
Figure 21 - Outside diameter of motor rotor removed from the motor stator. Note the magnesium hydroxide powder at the interface of the end lamination and the magnesium end ring. This is caused by galvanic corrosion across the interface. Note the overall color of the magnesium end ring; it is darkened in color, which can be seen better in the next image.

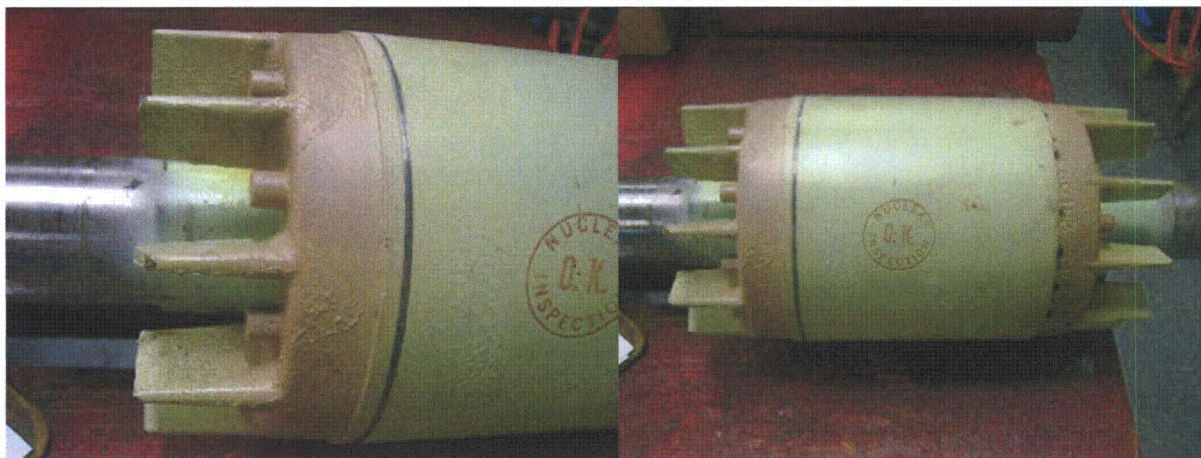
Figure 22 - Magnesium rotor with indications of thermally induced stress at the end rings on both sides. This can be seen by the brown discoloration of the end rings, which were originally the light green color. Magnesium hydroxide powder can be seen on the right hand end lamination to end ring interface. The left side had a small rub between the rotor laminations and stator, causing the paint to be removed where the stripe can be seen.

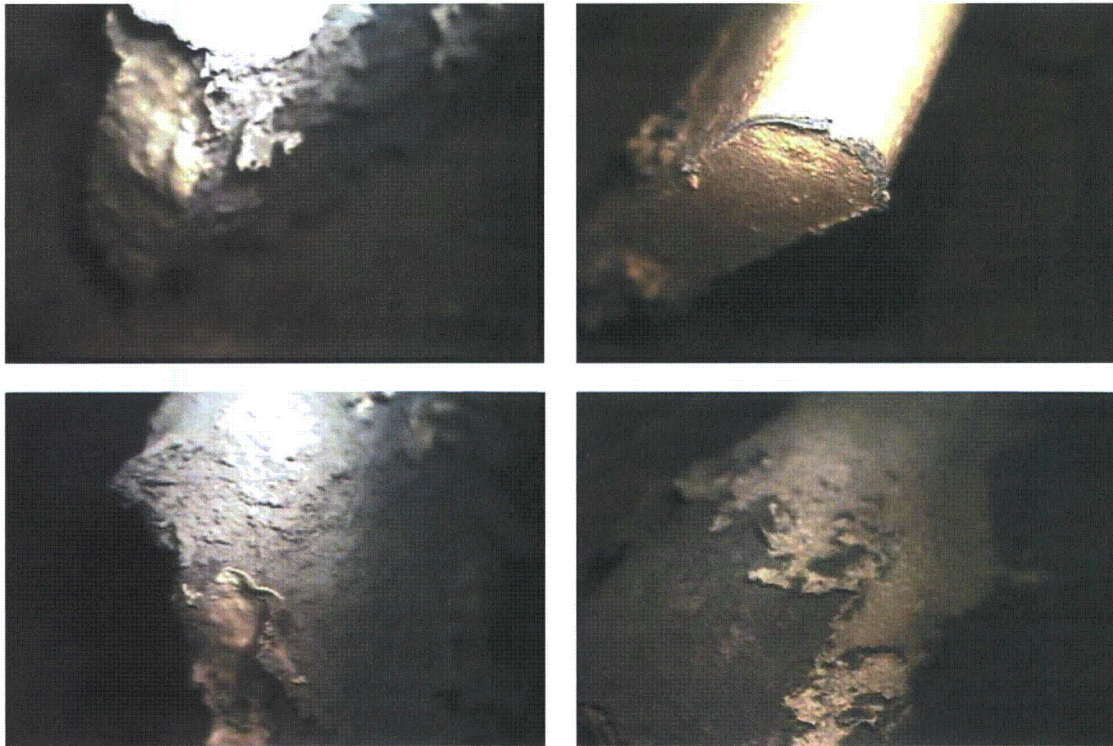
Figure 26 – Example of excessive corrosion on rotor cooling fins.

**Note:** For Group A Motors (Section 6.3.1) found to have one or more of the above indications shall be considered failed and the motor should be replaced or reconditioned. For Group B motors (Section 6.3.2) found to have one or more of the above indications shall be dispositioned by a formal engineering evaluation or replaced or reconditioned prior to return to service.

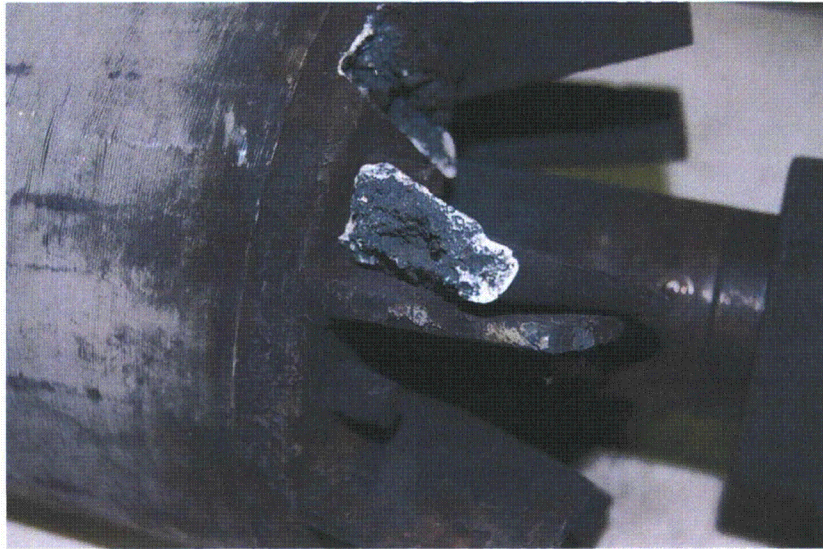
Figure 27 – Rotor with cooling fan/magnesium end ring detached.

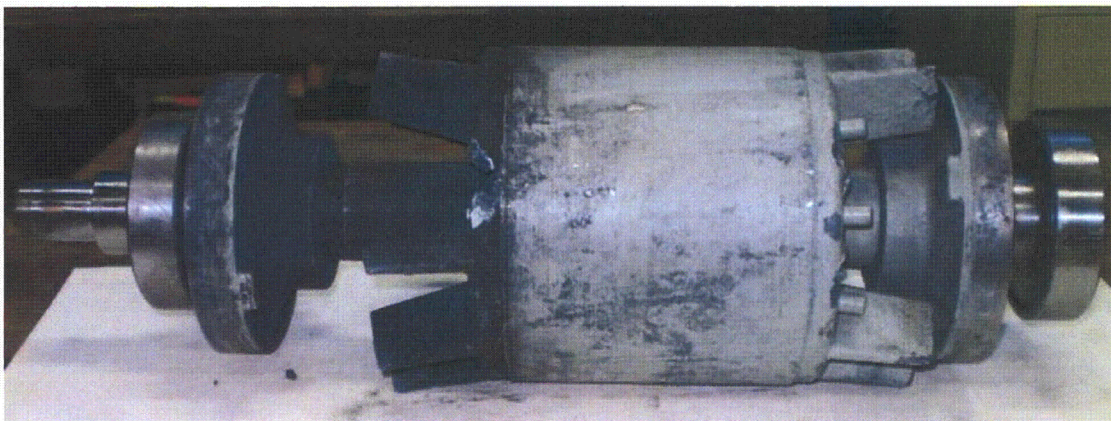
Figure 28 – Excessive corrosion of magnesium end ring combined with the cooling fins being deflected outwards from the body of the rotor.

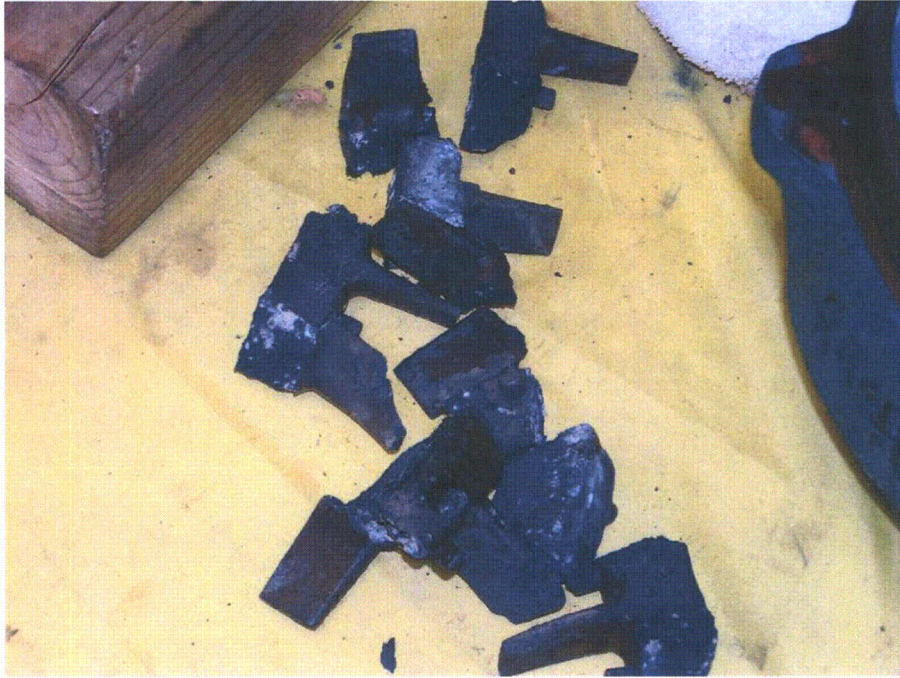
Figure 29 – Catastrophic failure of magnesium end ring.

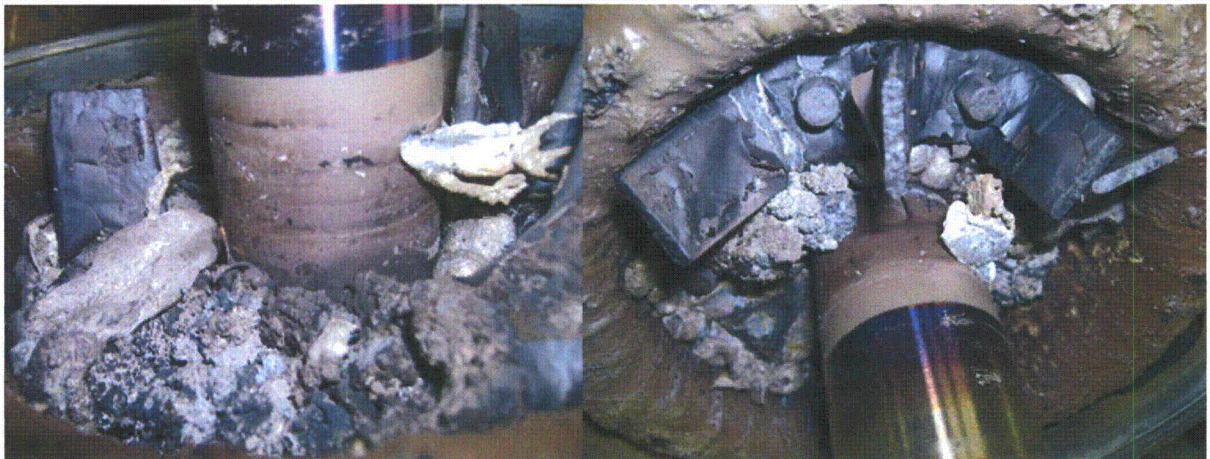
Figure 30 - Failed magnesium rotor. Note angularity of rotor fins relative to shaft and globs of molten magnesium. Note this is shown with the bearing bracket removed in a shop environment.

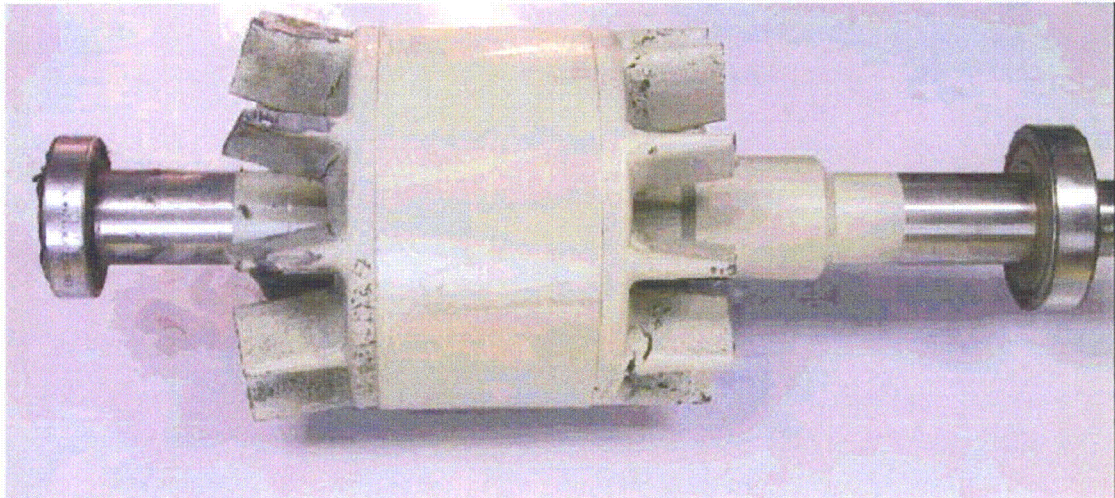
Figure 31 – Deflected cooling fins on left hand side with cracking evident. Right hand side cooling fins also demonstrate cracking.

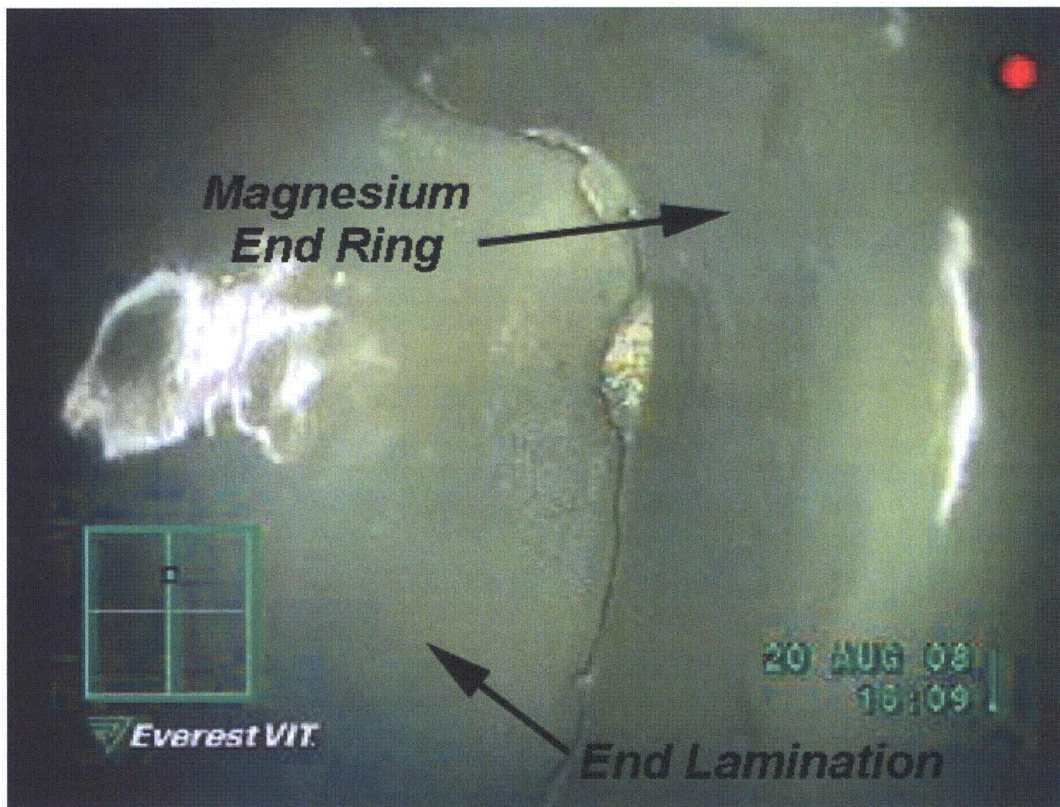
Figure 32 – Acceptable separation and paint cracking between magnesium end ring and end lamination with no corrosion present.

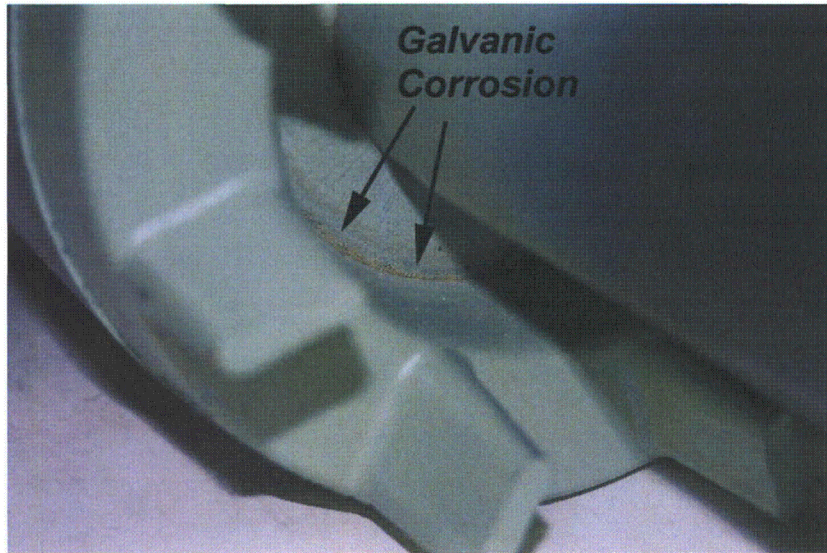
Figure 33 – Minor galvanic corrosion at the interference of the magnesium end ring and end lamination.

**Note:** For Group A Motors (Section 6.3.1) found to have one or more of the above indications shall be considered failed and the motor should be replaced or reconditioned. For Group B Motors (Section 6.3.2) found to have one or more of the above indications should be considered degraded and scheduled for another inspection or replacement or reconditioning within the greater of the end of the next fuel cycle or 24 months.

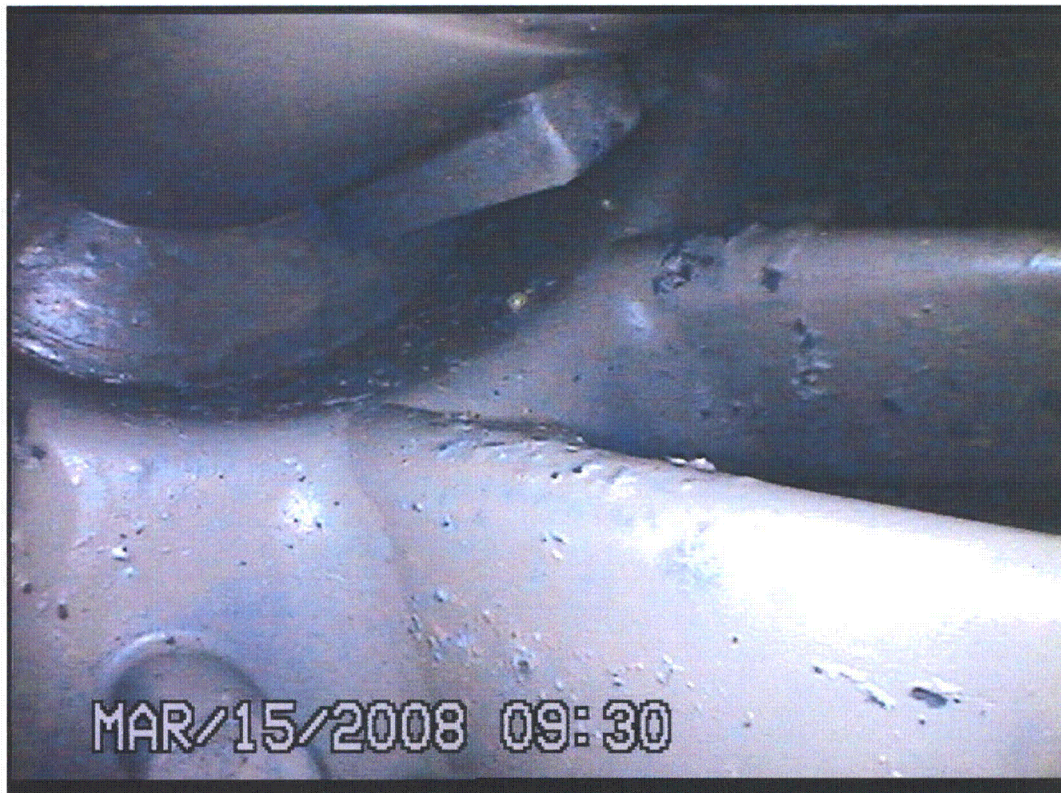
Figure 34 – Slight blistering onset of corrosion of the magnesium end ring/cooling fins coating.

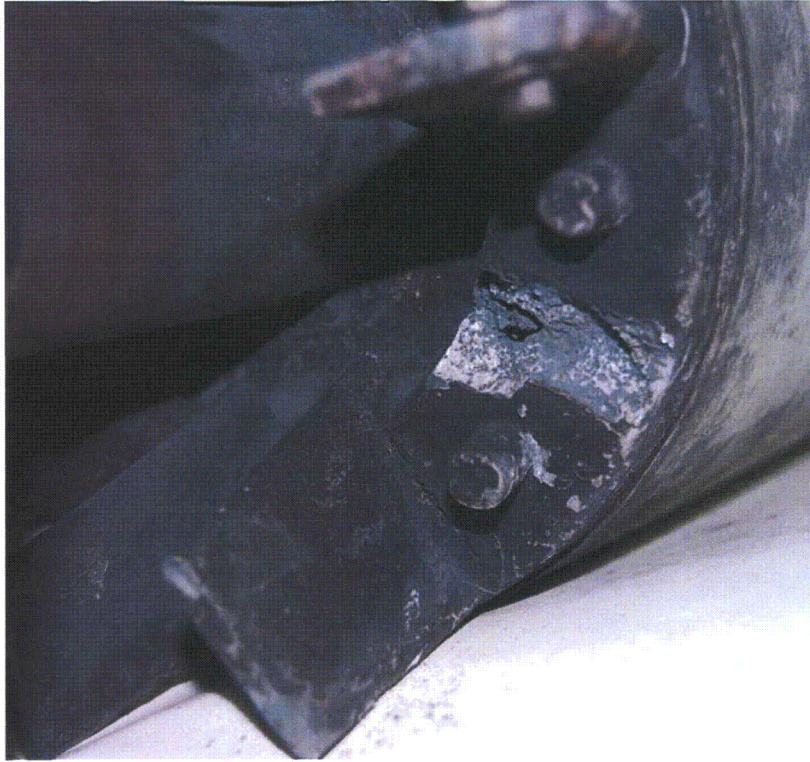
*Figure 36 – Magnesium rotor with black corrosion product build-up between the rotor end lamination and the magnesium end ring. NOTE: one cooling fin has broken off the end ring.*

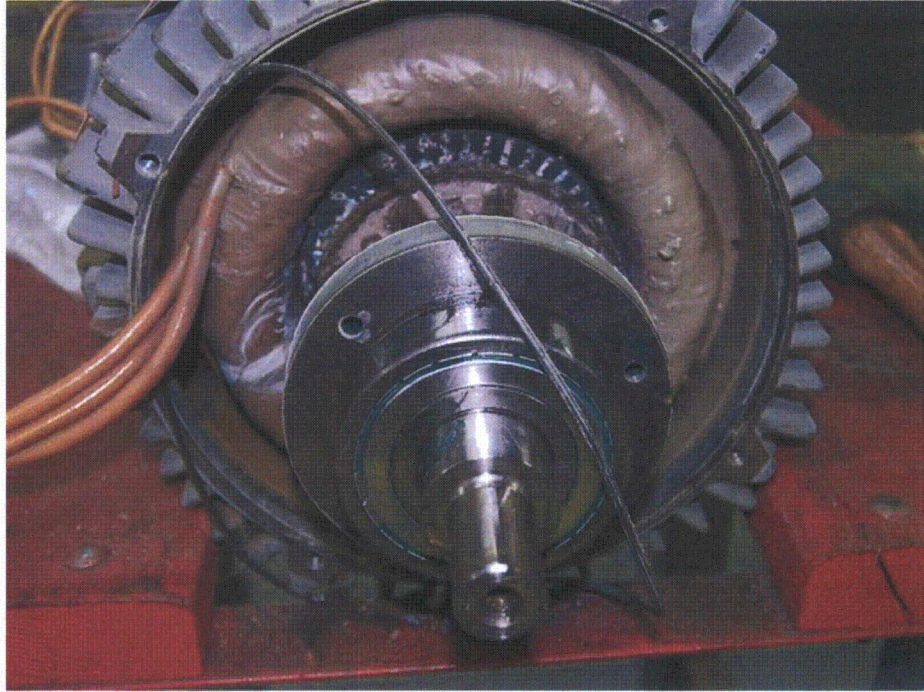
*Drive end of failed MOV motor. The bearing and bearing cap are installed on the shaft. A puller must be used to remove the bearing.*
