Event # 45105

PART 21 FOR MISSING PARTS ON ASCO SOLENOID VALVES

Subject – Missing insulating barrier and label on two (2) ASCO NPEFKX8300141EG  
10688 125/DC solenoid valves

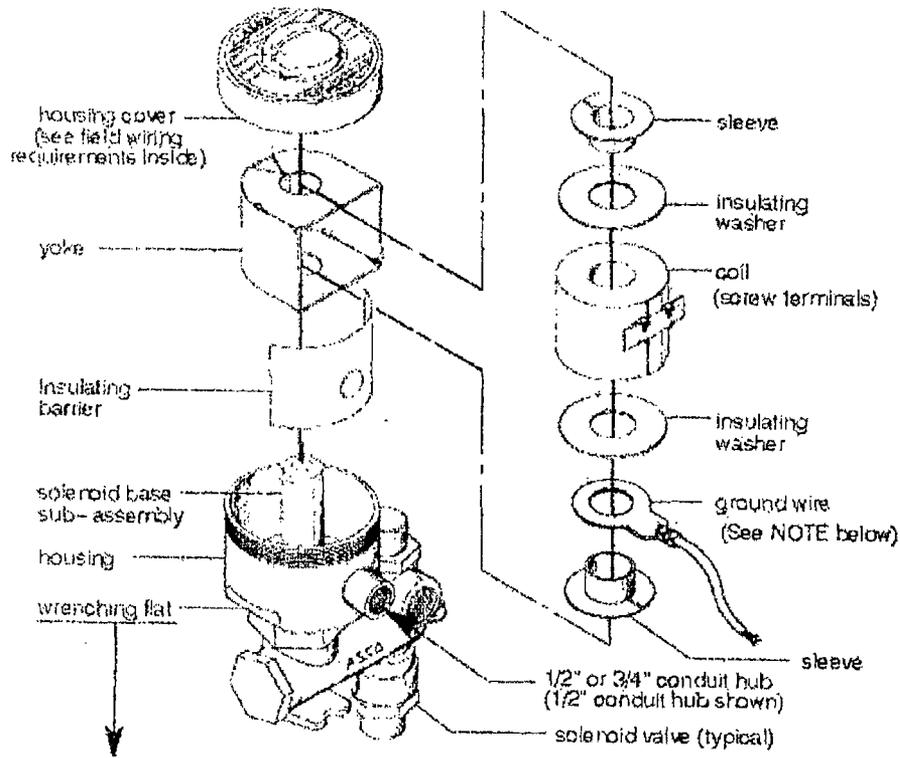
Figure 1.

**Background-** On 4/24/09 ASCO Engineering was made aware of a non-conformance in the valve assembly area. During the assembly of a solenoid valve, part number NPEFKX8300141EG 10688 125/DC, the valve assembler noticed that the valve was missing an insulating barrier. Ref Fig 1. Engineering reviewed the bill of materials (BOM) for the valve and confirmed that the insulating barrier (p/n 032818-004) was not listed on the BOM. In addition a wiring label (p/n 230195-001) used with screw terminal coils was also not included in the BOM.

**Impact on Performance** – The insulating barrier is used on ASCO valves supplied with screw terminal coils. The barrier provides an electrical insulation between the screw terminals of the coil and the metallic solenoid housing. The screw terminals of the coil are intended to serve as junction point for the field wire and the coil. If the screw terminals were to come in contact with the housing while the valve was energized there would be an electrical short resulting in a breaker / fuse trip. This would interrupt power being supplied to the valve and the valve would shift to the de-energized position.

Label is affixed to housing assembly

USE FIELD WIRE THAT IS RATED 150°C OR GREATER FOR CONTINUOUS DUTY AND THAT IS QUALIFIED FOR ALL EXPECTED SERVICE CONDITIONS INCLUDING POSTULATED ACCIDENT CONDITIONS

**Corrective Action** – Dominion Virginia Power – North Anna advised that one of the valves had been installed and one was still in their stock room area. The valve in the stock room was evaluated and confirmed to be missing the barrier. This valve is being returned and will be repaired at ASCO. Dominion Virginia Power – North Anna indicated that the installed valve will be evaluated during an upcoming outage. ASCO has recommended that a repair kit be installed at which time the barrier and wire label can be properly installed.

ASCO determined that the barrier was missing from the valve because it was not listed on the BOM and not supplied with the valve during assembly. Further investigation identified that when the valve components were being selected, the engineer modeled the BOM based on a design that does not use the barrier and label. In order to prevent future occurrences, ASCO has added a secondary verification whenever BOMs for new valves are created in order to verify that the correct parts have been selected.
