ANP-10280NP
Revision 2

Poolside Postirradiation Examination of MOX Lead Assemblies

April 2009

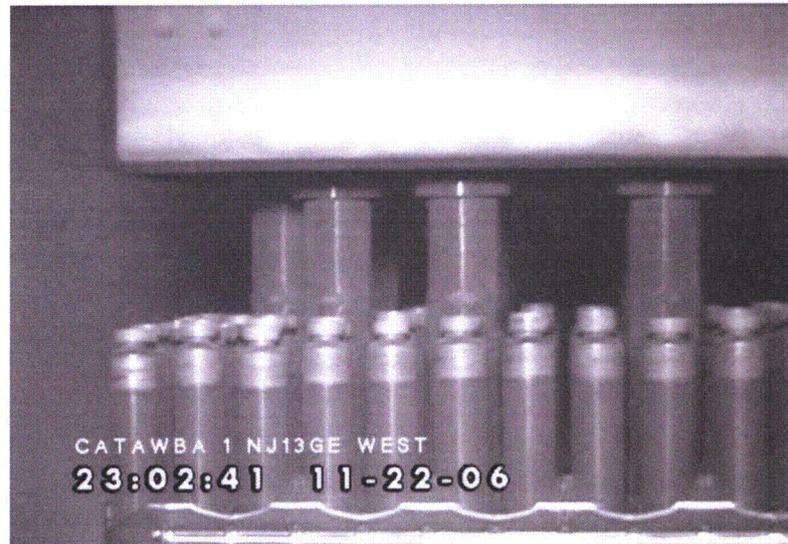
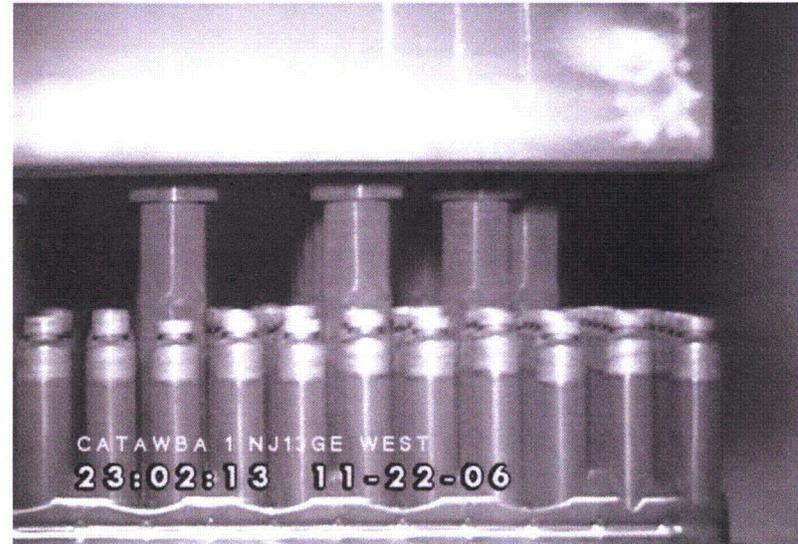
Figure 4-1—Top Ends of Fuel Rods as Seen on West Face of MX01, End of Cycle 1

A complete video record was made of all faces of all four lead assemblies. The record was stored in digital form for later review. The visual inspections indicated that the fuel assemblies were performing normally, that is, like low enriched uranium fuel assemblies. Sample photographs from the video record are shown in Figure 4-1 through Figure 4-6. As is described in Section 3.1, the individual video images do not cover the full width of a fuel assembly, so each of these figures shows first the left side followed by the right side. There is some overlap between the two images. To indicate the extent of overlap, the center (ninth) rod on the face is marked with "9" below each image.

The video record mentioned in Section 4.1.1 documents the appearance of the peripheral fuel rods. All fuel rods appeared to be in excellent condition, with light, uniform oxidation.

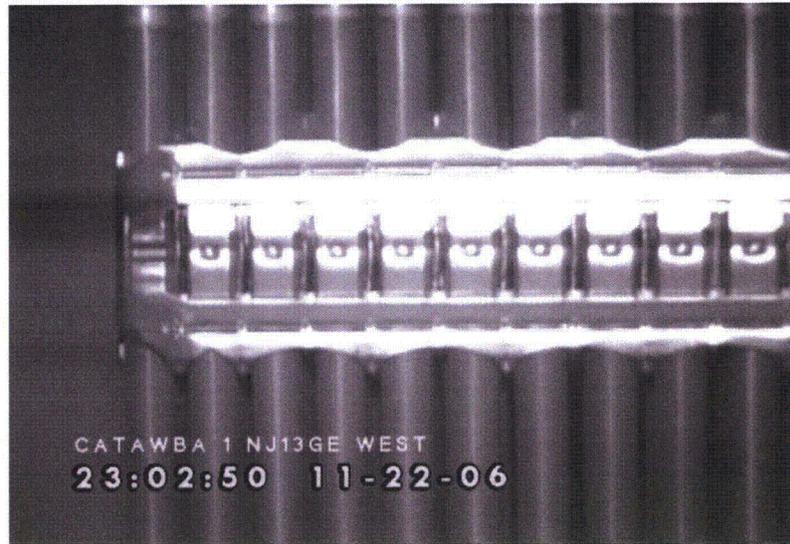
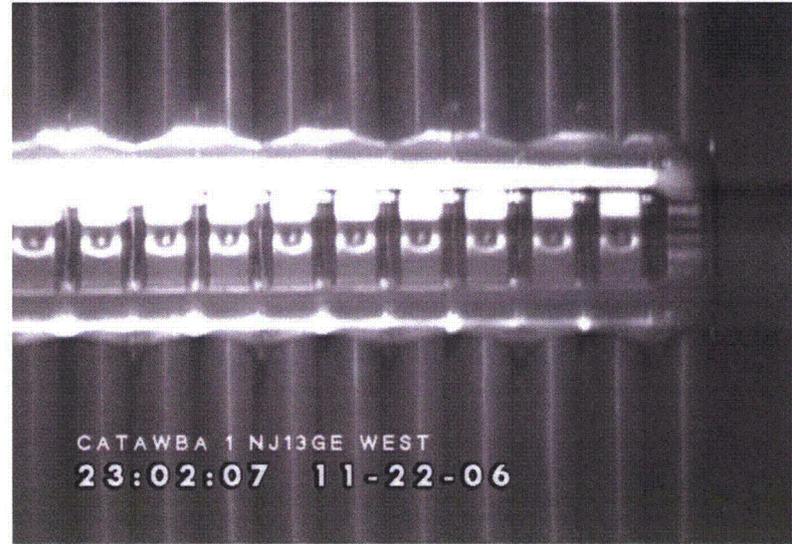
Figure 4-2—Top End Grid as Seen on West Face of MX01, End of Cycle 1

The video record documents the appearance of the periphery of the assembly, including fuel rods, spacer grids, mid-span mixing grids, and nozzles. All grids were found to be in excellent condition, with very little corrosion and no mechanical damage.

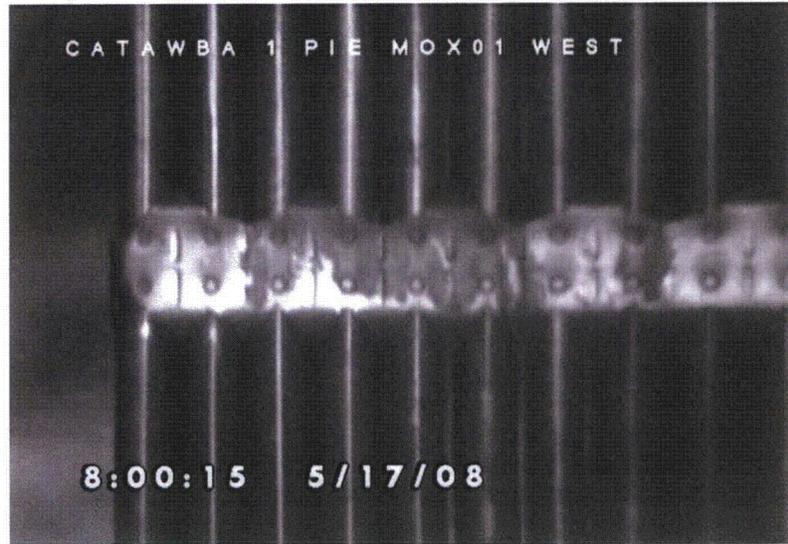
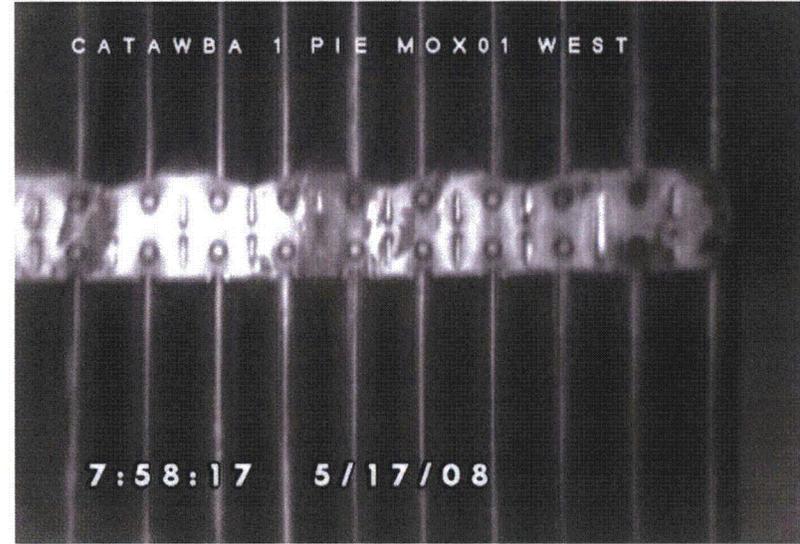
Figure 4-10—Middle Mid-span Mixing Grid as Seen on West Face of MX01, End of Cycle 2

The video record documents the appearance of the periphery of the assembly, including fuel rods, spacer grids, mid-span mixing grids, and nozzles. All grids were found to be in excellent condition, with very little corrosion and no mechanical damage. Some grids showed evidence of crud deposition; see Figure 4-10 for an example.

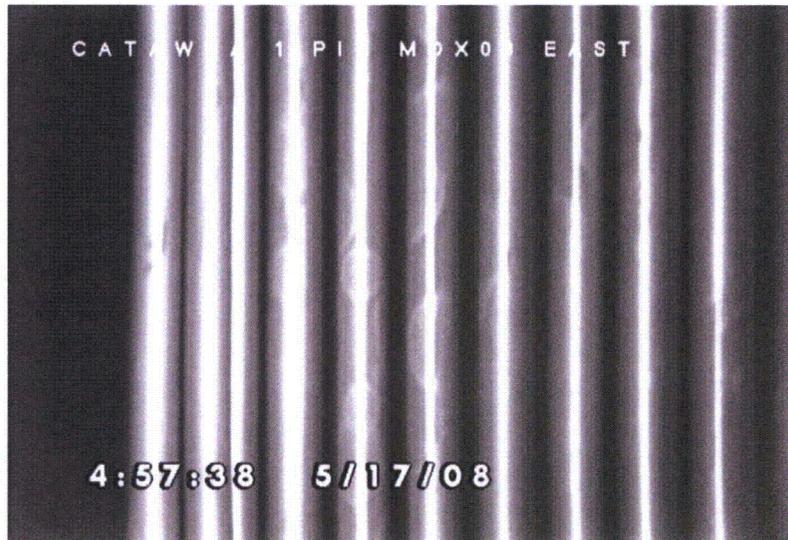
**Figure 4-13—Bowed Fuel Rods on East Face of MX03,
Span 8, End of Cycle 2**

The video record mentioned in Section 4.1.2 documents the appearance of the peripheral fuel rods. The color of the oxide was more variable than that after the first cycle, but the appearance was typical of second-cycle fuel. Fuel rod bow was apparent in some locations, but only in the bottom three spans. See Figure 4-13 and Figure 4-14 for some of the most severe examples. Apart from the bow, all fuel rods appeared to be in excellent condition.
