UNITED STATES
NUCLEAR REGULATORY COMMISSION

Subject: COOPER NUCLEAR STATION - NRC SPECIAL INSPECTION
REPORT 05000298/2009008

IR 05000298/2009008; 02/23/09 – 05/12/09; Cooper Nuclear Station; Special Inspection into emergency diesel generator lubricating oil pipe cracking and Amphenol connector deficiencies

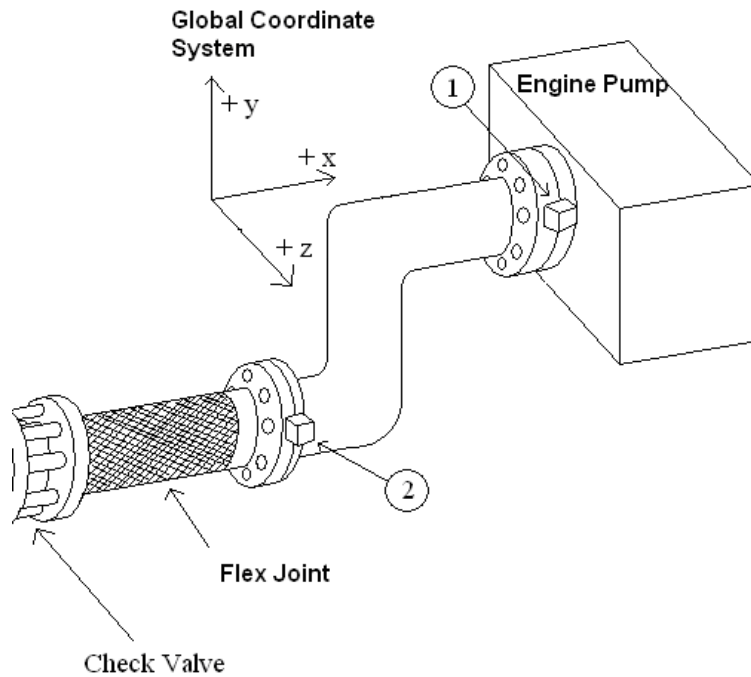
that caused the crack in the base metal resulted from vibration in the X-Direction (axial to the metal flexible hose and perpendicular to the crack face).

Figure 1: Lube Oil S-pipe with Flex Joint Showing X-, Y-, and Z-Direction(s)

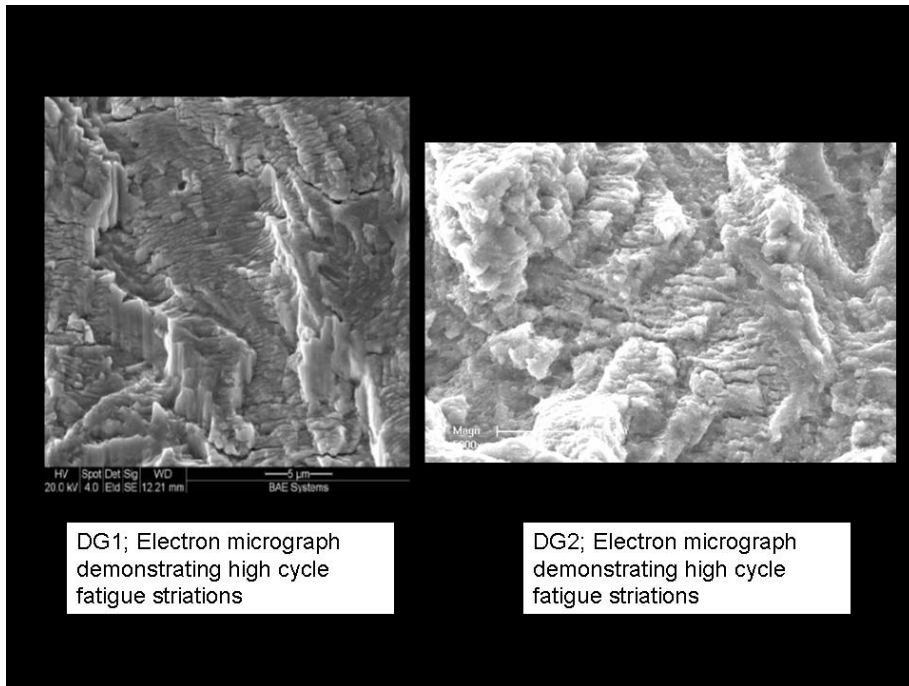
was flat and smooth with clear evidence of beachmarks and striations indicative of a high cycle fatigue failure mechanism (refer to Figure 2). The licensee initiated Condition Report 2009-00098 to resolve the NRC concerns related to misdiagnosis of the failure mechanism for the Emergency Diesel Generator 2 lubricating oil discharge S-pipe crack.

DG1; Electron micrograph demonstrating high cycle fatigue striations

DG2; Electron micrograph demonstrating high cycle fatigue striations

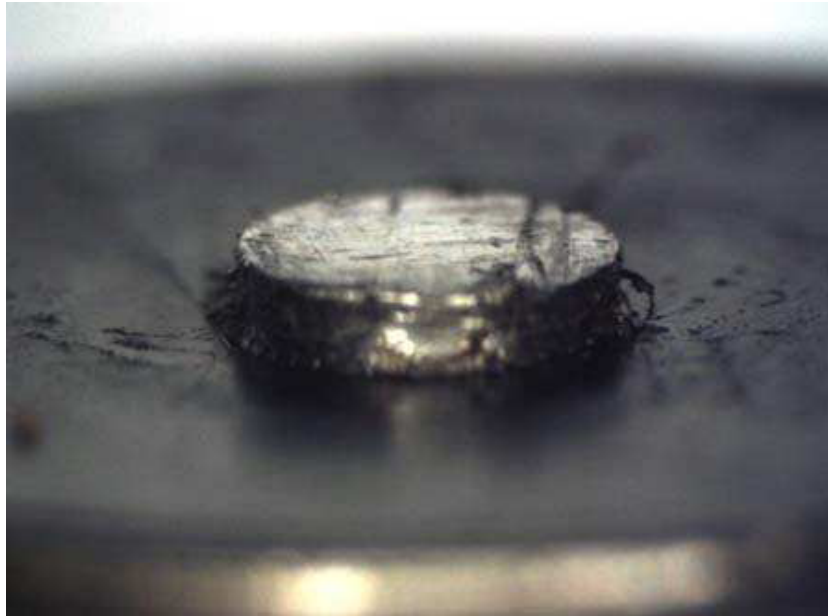
Figure 3 - Closeup of Magnetic Pickup Unit

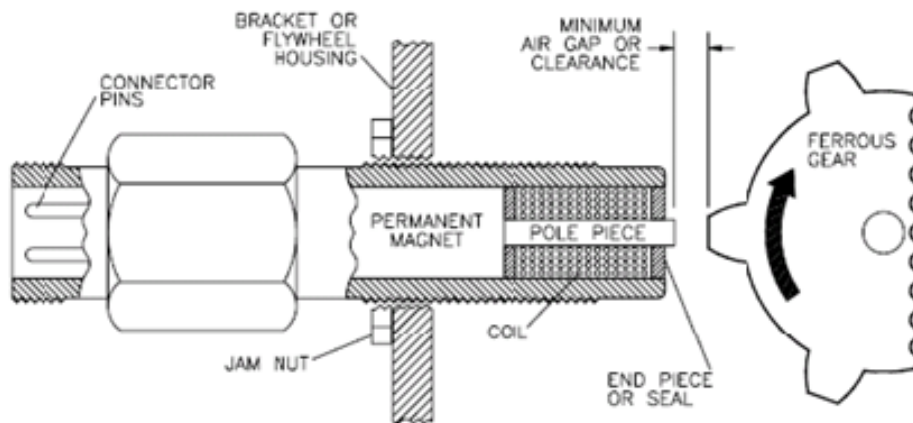
Figure 4: Typical Magnetic Pickup Arrangement

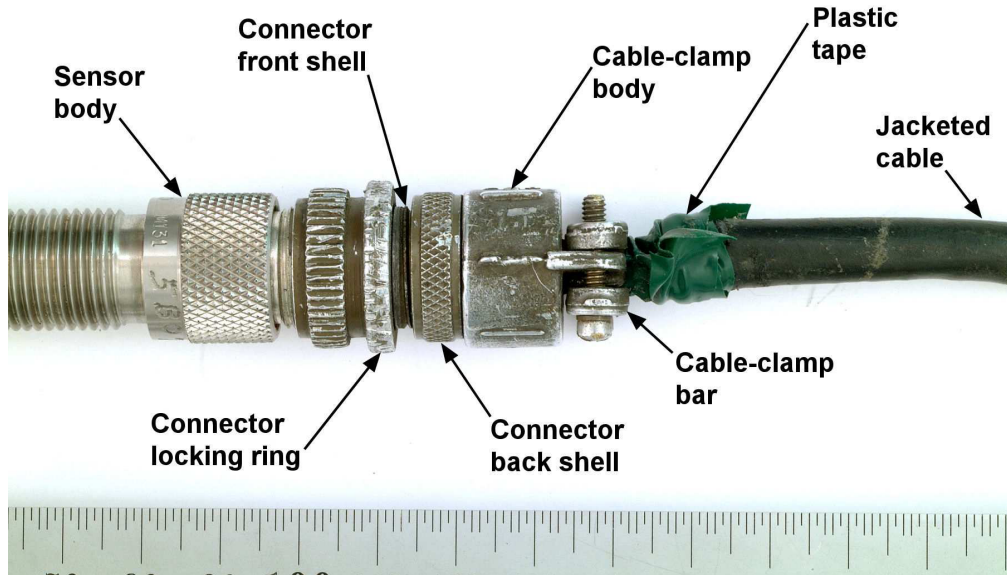
Figure 5: Inappropriate use of tape

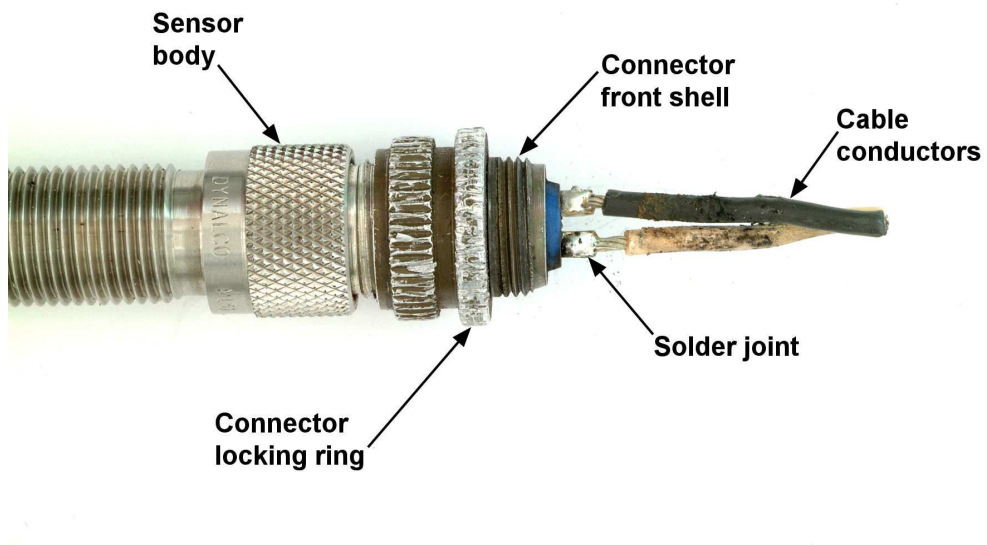
Figure 6: Photograph of poor solder connection

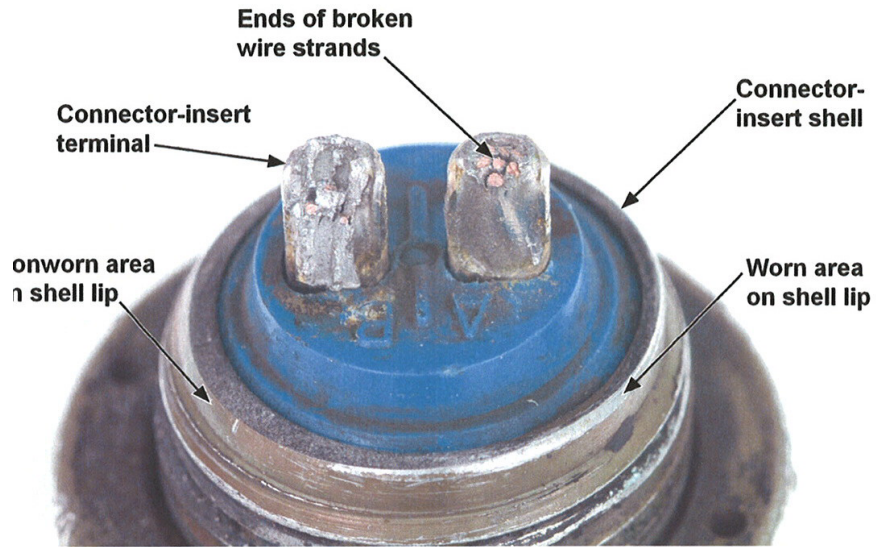
Figure 7: Poor Solder Connection

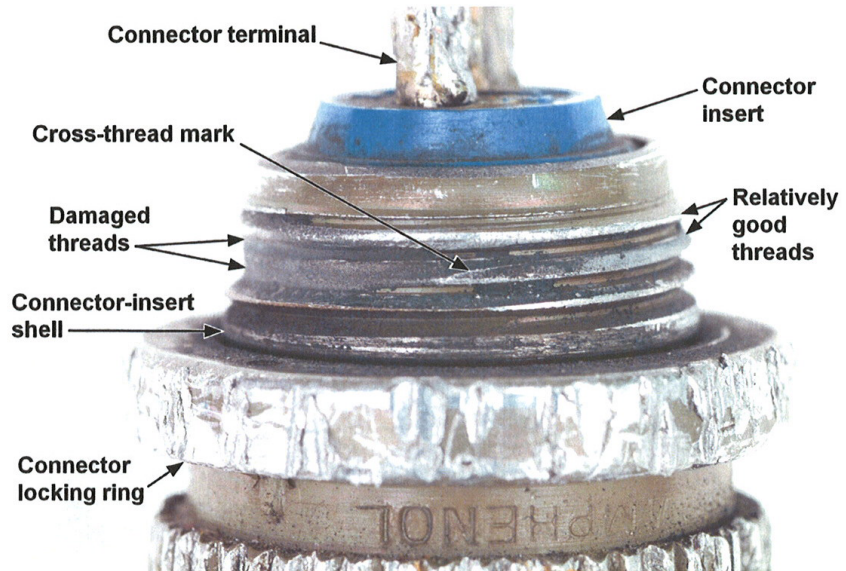
Figure 8: Cross-threaded Back Shell
