L-09-147

Beaver Valley Power Station, Unit No. 1  
Docket No. 50-334, License No. DPR-66  
LER 2009-001-00

**4. TITLE**  
Surveillance Test Inadvertently Violates Technical Specification 3.6.1 for Containment Operability

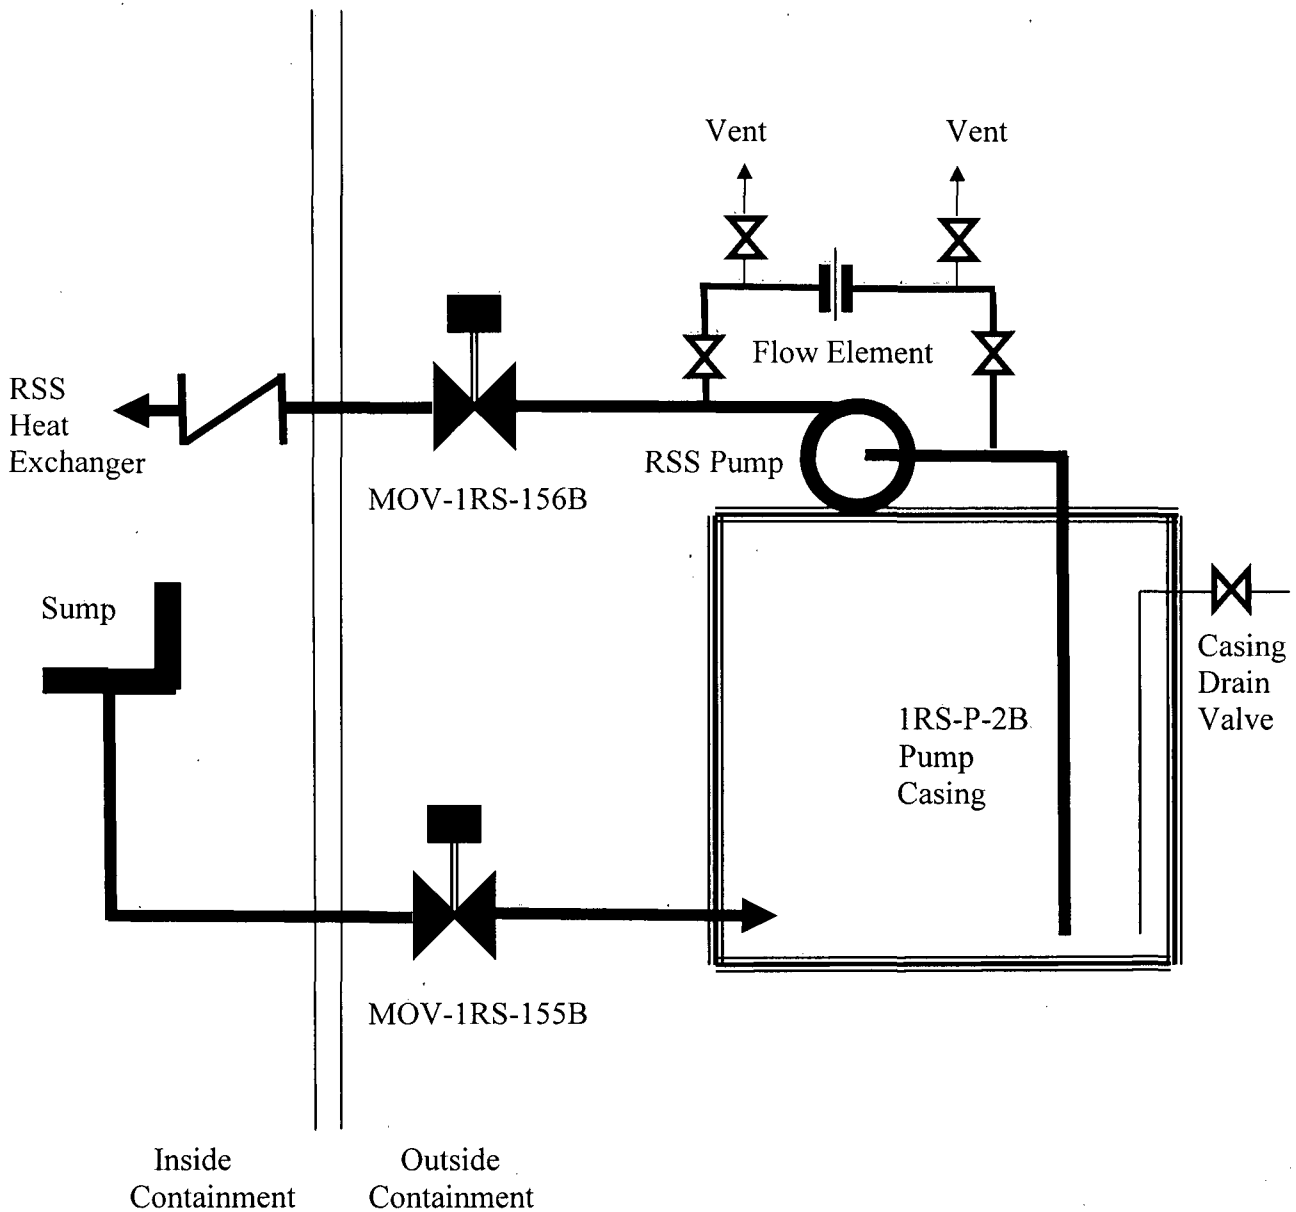
Simplified Drawing  
BVPS Unit 1 Recirculation Spray System Outside Pump Subsystem  
Test Configuration

On 03/26/2009 while operating in Mode 1, Beaver Valley Power Station (BVPS) Unit 1 commenced the performance of a Recirculation Spray System (RSS) flow test, pursuant to Technical Specification Surveillance 3.6.7.2 for one of the two outside RSS pumps [BE]. See the simplified drawing included at the end of this report. This containment spray system is normally maintained in a dry condition during power operation with its suction containment isolation valve (MOV-1RS-155B) and its discharge containment isolation valve (MOV-1RS-156B) open. This surveillance procedure, which previously was normally performed in Modes 5 and 6, was recently revised to allow performance in all modes.

At 04:18 on 03/28/2009 during the draining operation, the Shift Manager recognized that the CIVs on this RSS train's piping needed to be de-energized while closed since the RSS pump's vent and drain valves were open. These CIVs receive an 'open' signal following a containment isolation-Phase B (CIB) signal during a design basis Loss-of-Coolant-Accident (LOCA), and not the typical 'close' signal. In the configuration with open manual valves on the pump's casing, containment operability would have been compromised if a LOCA were to occur pressurizing containment. Since this RSS train's CIVs (the containment pressure boundary during the surveillance) remained energized, they would have automatically

opened following a CIB signal, and resulted in a path to pressurize the pump's casing. The two CIVs on this RSS piping train were immediately de-energized, removing this portion of the RSS piping from potentially becoming an extension of the containment boundary.

Although the Required Action for TS 3.6.7 for one inoperable RSS subsystem was entered at the start of the surveillance procedure, it was not recognized that TS 3.6.1 for Containment operability was also being entered whenever a normally-closed manual drain/vent valve on the pump's casing was opened by the surveillance procedure while this train's CIVs were energized.

1. The subject Recirculation Spray System surveillance procedures will be revised to include reference to Containment Technical Specification 3.6.1 and the necessary steps to ensure compliance, such as maintaining the suction and discharge CIVs in the de-energized and closed position.
