H. B. ROBINSON STEAM ELECTRIC PLANT, UNIT NO. 2
DOCKET NO. 50-261/LICENSE NO. DPR-23

LICENSEE EVENT REPORT NO. 2009-001-00
EMERGENCY DIESEL GENERATOR INOPERABLE IN EXCESS
OF TECHNICAL SPECIFICATIONS ALLOWED COMPLETION TIME

4. TITLE
Emergency Diesel Generator Inoperable in Excess of Technical Specifications Allowed Completion Time

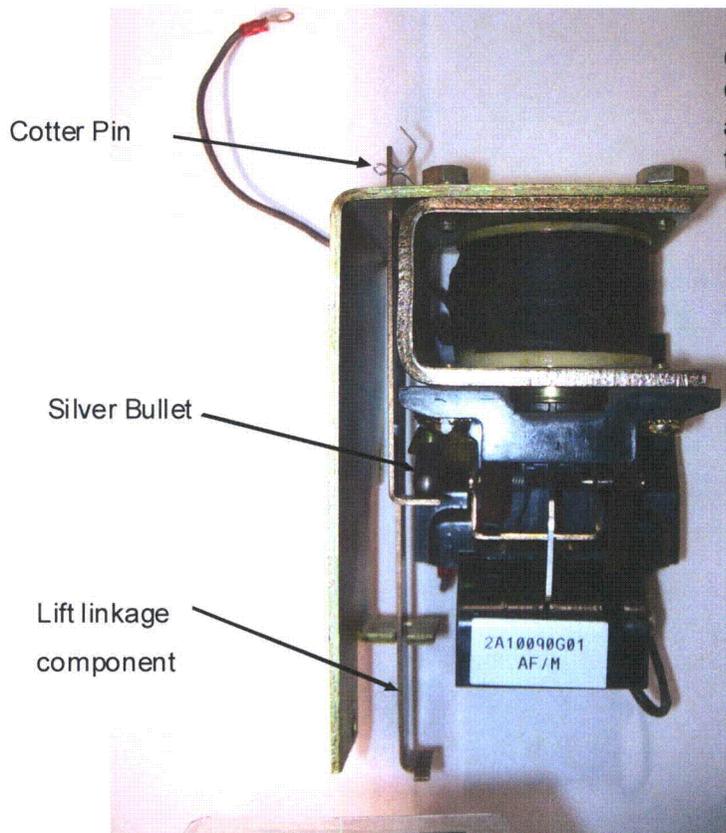
The cause of the event was determined to be a vendor design error resulting from a modification to the breaker's lifting link assembly. This modification used a cotter pin in place of a drive screw/rolled pin. The cotter pin that was used to retain the relay's mechanical lift linkage had rotated to a position that prevented complete return of the lift linkage to its normal position (see picture at the end of this report). Therefore, the lift linkage maintained the control relay trip pin engaged and maintained the control circuits open preventing the breaker from closing.

Overall view of Control relay assembly depicting failed position.

- The Appendix R isolation switch, EDG output breaker switch, generator synchronize switch, and control power fuses for breaker 52/27B were replaced.
- Cotter pins on breakers 52/17B and 52/27B were reconfigured in a manner to not interfere with the control relay mechanism.

- The cotter pin in both EDG 'A' and EDG 'B' control relay lift link will be replaced with a spiral ring. This modification is currently listed for completion in Refueling Outage (RO)-26, scheduled to end on May 15, 2010.
- Procedure, CM-305, "Westinghouse 'DB' Type Circuit Breakers Maintenance," is scheduled to be revised by August 12, 2009, to require the use of a spiral ring instead of a cotter pin.
- The cotter pins for breakers 52/18B, 52/22B, 52/28B, and 52/29B control relay lift links will be replaced with a spiral ring. This modification is currently listed for completion in RO-26, scheduled to end on May 15, 2010.
