SUBJECT: NRC SITE VISIT TO THE OCONEE NUCLEAR STATION ON
JUNE 15, 2009

SUMMARY OF NRC SITE VISIT TO THE OCONEE NUCLEAR STATION JUNE 15, 2009

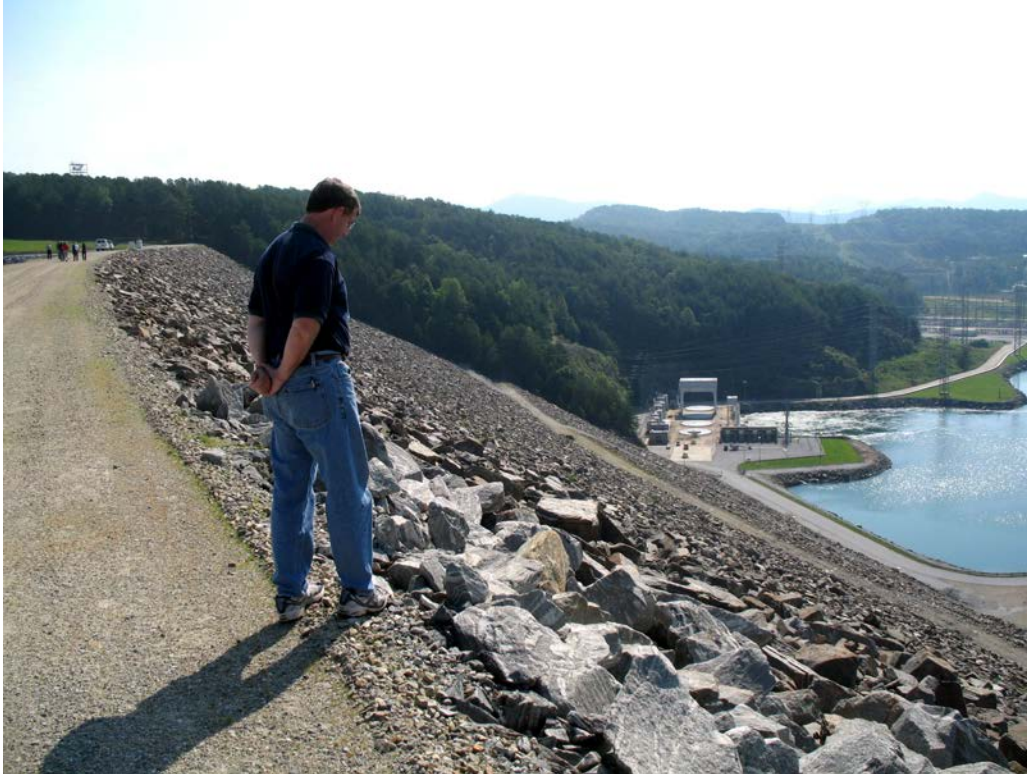
Jocassee Dam with hydroelectric powerhouse visible in background.

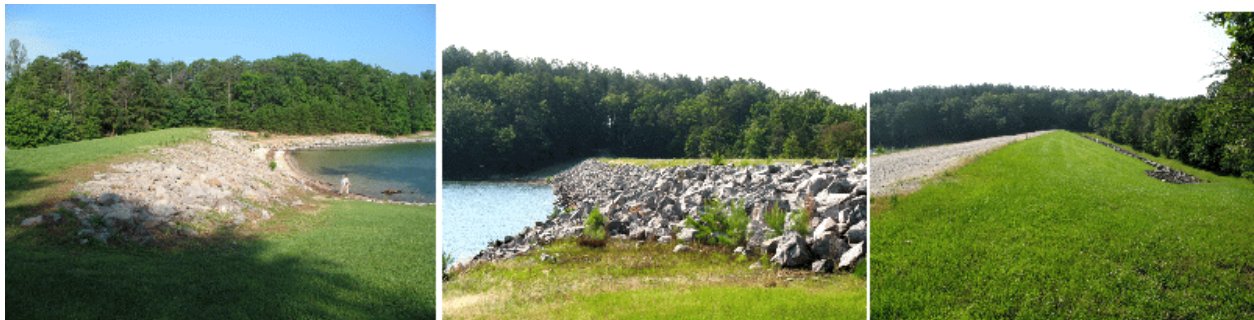
There are two earthen saddle dikes west of the main Jocassee dam, which could potentially function as an uncontrolled spillway in the event of a severe storm coupled with an inoperable spillway gate. The crest elevations of these dikes are the same as that of the main dam. These two saddle dikes could provide emergency outlets that could prevent overtopping failure of the Jocassee dam. Overtopping failures are the most hazardous for any dam. As shown in the photos below, Saddle Dikes #1 and #2 do not have rip rap on their downstream sides. If overtopped, they would rapidly erode forming breaches that would drain the reservoir down to the base level of the dikes. This would still allow the reservoir to retain most of its water volume, averting a catastrophic emptying of the entire lake. Both dikes are protected from wave erosion by rip rap armoring on the lake-facing slopes. Lowering the saddle dikes by ~0.5 m would provide further assurance that if a probable maximum flood inflow occurred to Jocassee Lake, failure of the saddle dikes would prevent overtopping and catastrophic failure of Jocassee Dam.

Saddle dikes at Jocassee Lake are protected from wave action by rip rap on sides facing lake. Top: Saddle Dike #2. Middle: rip rap on lake side of Dike #1. Right: downstream side of Dike #1 has grass but no rip rap (french drain is visible along toe of dam).

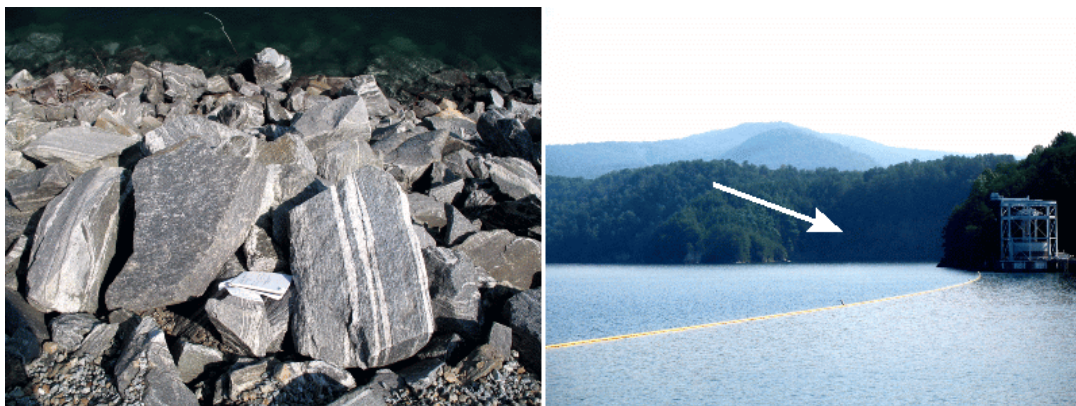
The main Jocassee dam was observed to be in good condition without any obvious signs of instability. The hydrogeologist identified the rock type as biotite gneiss (see figure below) used for rip rap and reportedly used as rockfill material in the Jocassee dam. This rock type is not the kind that would degrade over time. The staff found no evidence of degradation of the rockfill material within the dam because the seepage observed was clear with no obvious suspended solids.

Upper left: Biotite gneiss (metamorphic rock) that serves as rip rap at Jocassee Dam. This rock type is extremely durable and not subject to breakdown over time under saturated conditions. Upper right: Arrow points to lake embayment that Duke representatives identified as the main quarry site (now submerged) used to obtain Jocassee Dam rock fill materials. Structure at right is one of two Jocassee intake structures.

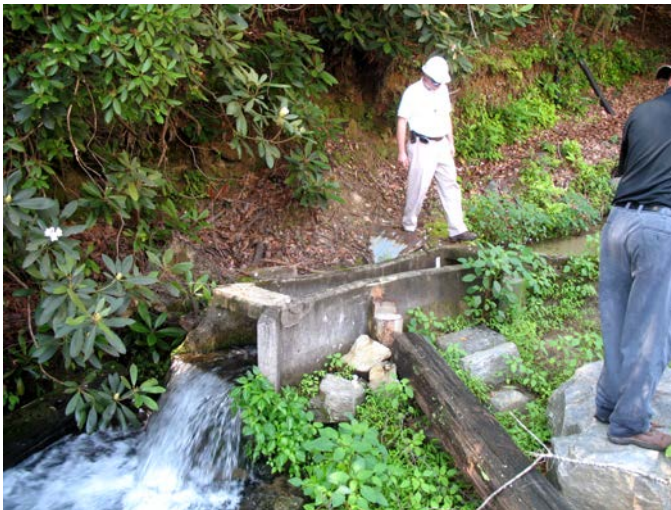
In previous inspections of the Jocassee dam, FERC identified the seepage of water from the abutments as potential failure modes for the dam, and recommended that Duke continue the monitoring of the seepage and establish threshold levels for the seepage. During this trip, the NRC review team observed the seepage of water in the abutments and was informed by the Duke staff that the measured seepage was within the “action levels” determined by them based on historical seepage data at the site. Furthermore, the seepage water was clean and clear with no sediment present, indicating no apparent erosion or degradation of embankment materials. Duke provided measured seepage data, which the NRC team is reviewing.

Clear discharge from a flume at the main seepage collection point low on the western abutment of Jocassee Dam.

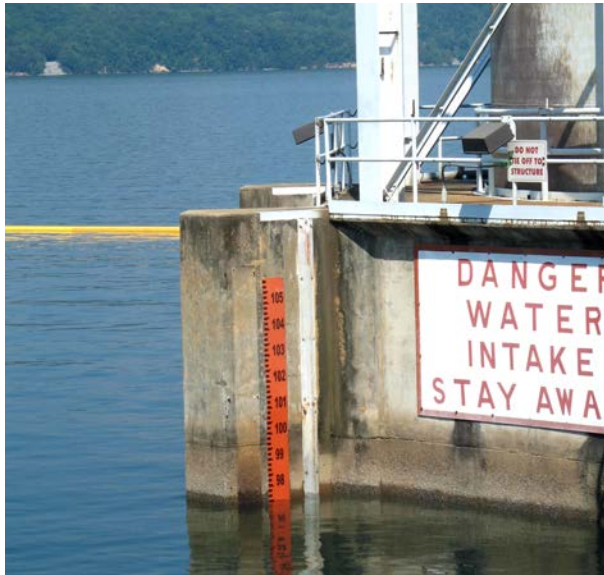
Duke Power monitors the Jocassee Reservoir level and has a camera trained on a gauge at one of the intake structures for real-time observations. The gauge is shown in the figure below.

Gauge to measure height of Jocassee lake stage.

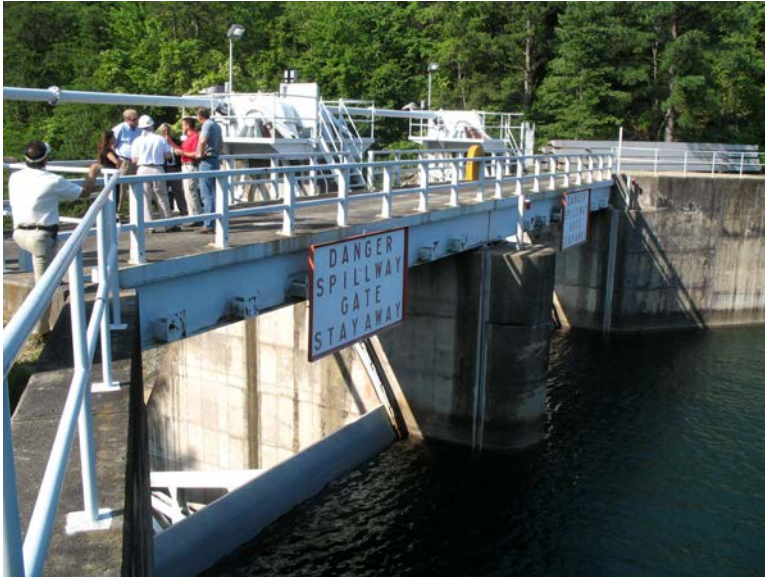
The NRC staff also visited the spillway for Jocassee Lake. It is located west of the dam and east of the Saddle Dikes. The spillway is controlled by two large radial gates. The report by FEI (2004) discusses potential failure modes (PFM) of Jocassee Dam. One scenario examined was overtopping of the dam caused by failure to operate the radial gates during a flood. Overtopping was classified as Category IV (ruled out) given the current programs of inspection, testing, maintenance, surveillance, and backup power. FEI (2004) reports there are two backup portable compressors that could be used to open the gates, and that the gates could also be opened with a hand crank or with a crane. Our observations at the spillway found that a support frame for an air-operated motor is bolted to the platform where the hand crank would be used. A hand crank could not be used unless a ratchet device is provided or unless the support frame is removed. Also, it was not obvious where a lifting device for a crane could be attached to the radial gates. If water overtopped the gates, they would be under water and the downstream force would be very large, making it challenging to hook onto the gates for lifting.

Spillway structure for Jocassee Reservoir.
