June 25, 2009

SUBJECT: NRC SITE VISIT TO THE OCONEE NUCLEAR STATION ON
JUNE 15, 2009

SUMMARY OF NRC SITE VISIT TO THE OCONEE NUCLEAR STATION JUNE 15, 2009

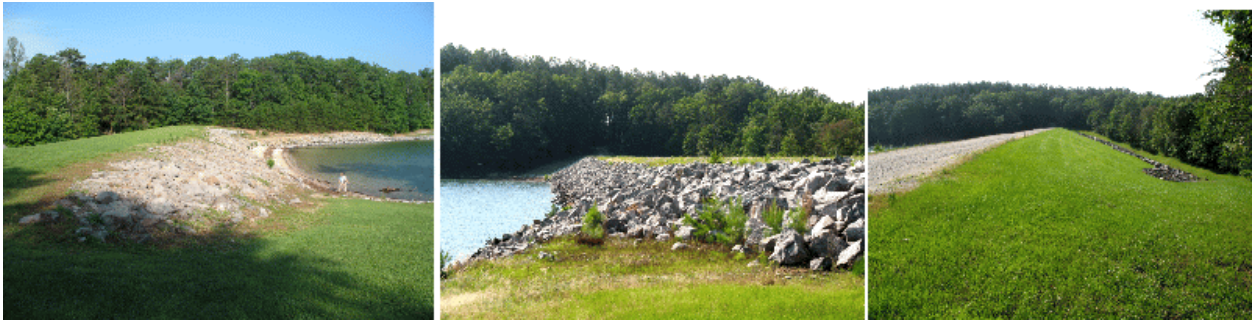
There are two earthen saddle dikes west of the main Jocassee dam, which could potentially function as an uncontrolled spillway in the event of a severe storm coupled with an inoperable spillway gate. The crest elevations of these dikes are the same as that of the main dam. These two saddle dikes could provide emergency outlets that could prevent overtopping failure of the Jocassee dam. Overtopping failures are the most hazardous for any dam. As shown in the photos below, Saddle Dikes #1 and #2 do not have rip rap on their downstream sides. If overtopped, they would rapidly erode forming breaches that would drain the reservoir down to the base level of the dikes. This would still allow the reservoir to retain most of its water volume, averting a catastrophic emptying of the entire lake. Both dikes are protected from wave erosion by rip rap armoring on the lake-facing slopes. Lowering the saddle dikes by ~0.5 m would provide further assurance that if a probable maximum flood inflow occurred to Jocassee Lake, failure of the saddle dikes would prevent overtopping and catastrophic failure of Jocassee Dam.

Saddle dikes at Jocassee Lake are protected from wave action by rip rap on sides facing lake. Top: Saddle Dike #2. Middle: rip rap on lake side of Dike #1. Right: downstream side of Dike #1 has grass but no rip rap (french drain is visible along toe of dam).

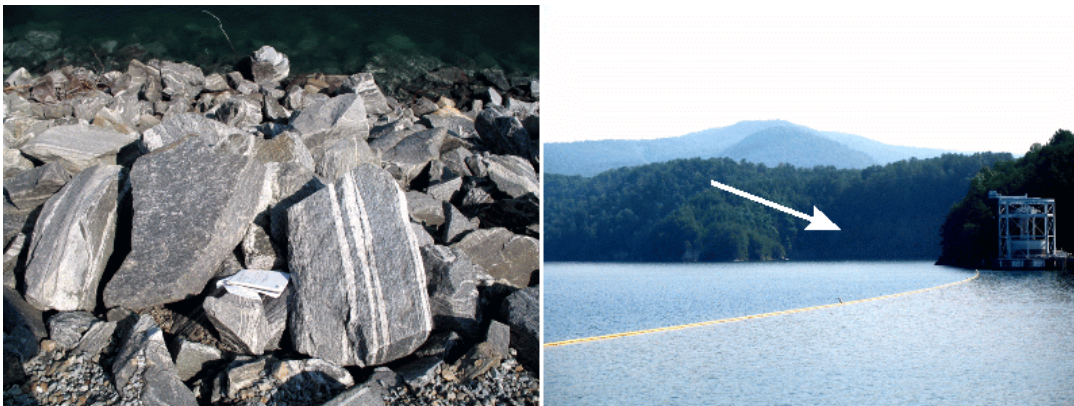
The main Jocassee dam was observed to be in good condition without any obvious signs of instability. The hydrogeologist identified the rock type as biotite gneiss (see figure below) used for rip rap and reportedly used as rockfill material in the Jocassee dam. This rock type is not the kind that would degrade over time. The staff found no evidence of degradation of the rockfill material within the dam because the seepage observed was clear with no obvious suspended solids.

Upper left: Biotite gneiss (metamorphic rock) that serves as rip rap at Jocassee Dam. This rock type is extremely durable and not subject to breakdown over time under saturated conditions. Upper right: Arrow points to lake embayment that Duke representatives identified as the main quarry site (now submerged) used to obtain Jocassee Dam rock fill materials. Structure at right is one of two Jocassee intake structures.

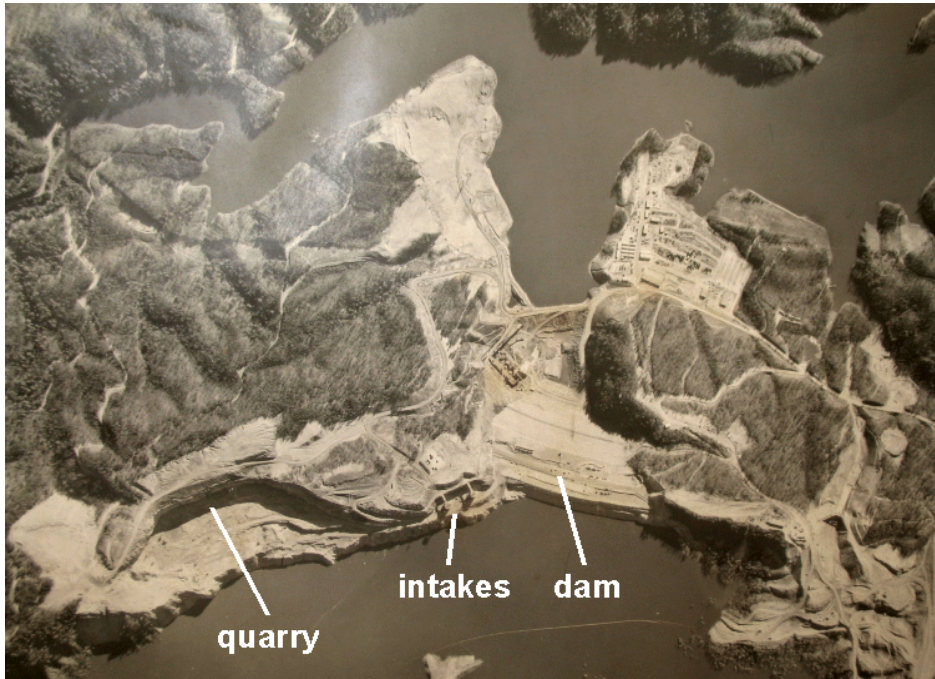
Historic photograph of Jocassee Dam during construction.

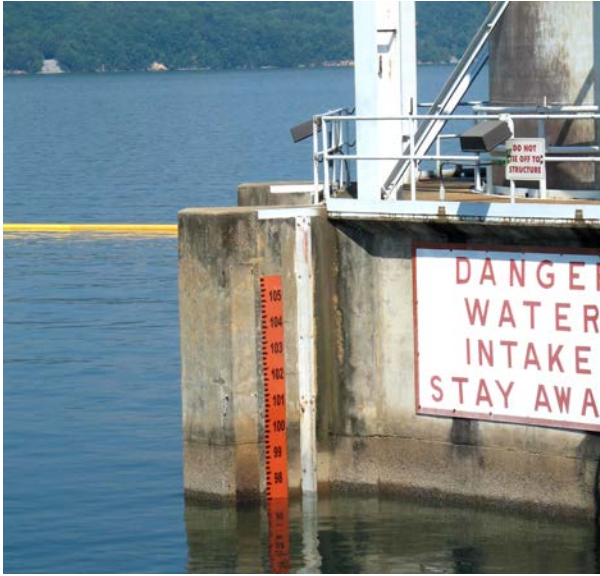
Duke Power monitors the Jocassee Reservoir level and has a camera trained on a gauge at one of the intake structures for real-time observations. The gauge is shown in the figure below.

Gauge to measure height of Jocassee lake stage.

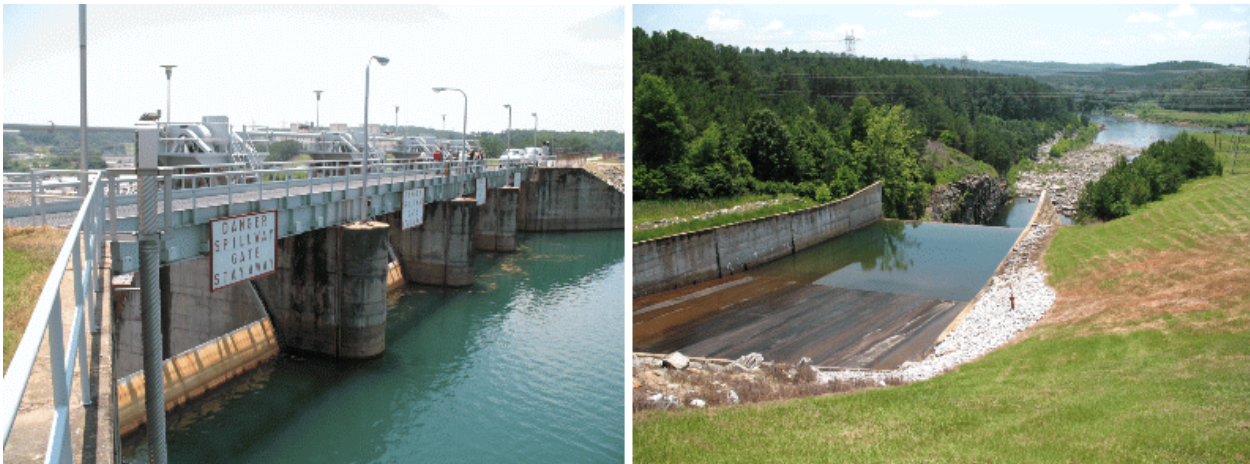
In the afternoon of June 15, 2009, the NRC review team visited the Keowee dam and its appurtenant structures, and found them to be in good condition.

Keowee Dam spillway with four radial gates (left), and view of outflow channel (right).
