SUBJECT: NRC SITE VISIT TO THE OCONEE NUCLEAR STATION ON  
JUNE 15, 2009

## SUMMARY OF NRC SITE VISIT TO THE OCONEE NUCLEAR STATION JUNE 15, 2009

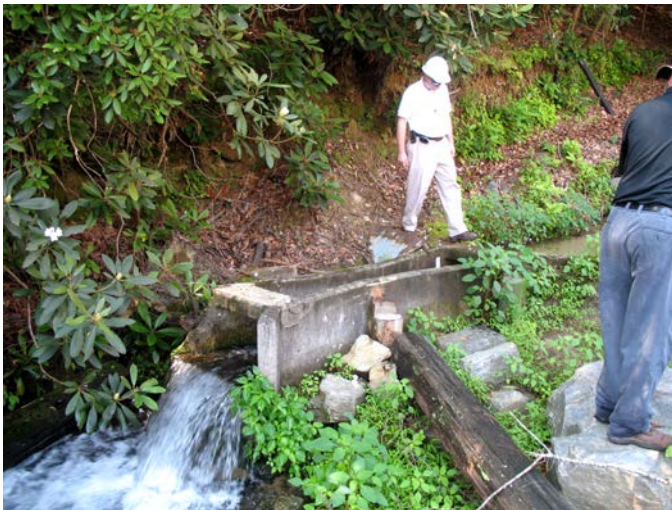
In previous inspections of the Jocassee dam, FERC identified the seepage of water from the abutments as potential failure modes for the dam, and recommended that Duke continue the monitoring of the seepage and establish threshold levels for the seepage. During this trip, the NRC review team observed the seepage of water in the abutments and was informed by the Duke staff that the measured seepage was within the “action levels” determined by them based on historical seepage data at the site. Furthermore, the seepage water was clean and clear with no sediment present, indicating no apparent erosion or degradation of embankment materials. Duke provided measured seepage data, which the NRC team is reviewing.

**Clear discharge from a flume at the main seepage collection point low on the western abutment of Jocassee Dam.**
