Subject: LER 2009-002-00 – Emergency Diesel Actuation Caused by Degraded DC  
Control Battery

Grand Gulf Nuclear Station, Unit 1  
Docket No. 50-416  
License No. NPF-29

**4. TITLE** Emergency Diesel Generator Actuation Caused by a Degraded DC Control Battery

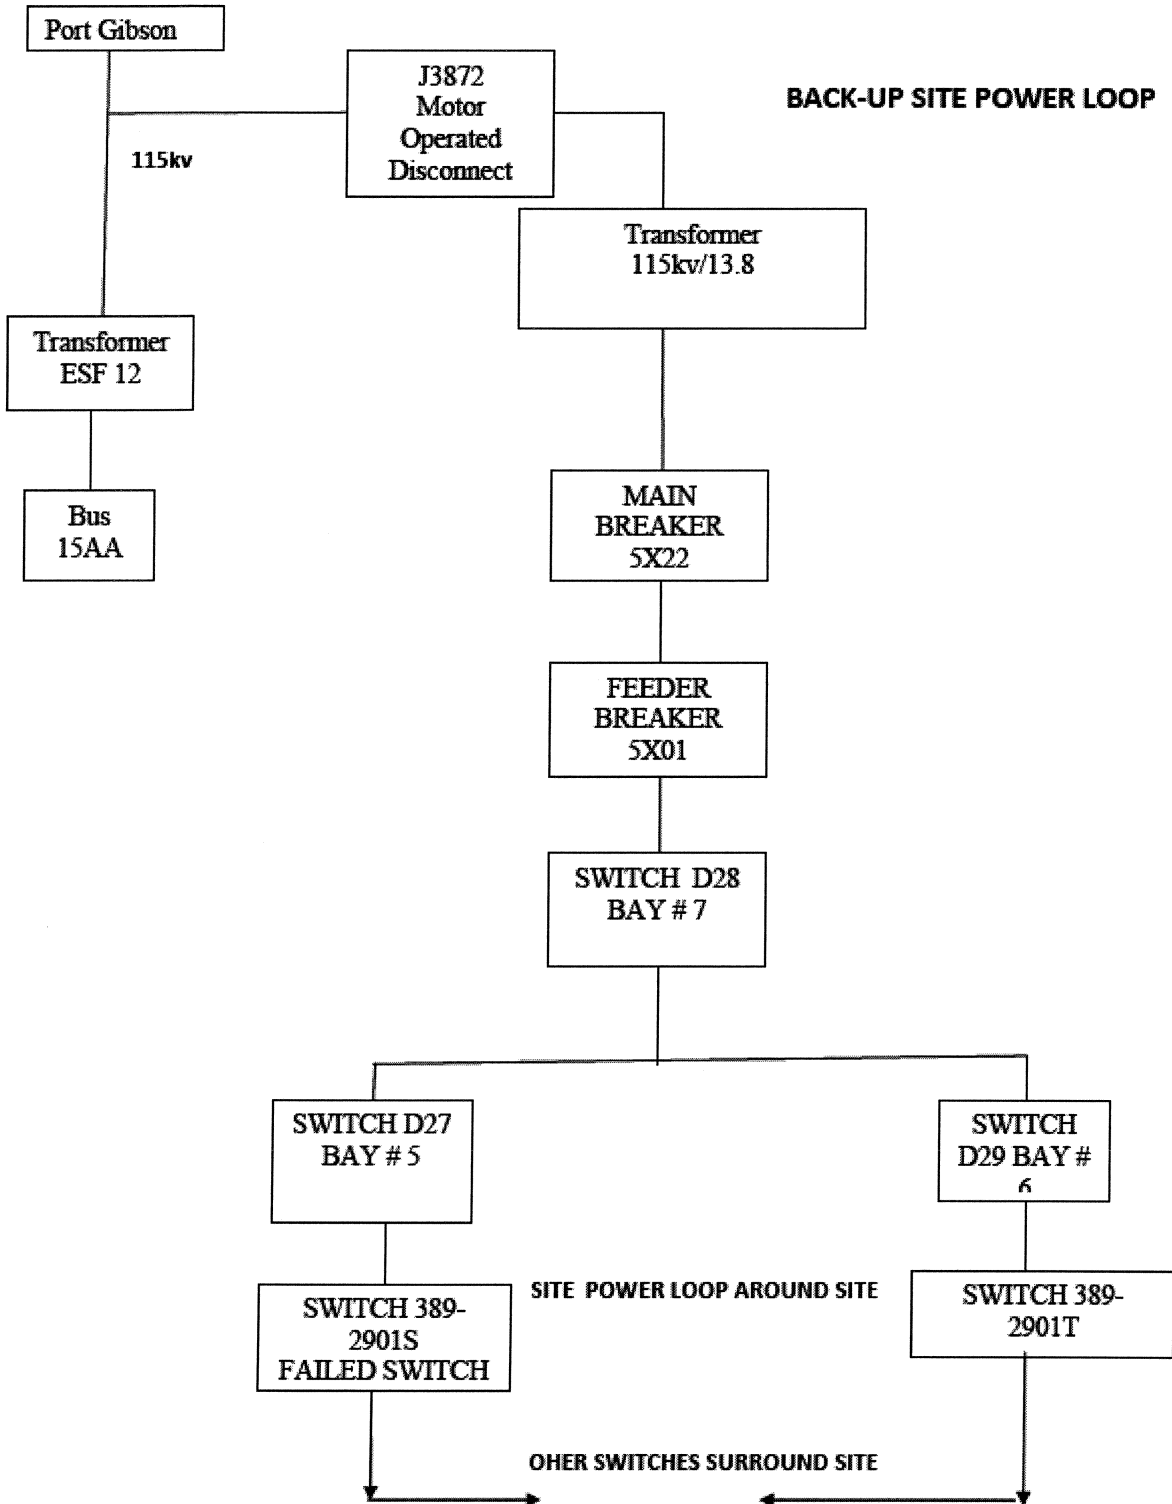
**Figure 1 – Simplified Drawing**

A valid Engineered Safety Feature actuation for Division 1 Emergency AC power for the 15AA bus occurred at 2327 hours CDT on May 5, 2009 due to a degraded voltage condition on ESF Transformer 12. A simplified drawing is provided to assist with explanation of the event in Figure 1. ESF Transformer 12 was supplying power to the 15AA bus due to Service Transformer 21 being out of service for maintenance. A fault occurred on the site power loop at switch 389-2901S initiating trip signals to breakers 5X01 and 5X22. When power switch 389-2901S faulted, both breakers failed to trip at the prescribed settings. These breakers should have cleared the fault in 3 to 5 cycles. However, about 21 seconds later, the site power loop 115 kV/13.8 kV transformer high over current backup circuitry responded and caused the transformer differential lockout relay to activate, sending trips to main breaker 5X22 and the motor operated air breaker switch J3872 at which point the fault cleared.

During the fault condition, the voltage on the incoming 115 kV offsite power circuit from Port Gibson degraded to 101.5 KV (approximately 0.883 Percent Undervoltage-PU or 88.3%) and persisted for approximately 21 seconds until the fault cleared. Since the Division 1 ESF 15AA bus was aligned to receive power from the ESF Transformer 12 and the 115 kV line offsite power circuit from Port Gibson, the protective settings for the 15AA bus Division 1 Load Shed and Sequencing panel were met for the sustained (21 seconds) degraded grid values of 0.9 PU for 9 seconds. This resulted in the LSS panel tripping the incoming feeder breaker (152-1511) to the 15AA bus from ESF Transformer 12, stripping the loads from the bus, starting the Division 1 EDG, connecting the EDG to the 15AA bus when voltage and frequency were stable, and sequencing the required loads to the bus.

Operators implemented appropriate off normal event procedures to mitigate the transient and all systems, following the event, responded as designed. The faulted electrical switch 389-2109S was found smoldering and emitting smoke. The onsite fire brigade was dispatched but no extinguishing agents were administered due to the fire self-extinguishing.

The cause of the ESF actuation was a 90% bus undervoltage condition that lasted for greater than nine seconds due to feeder breaker 5X01 and main breaker 5X22 failing to open and clear a fault on over current in the required 3 to 5 cycles. The 5X01 and 5X22 breakers did not open in the required 3 to 5 cycles due to low DC control voltage, which was caused by a degraded 48 VDC battery bank [BTRY]. The battery bank (24 cells) was inspected and found to have visual cell damage in one cell. Additional cell testing was performed on the battery bank and two of the tested cells were found to have unsatisfactory results. The battery bank in question is 13 years old, located in an outside metal building, and maintained by Entergy, Mississippi personnel.

Immediate Corrective Actions – The degraded 48 VDC battery bank was replaced with a new 48 VDC battery bank on May 11, 2009 and the new battery is working properly. Additionally, breaker maintenance and testing was performed on breakers 5X01 and 5X22.
