SUBJECT: BEAVER VALLEY POWER STATION, UNIT 1 - NRC ROUTINE INSPECTION
REPORT 05000334/2009006

Report No. 05000334/2009006

Facility: Beaver Valley Power Station, Unit 1

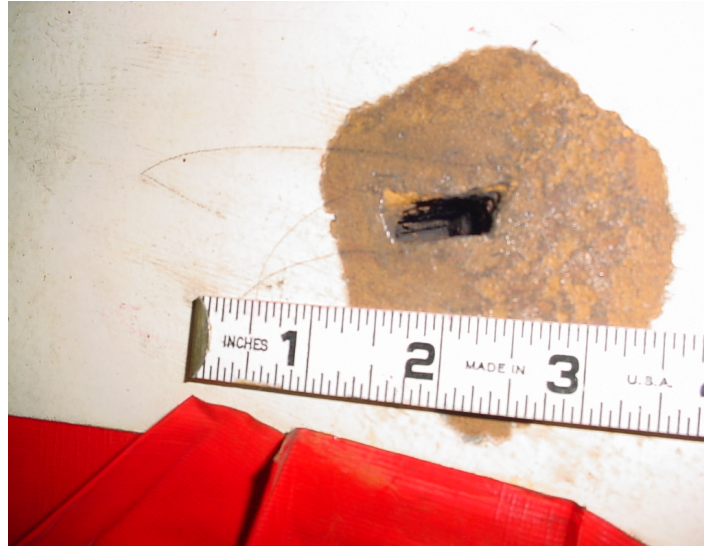
The licensee cleaned the blistered paint area on April 23, 2009, to allow further evaluation. Upon removal of the paint blister, the FENOC examiner, conducting the visual inspection, observed a rectangular through-wall hole in the steel containment liner. The size of the hole was approximately 1" x 3/8" in the 0.375" nominal thick steel liner plate fabricated from ASME SA-516, Gr. 60 material. (Photograph in Attachment B pertains)

The cause of the through-wall flaw in the liner was determined by the licensee to be corrosion pitting originating from the concrete side of the containment liner at the point of interface between the steel liner and the wood debris that was embedded in the 4'-6" inch thick Reactor Containment Building (RCB) concrete wall. The licensee presumes that the wood was left embedded in the concrete containment building wall, likely, as a result of inadequate housekeeping and quality assurance practices during original construction of the containment building structure in the early 1970's.

April 23, 2009 - A VT-3 (i.e, a direct visual) inspection confirmed a through-wall hole of the containment steel liner. The flaw that penetrated the liner was sized as approximately 1" horizontal x 3/8" vertical; documented in Condition Report CR 09-57762; and reported to the NRC per 10CFR50.72, as Event Notification No. 45015.

BEAVER VALLEY UNIT 1 LINER HOLE

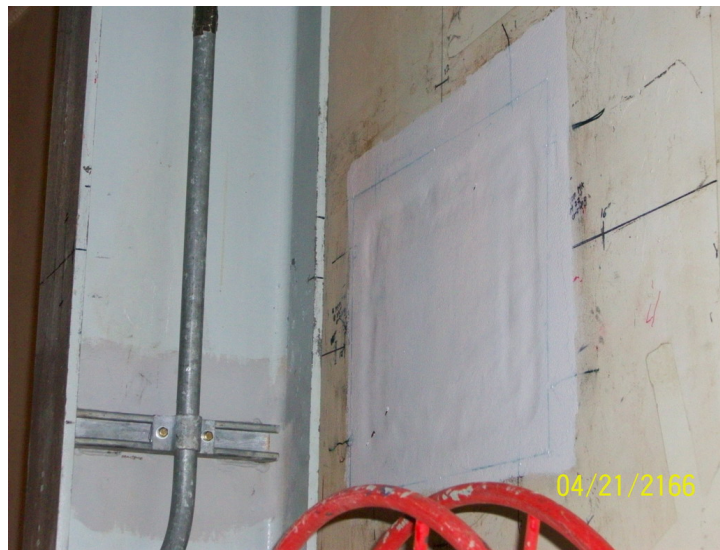
BEAVER VALLEY UNIT 1 LINER REPAIR

Subsequently, the licensee restored and repaired the affected area by grouting the concrete area that was displaced by the wooden debris, and welding a new section of steel plate to replace the previously removed portion of the liner. The work was accomplished in accordance with Engineering Change Package (ECP) 09-0365-001 and Work Order 200367242.

The LLRT was completed successfully and the repaired area was determined to fully meet the applicable ASME codes and standards. A protective white epoxy coating was applied to the repaired liner plate area; and the liner was restored to specification prior to plant startup. (Photograph in Attachment B pertains)

May 3, 2009 - Following removal of the wood, the void created in the concrete containment wall was grouted; and the liner opening was repaired by welding a new piece of steel plate in the opening, that was supported by a 2" inch schedule 80 pipe approximately 1" inch long which was tack welded to the replacement plate. The support was added to ensure the plate met the containment design specification with respect to allowable stresses. After welding of the replacement plate, Magnetic Particle and volumetric Ultrasonic Test (UT) inspections were completed that confirmed the integrity of the weldment. The affected liner section replacement was completed per ECP 09-0365-001 and in accordance with ASME Code requirements.
