Subject: PZR Safety Questions and Attachments

Enclosed document will be reference in an upcoming Calvert Cliffs inspection report.

From: Furio, Patricia S [Patricia.Furio@constellation.com]
Sent: Thursday, March 12, 2009 8:48 AM
To: Harry Balian
Cc: Kennedy, Silas
Subject: FW: PZR Safety Questions
Attachments: Document.pdf; BV02950 Body Inlet.JPG; Inlet Nozzle.JPG

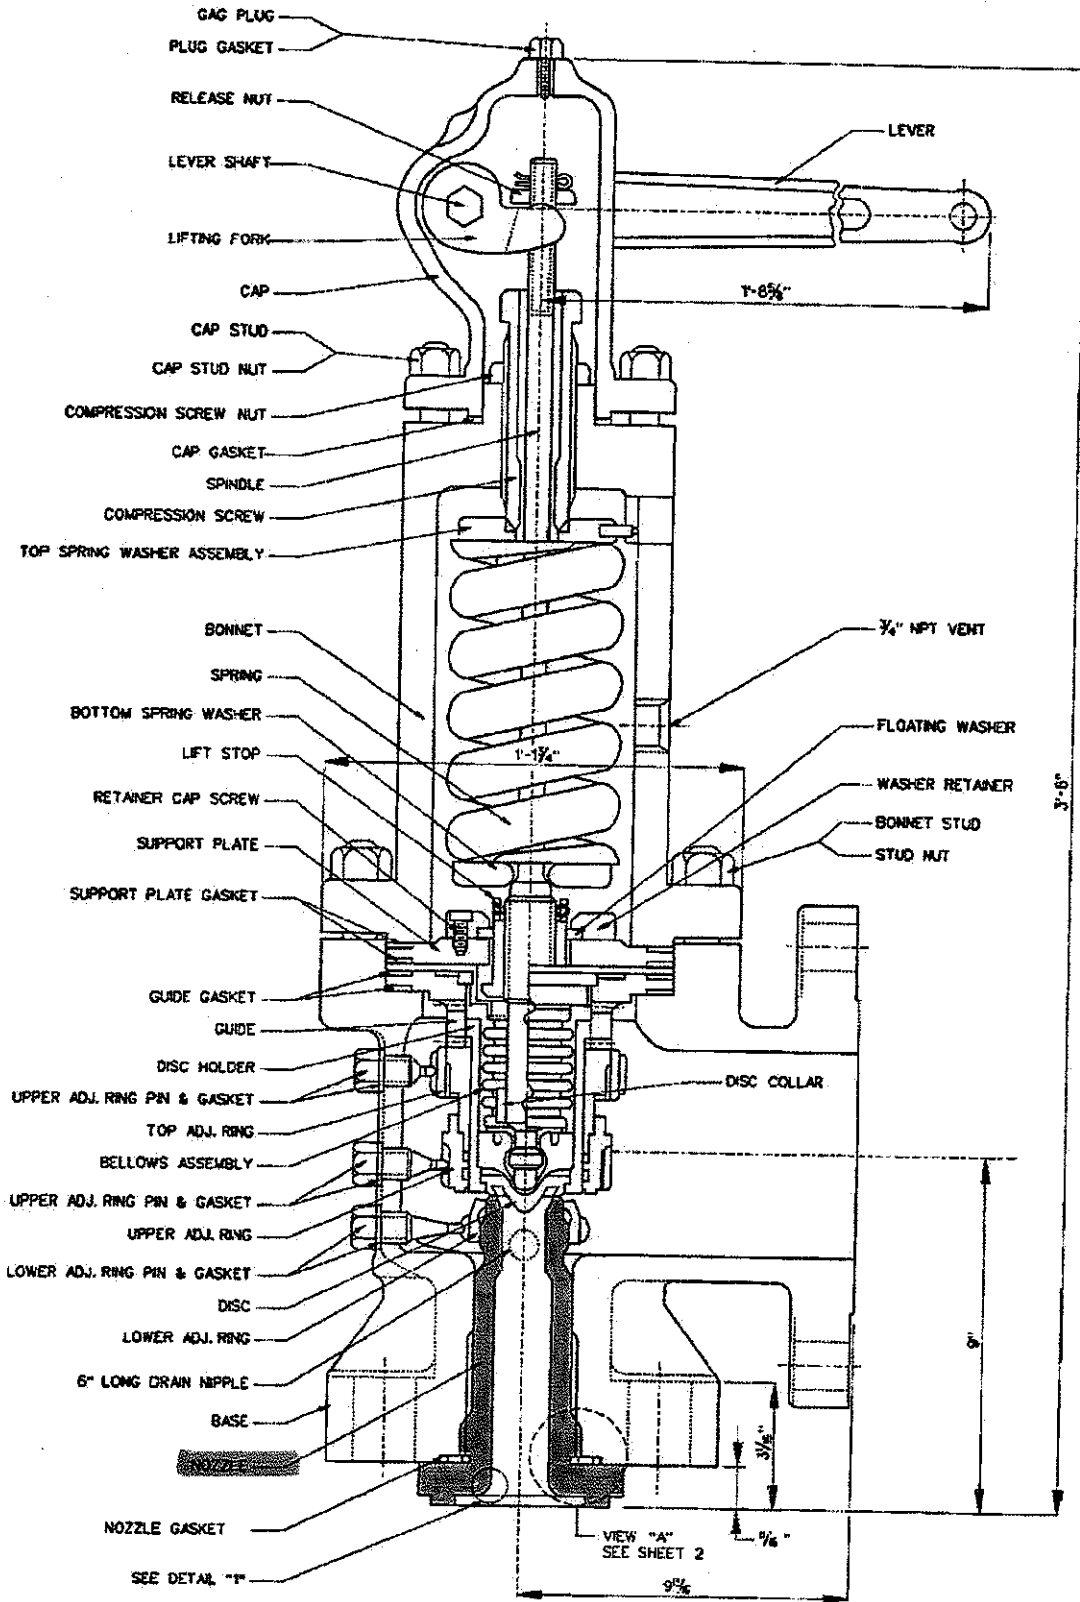
Figure 1

See the attached drawing and two pictures. The sealing flange for the inlet to the valve is a nozzle that gets screwed into the body/base of the valve. It is torqued to 600 ft lbs on installation. That torque is checked and re-torqued if necessary during every rebuild.

The main concern would be leakage around the c-seal that is between the valve body and the inlet nozzle (This seal would only see pressure if the valve was open). Review of our test records show that it is not uncommon to find the nozzle torque less than 600 ft lbs.

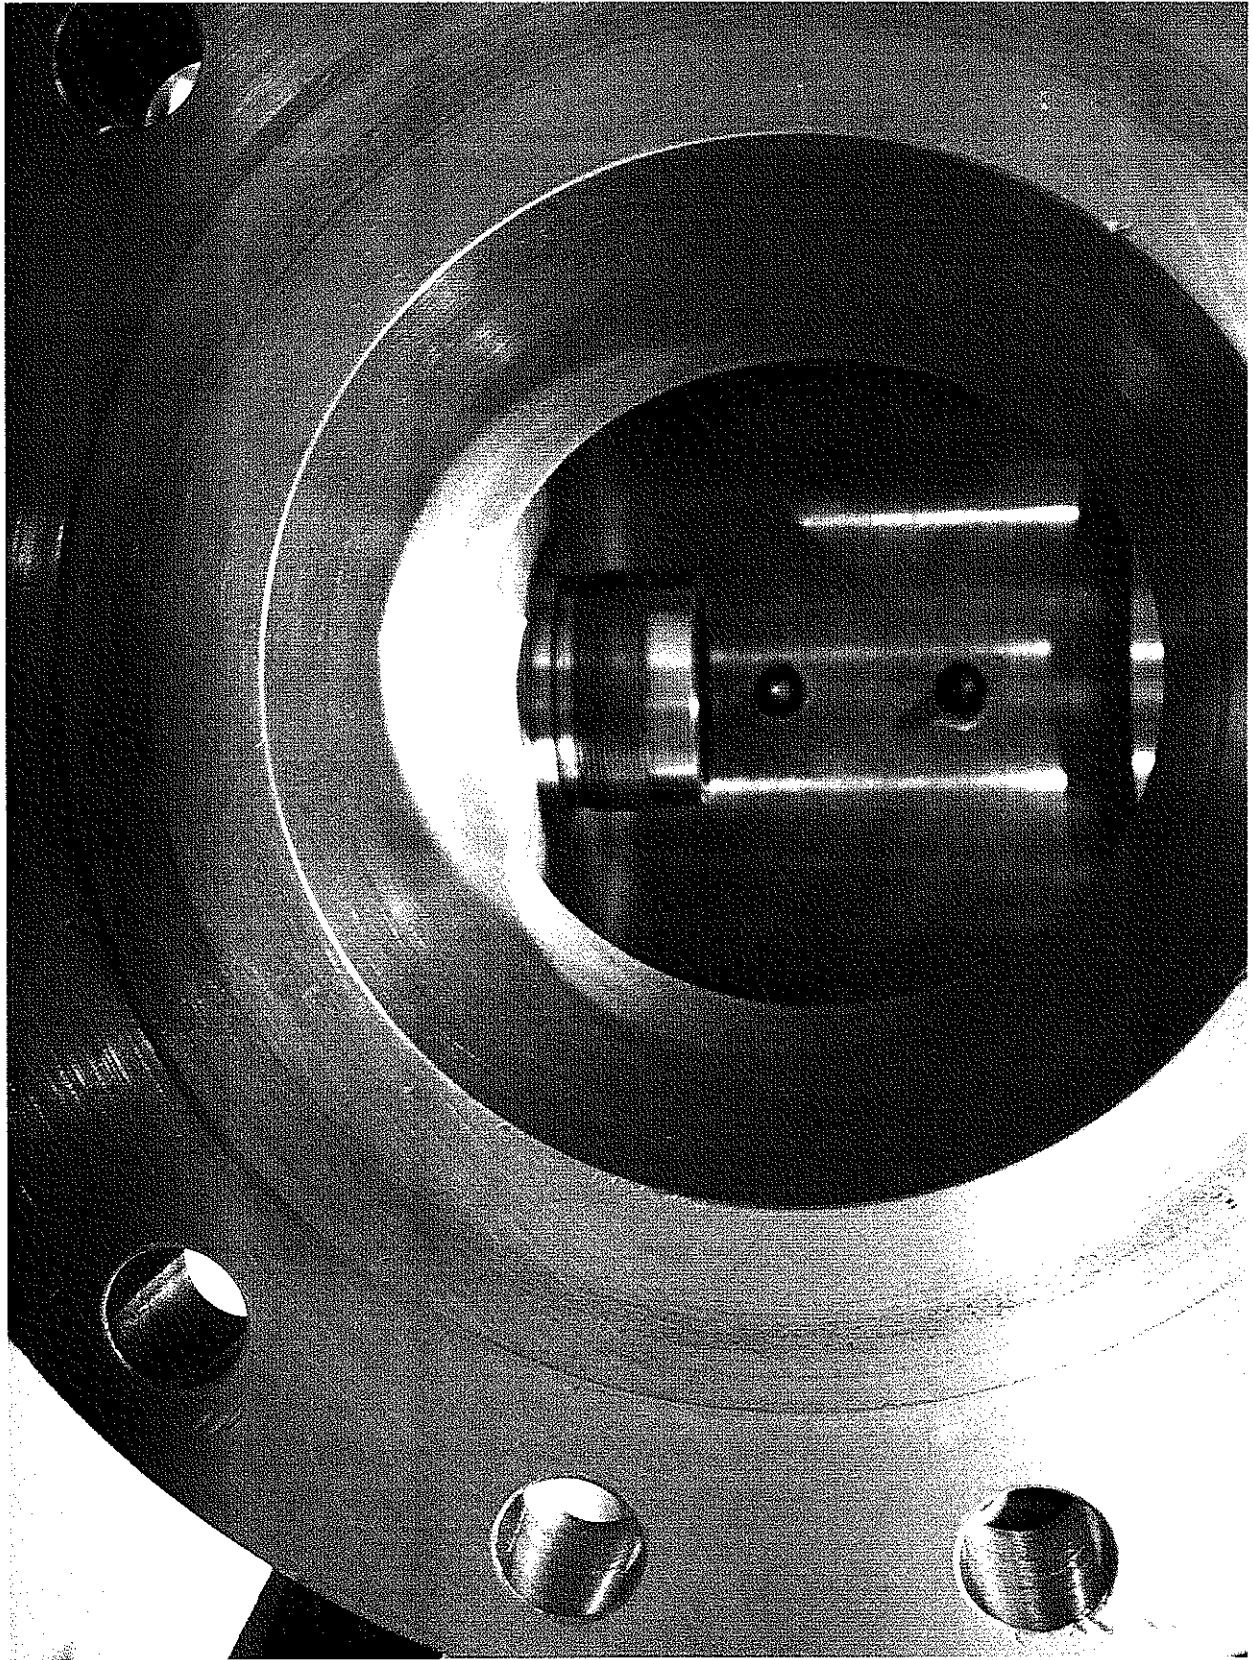
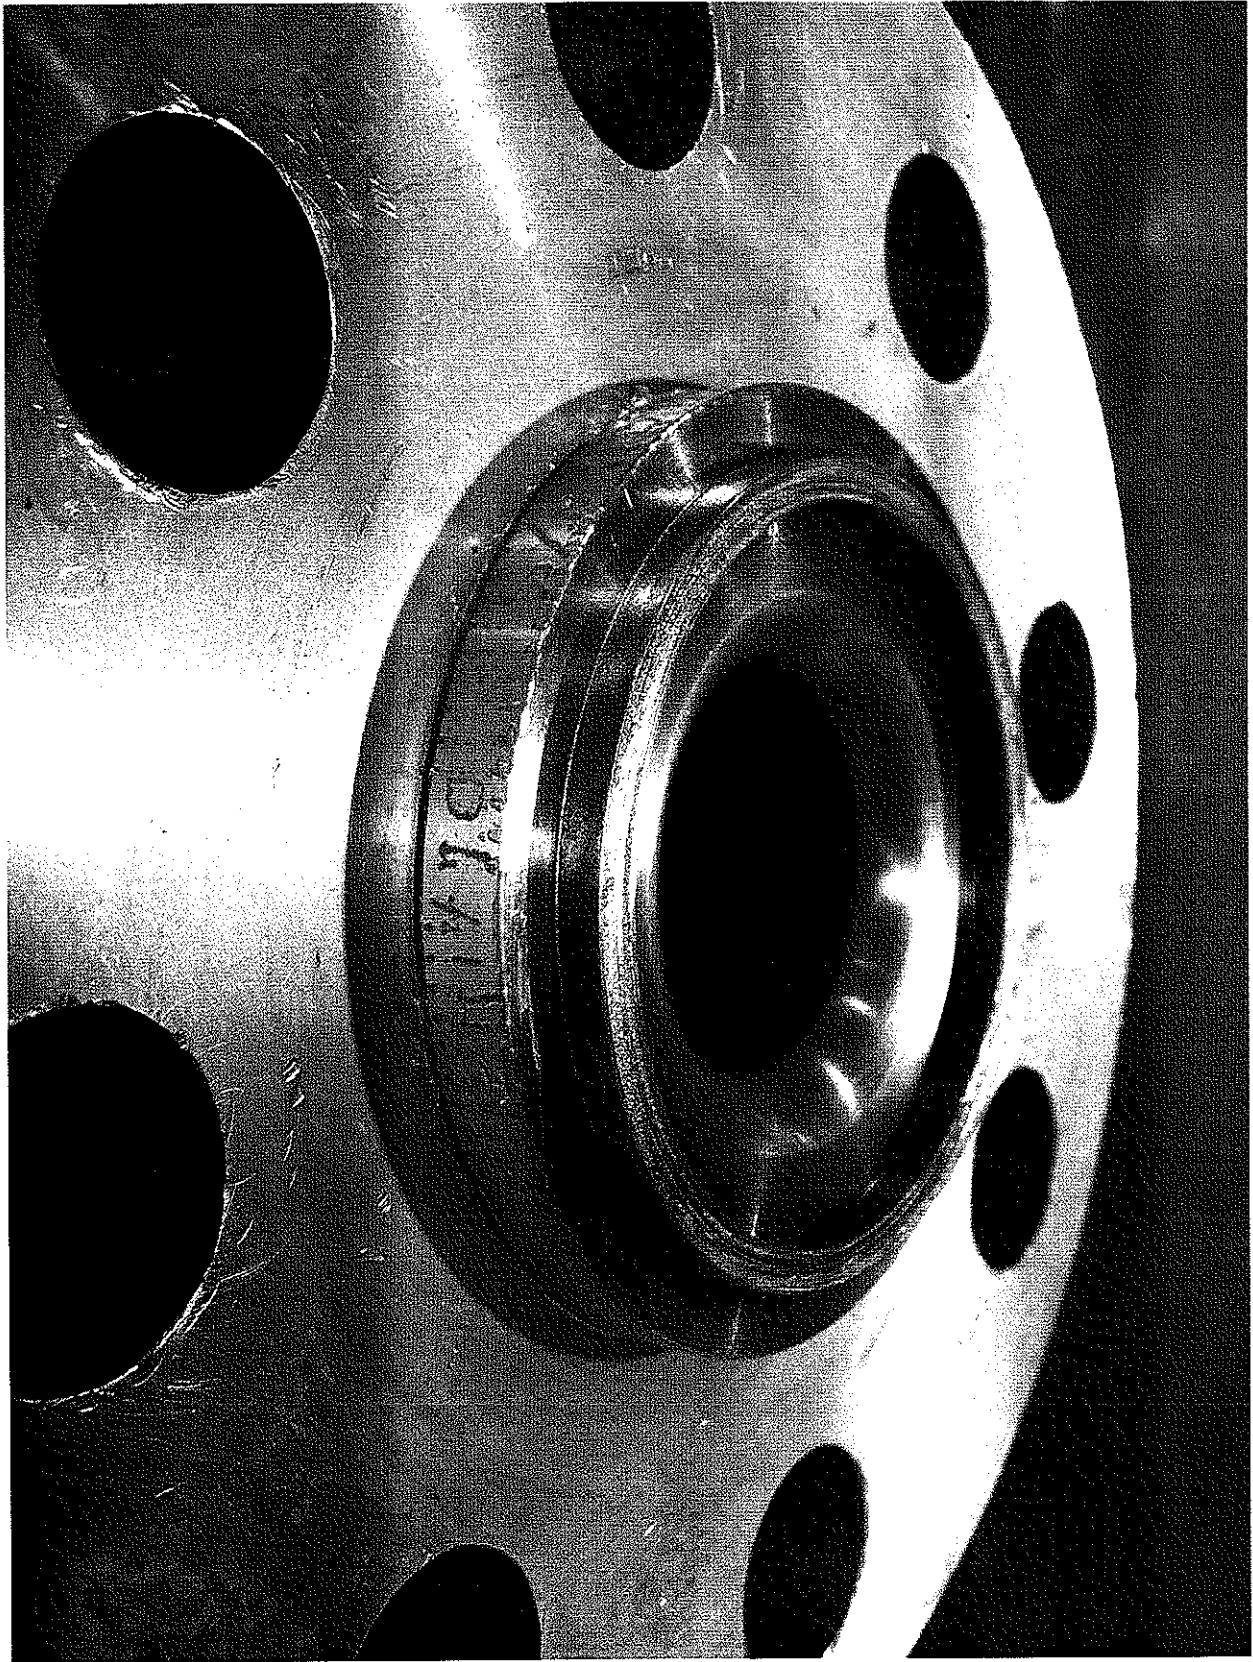
KEVIN,
AS WITH ANY FASTENER, THREAD-TORQUE DEGRADES WITH HEATING AND COOLING CYCLES. IT IS NOT UNUSUAL TO FIND NOZZLES LOOSE. THE BODY-NOZZLE THREAD CONNECTION HOLDS THE NOZZLE IN PLACE UNTIL THE VALVE IS INSTALLED. WHEN THE VALVE IS INSTALLED, THE FLANGE OF THE NOZZLE IS SANDWICHED BETWEEN THE MATING FLANGES. A LOOSE NOZZLE DOES NOT AFFECT SET PRESSURE. HOWEVER, IT COULD AFFECT THE TIGHTNESS OF THE C-SEAL JOINT BETWEEN THE FACE OF THE BODY FLANGE AND THE BACKSIDE OF THE NOZZLE FLANGE. THIS MEANS THE JOINT COULD LEAK ON BACKPRESSURE TESTING. IN GENERAL DURING REFURBISHMENT IF THE NOZZLE IS FOUND LOOSE, DRESSER RECOMMENDS THAT THE NOZZLE BE RE-TORQUED. CAUTION! DO NOT USE THE TORQUE VALUES GIVEN ON PAGE 42 OF THE 31700 INSTALLATION AND MAINTENANCE MANUAL (DATED 10-28-78, REVISION 4, AND EARLIER). FOR THE 31739 PSV THE REVISED RECOMMENDED TORQUE IS 550-600 FT-LBS. THE HIGHER VALUES IN THE MANUAL MAY DISTORT THE FLANGE OF THE NOZZLE LEADING TO JOINT LEAKAGE. THERE IS NO RECOMMENDED PRACTICE FOR PREVENTING DEGRADATION OF THE NOZZLE TORQUE.
