Subject: Notification of a Potential Safety Hazard, 10CFR Part 21, Report No. 09-01

REPORT OF A POTENTIAL SAFETY HAZARD

Subject: 033 and 306 Fire/Smoke Dampers Failure Analysis, Rev 4

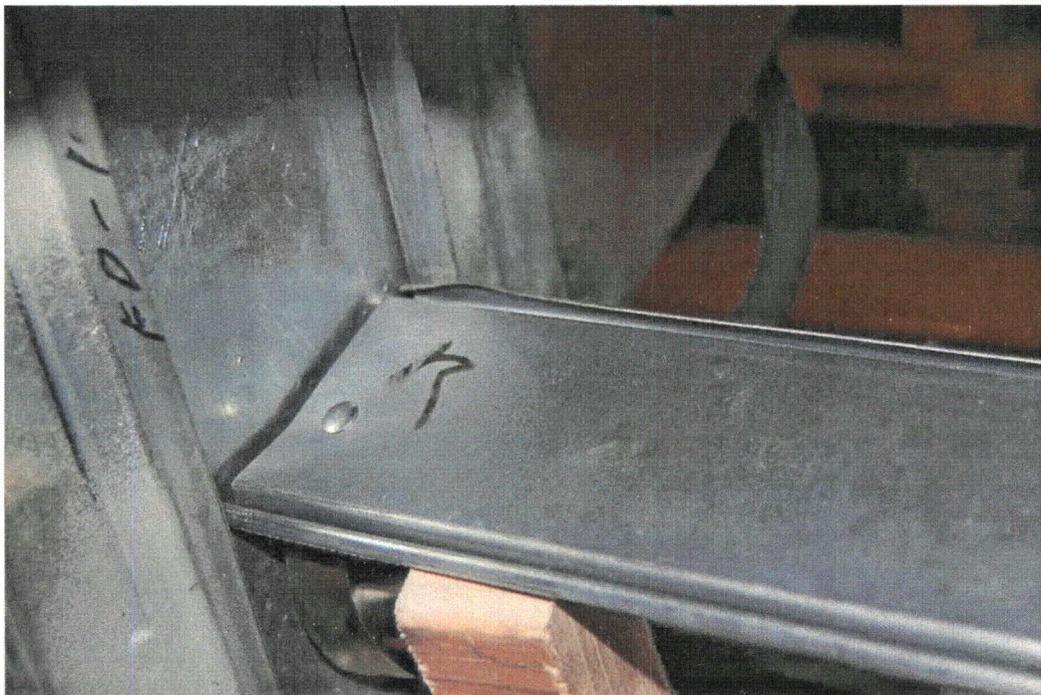
During inspection of the 033 damper, the lower blade separated from the adjacent blade in the same fashion as the 306 damper did in the field, after its installation.

*033 Damper at PMT facility with bottom blade separated from adjacent blade.
Note starting point for separation at end of blade.*

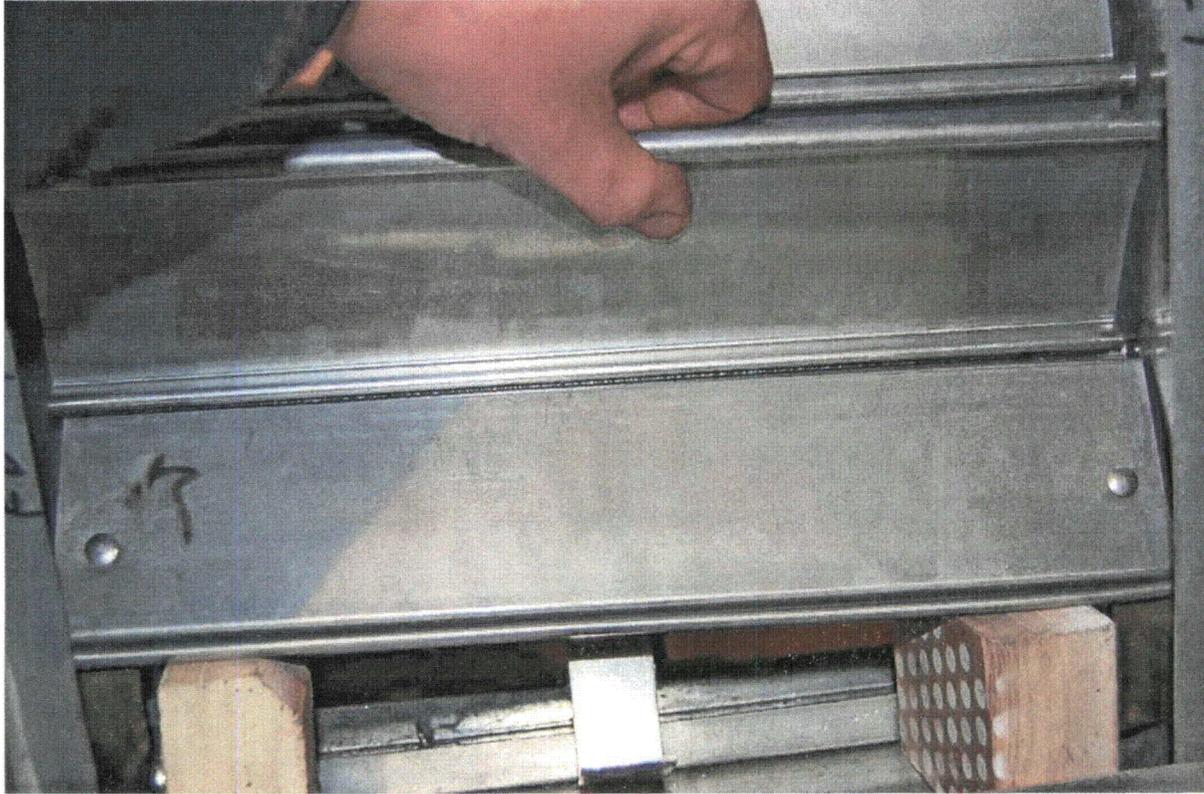
033 Damper at PMT shop with bottom blade re-attached to adjacent blade.

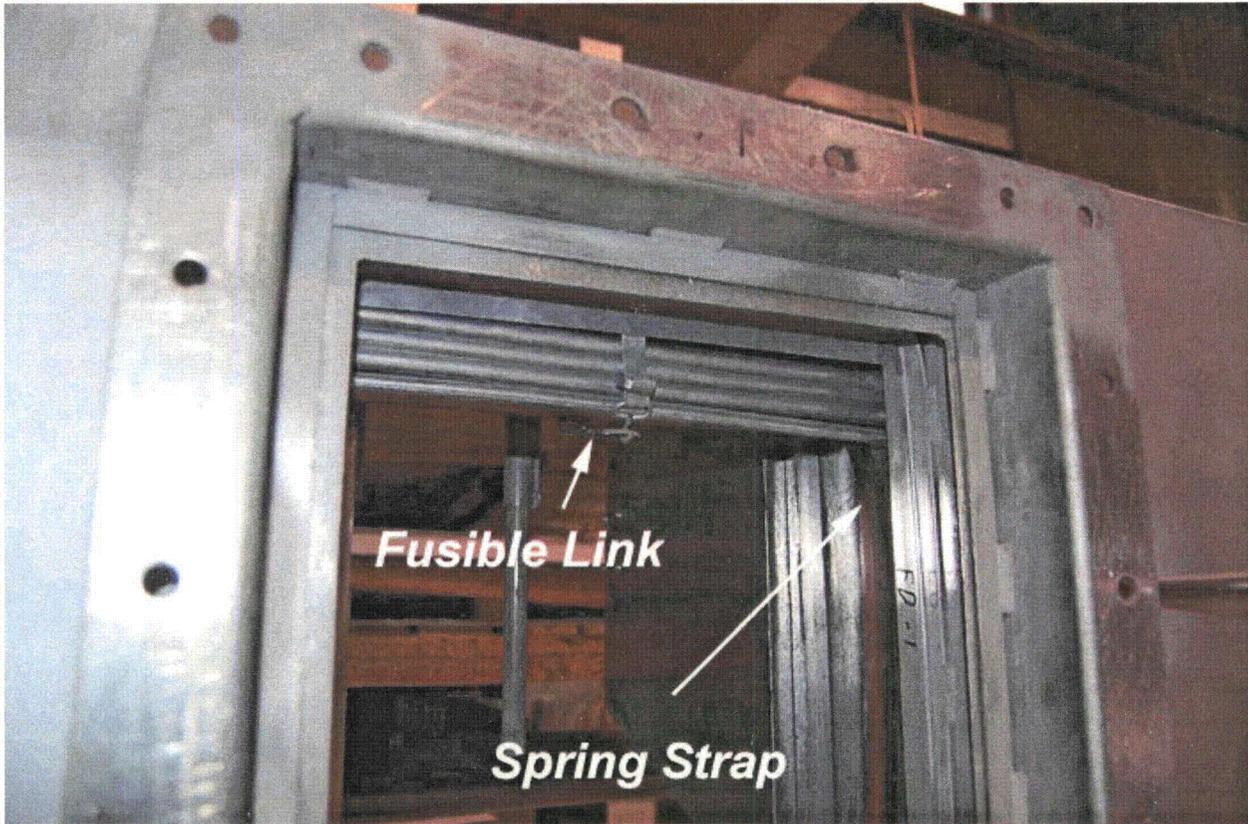
Spring Strap (closure spring) riveted onto the lowest blade assembly. There are two, one on the left side of the damper and one on the right. The fusible link can be seen in the center of the damper holding it in the open position.

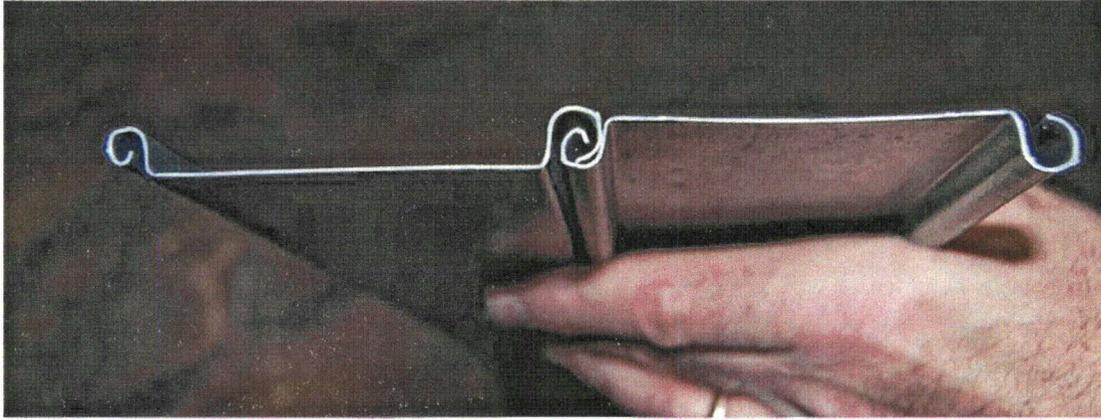
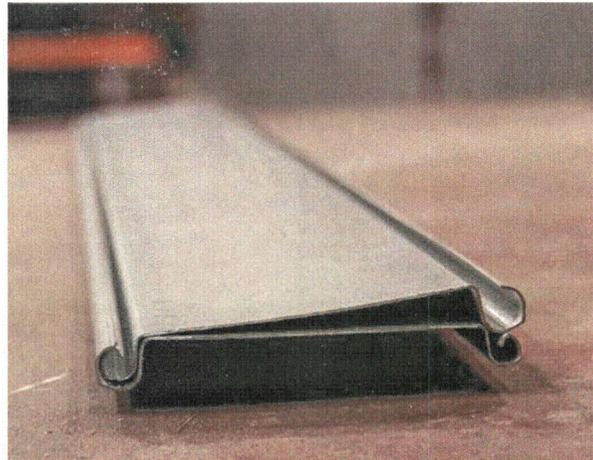
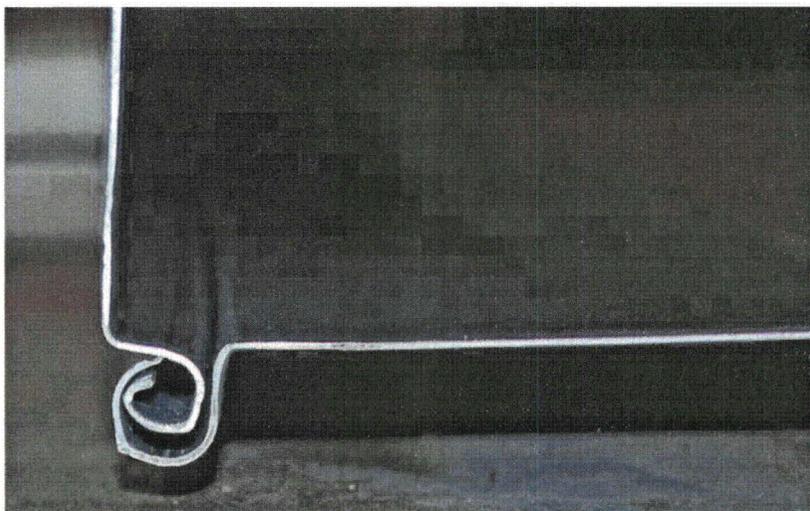
*Images of fire damper blades in various positions.
These blades could not be separated by pulling with directly opposing forces in any position.*

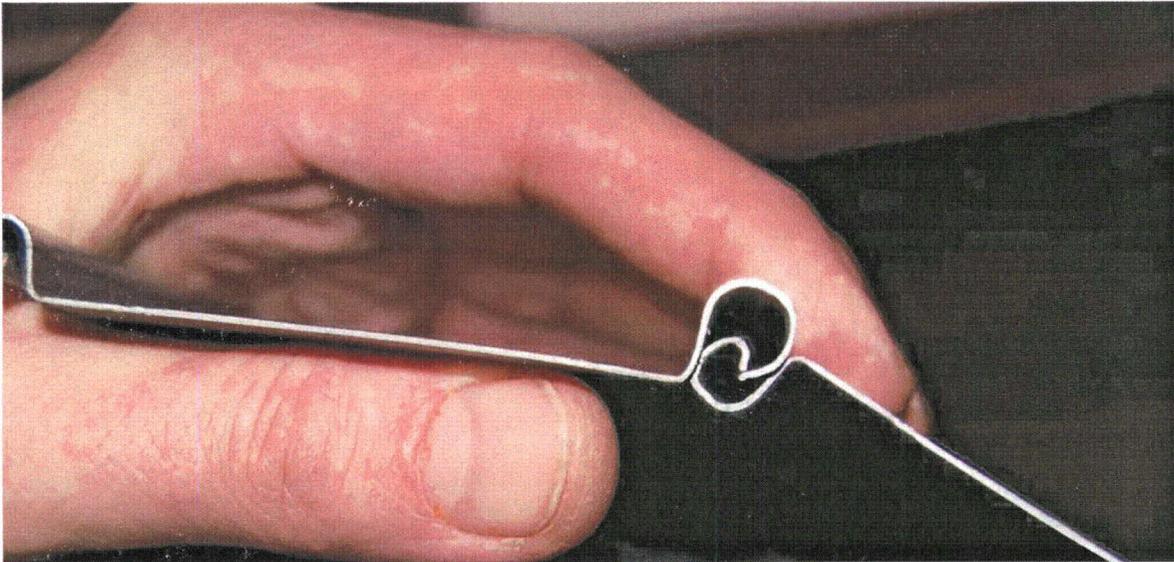
Attempt to separate damper blades after dimensional opening of female side.

After the female side of the blade was physically opened up, the blades could not be separated by applying opposing forces. Side forces were then placed on the blades and the damper blades separated. This could only be accomplished with the blades at an approximate 150 degree angle relative to each other. Any other position would not allow separation.

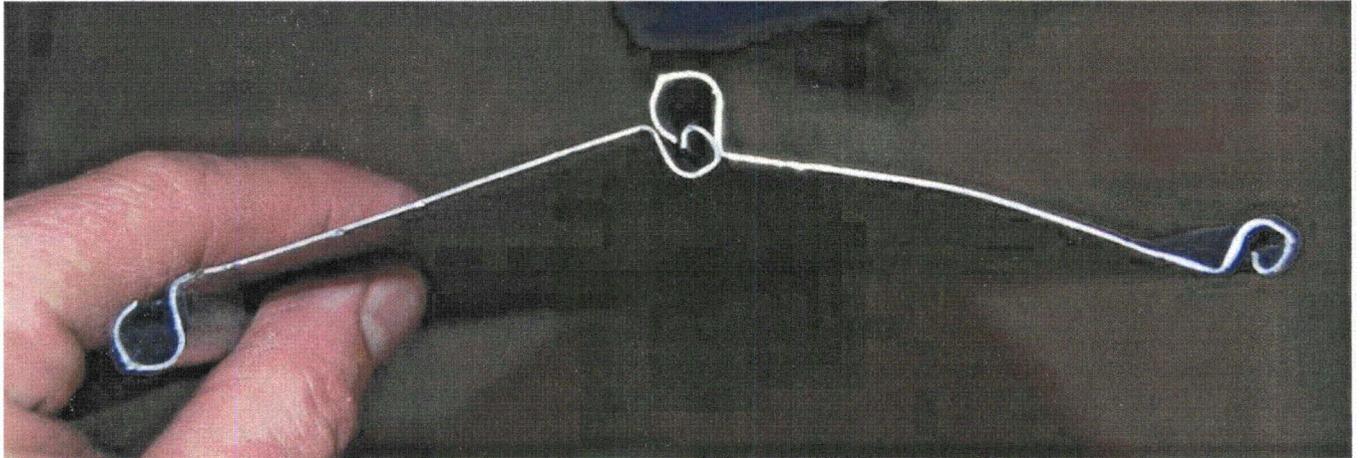
Placement of side loads on damper blades after dimensionally opening up female blade allowed the blades to separate. The blades must separate from left to right or right to left. The separation cannot occur in the middle and work its way out.

It was noticed that after the blades separated, the female dimension of the "hook" had dimensionally opened up even further (larger inside dimension). The blades in both the DAEC dampers and test unit could be put back together, but the female "hook" now had too large of a dimension and the blades could be easily separated after the initial separation evolution had occurred.

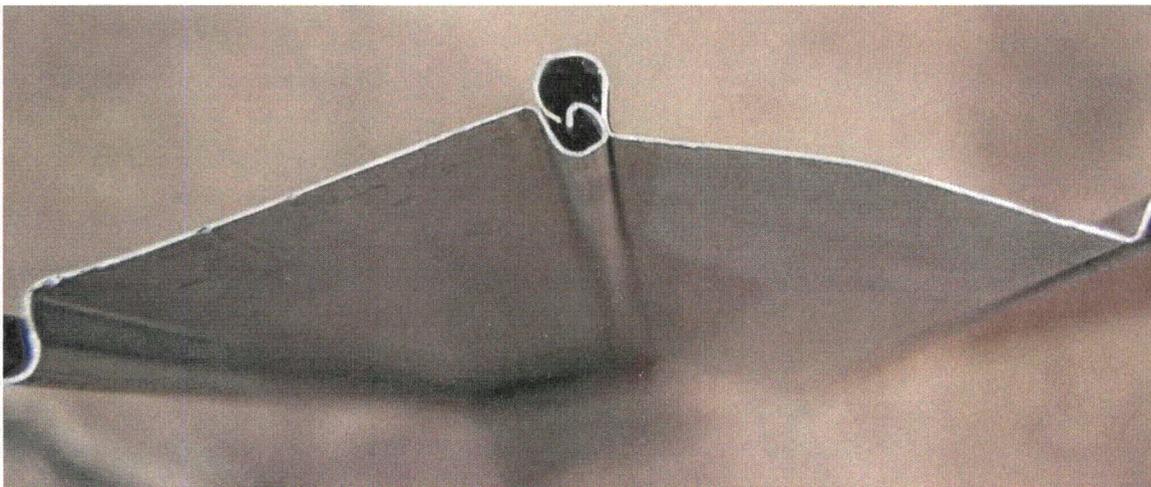
Blade separation of male and female sides. This must occur with side load forces to occur. Once the blade separates the first time, the female "hook" dimension opens up allowing for repeated separations.
