Tennessee Valley Authority
Post Office Box 2000
Soddy Daisy, Tennessee 37384-2000

SEQUOYAH NUCLEAR PLANT (SQN) FACILITY NO. 0-330628 - REPORT REQUEST
FOR SUMMARY OF FAILURE OF PRESSURE TEST FOR PIPING ASSOCIATED
WITH UNDERGROUND STORAGE TANKS (USTs)

SEQUOYAH NUCLEAR PLANT REPORT REQUEST FOR SUMMARY OF FAILURE OF PRESSURE TEST FOR PIPING ASSOCIATED WITH UNDERGROUND STORAGE TANKS (USTs)

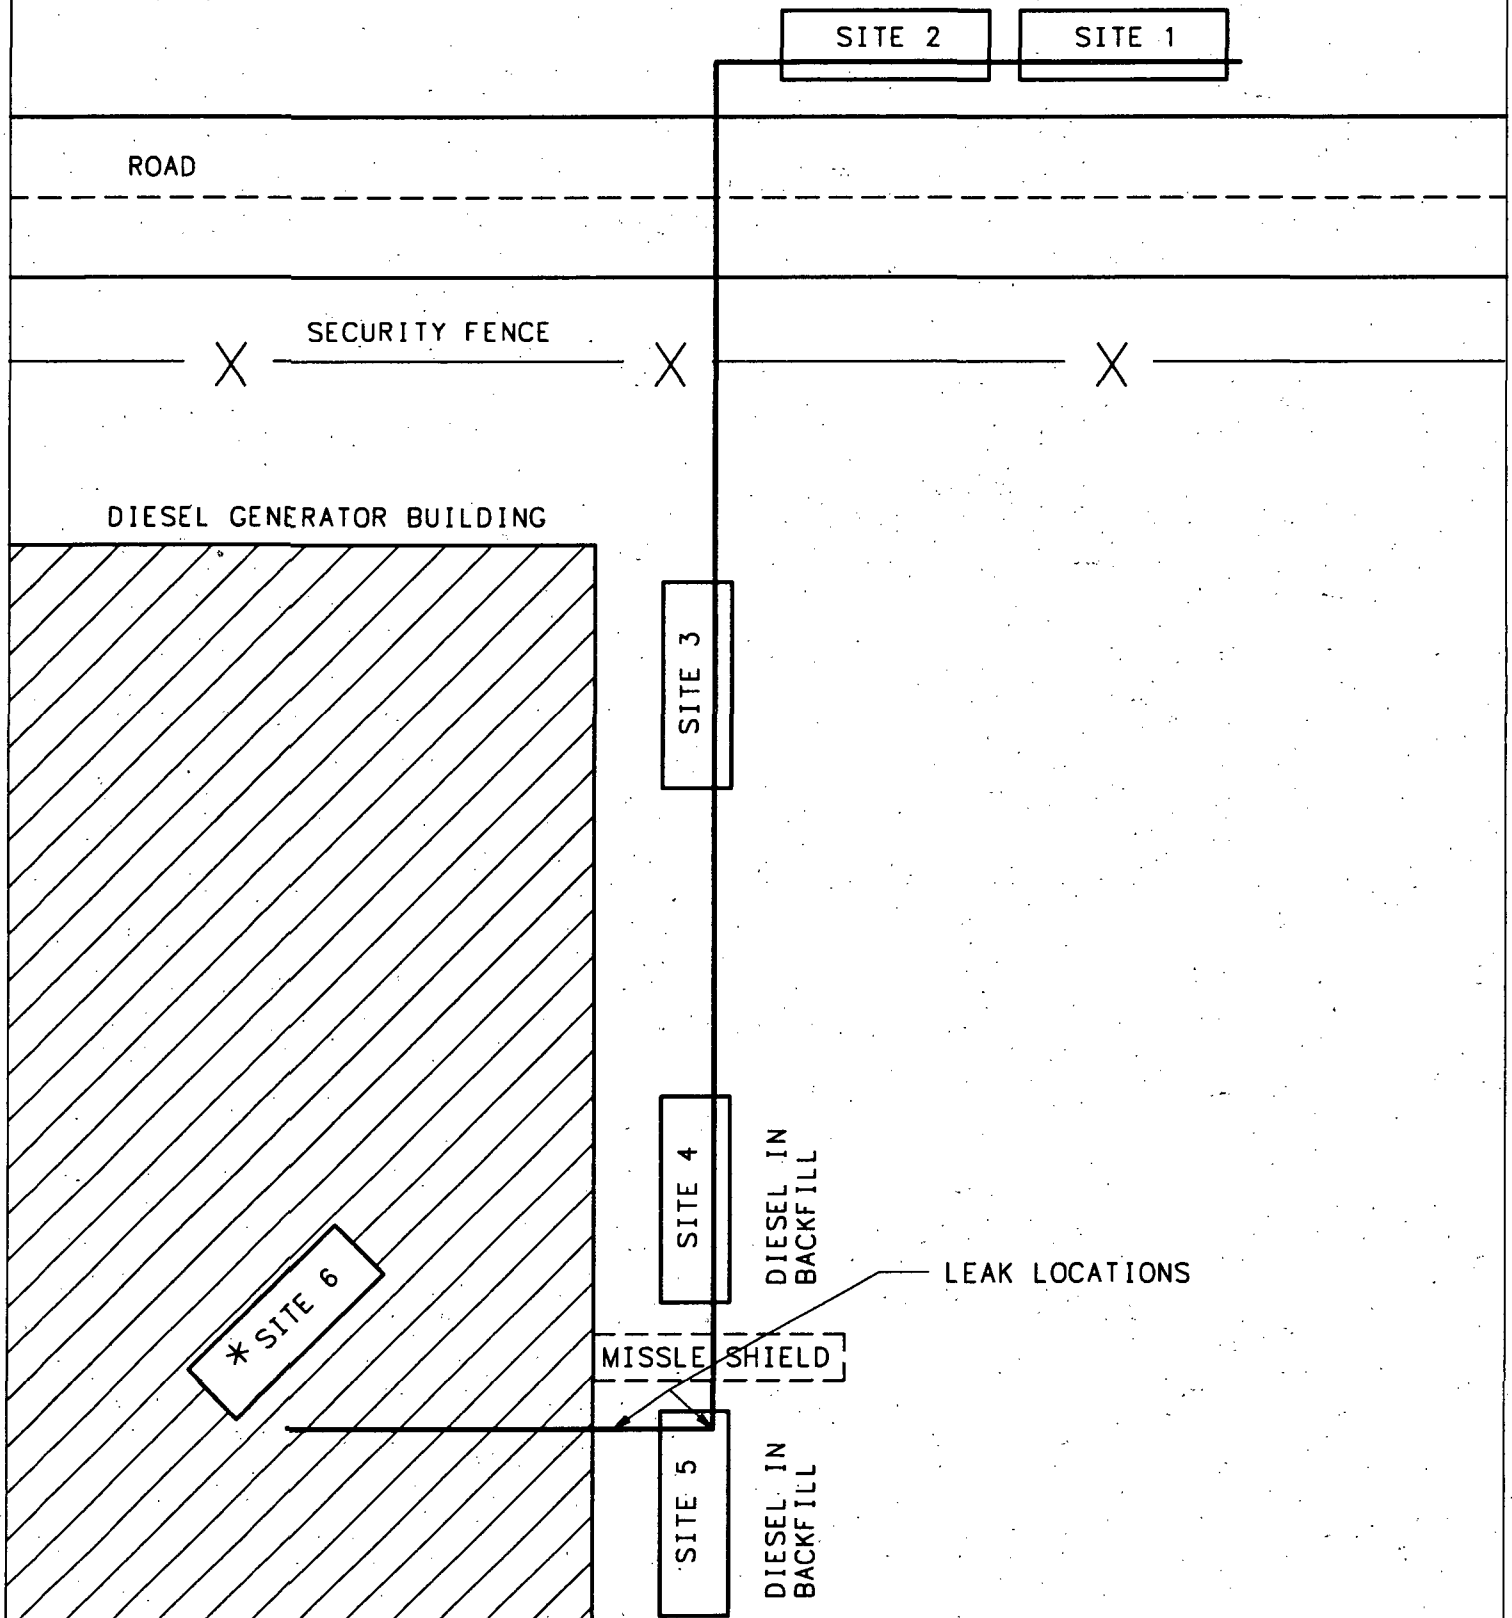
ATTACHMENT 1

2. On Wednesday July 1, Structural Integrity (SI) began ultrasonic pipe testing using Guided Wave technology. The first location was inside the diesel generator building (Site 6). The second area was a midpoint along the sidewalk outside the building (Site 3). The third location was near the FOSTs (Site 1). The data collected did not give SI a full scan of the pipe. Two additional areas were then excavated (Sites 2 & 4). Site 4, had an obvious odor of diesel when the backfill around the piping was exposed. Further testing at these additional sites resulted in inconclusive results. SI then conducted a rudimentary "over the line survey" and although not conclusive showed a possible indication of a piping breach. (see Attachment 1)

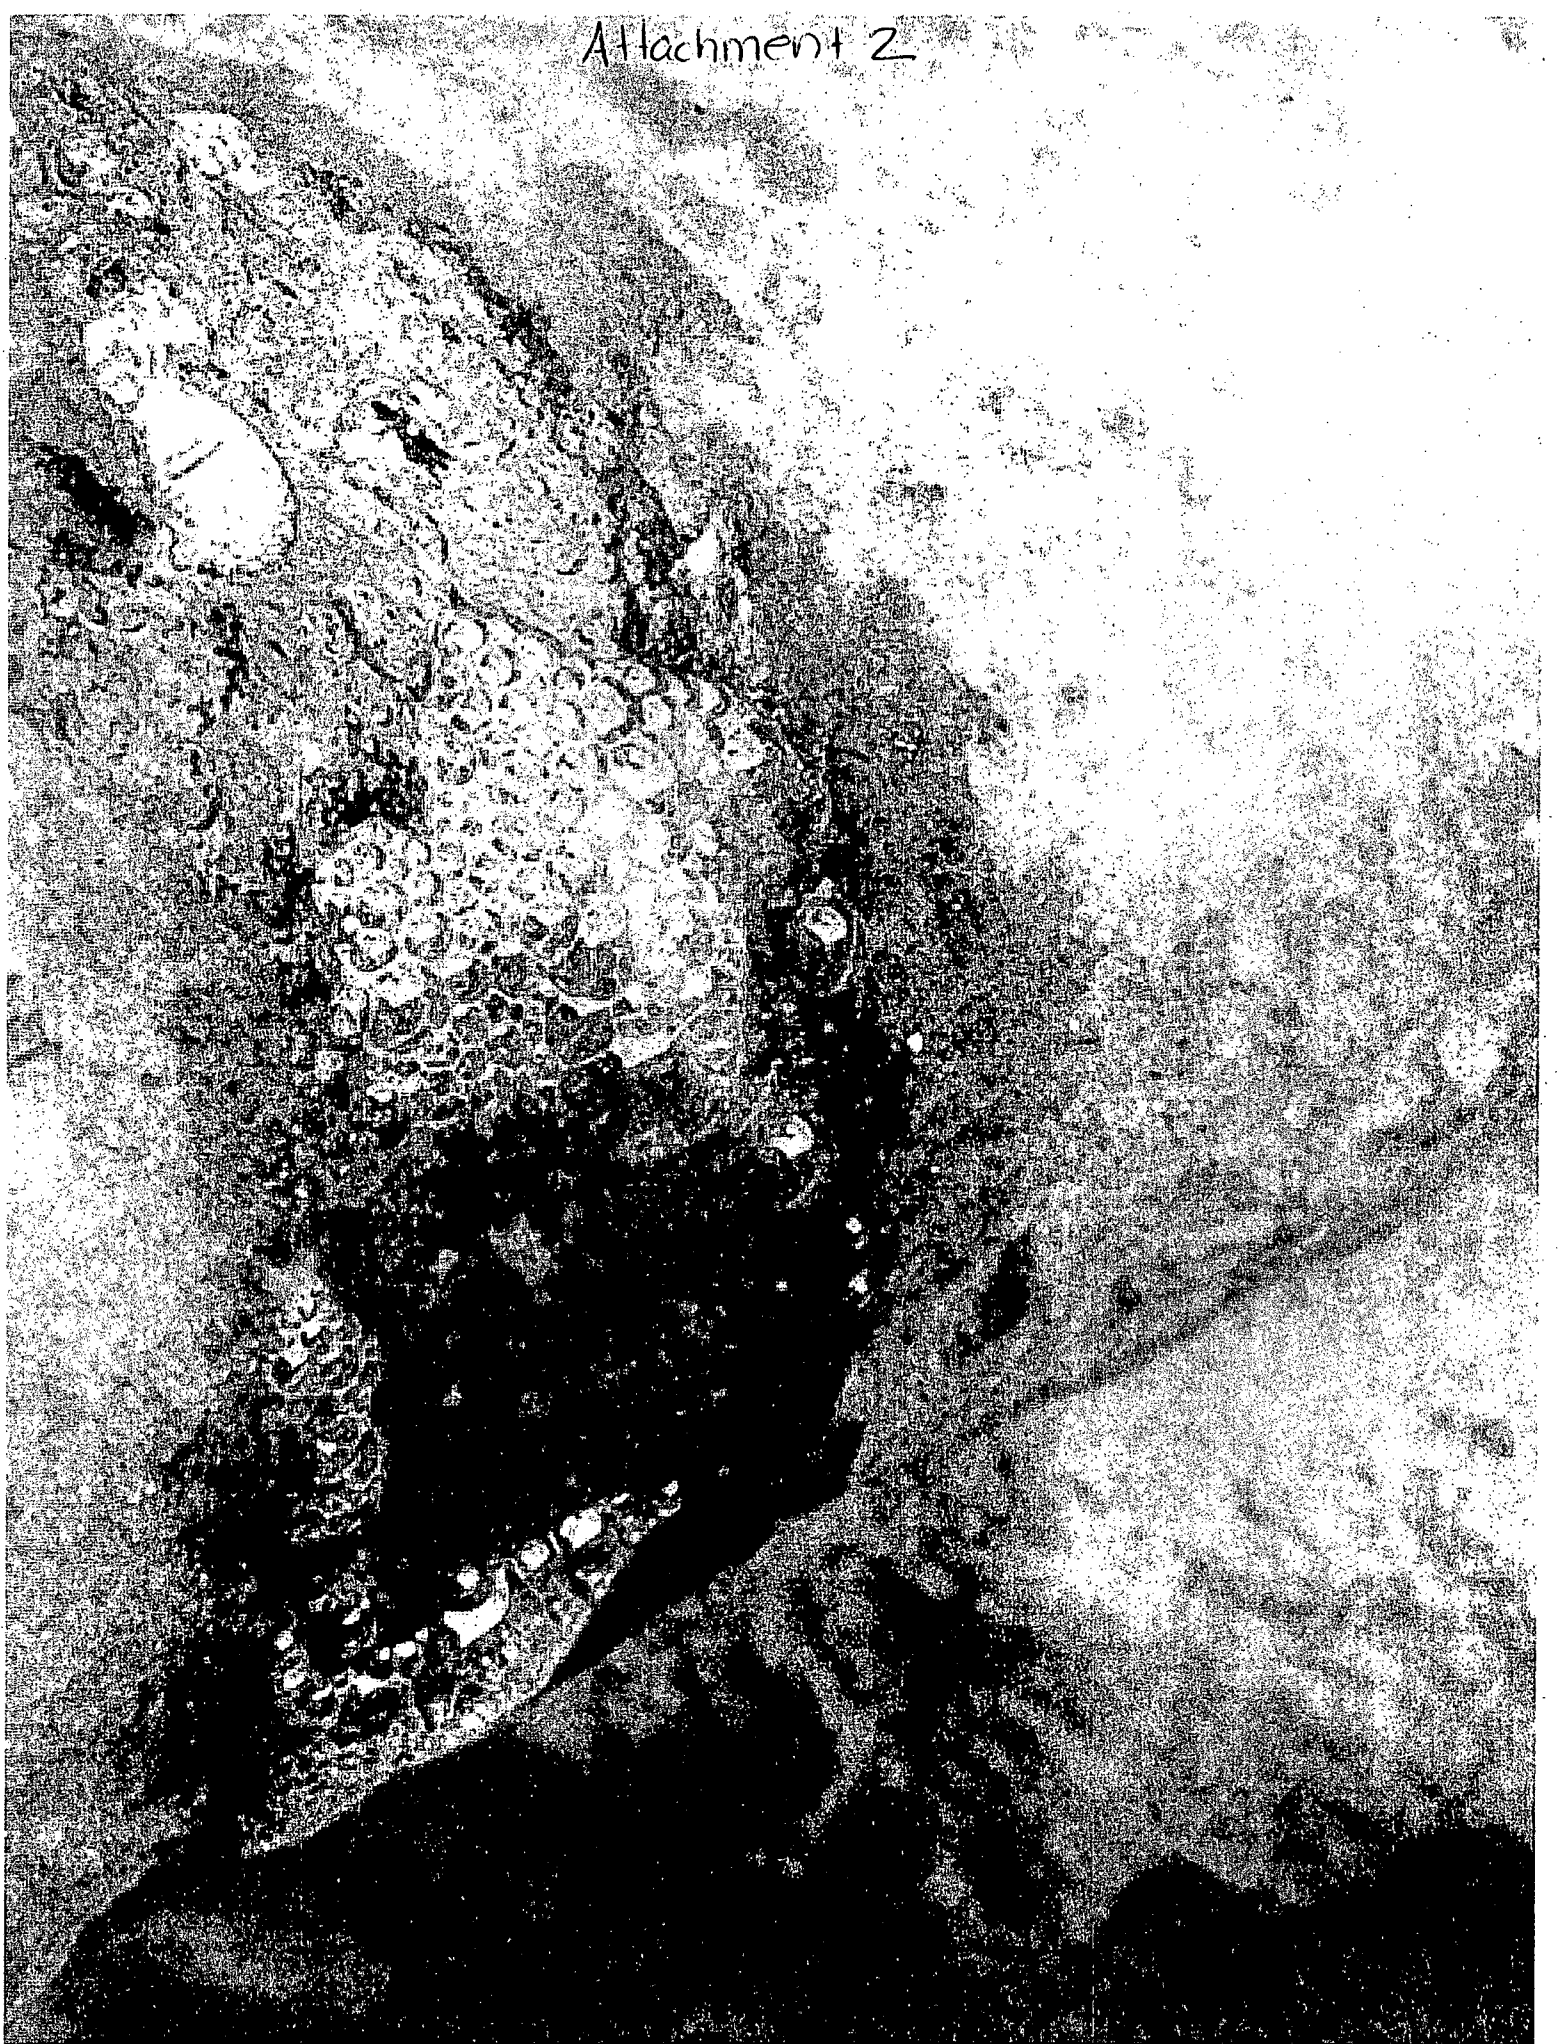
Attachment 2

4. On Friday July 3, additional backfill and clay were removed to expose five welds: four welds on the 45 and 90 that lead into the building (Site 5) and one weld on the straight run of pipe (Site 4). The coal tar tape around the four welds had deteriorated over time. A pressure test was run once again and all five welds were tested using Snoop. Bubbles were formed and gas could be heard escaping from one of the locations. (see Attachments 2, 3, and 4)

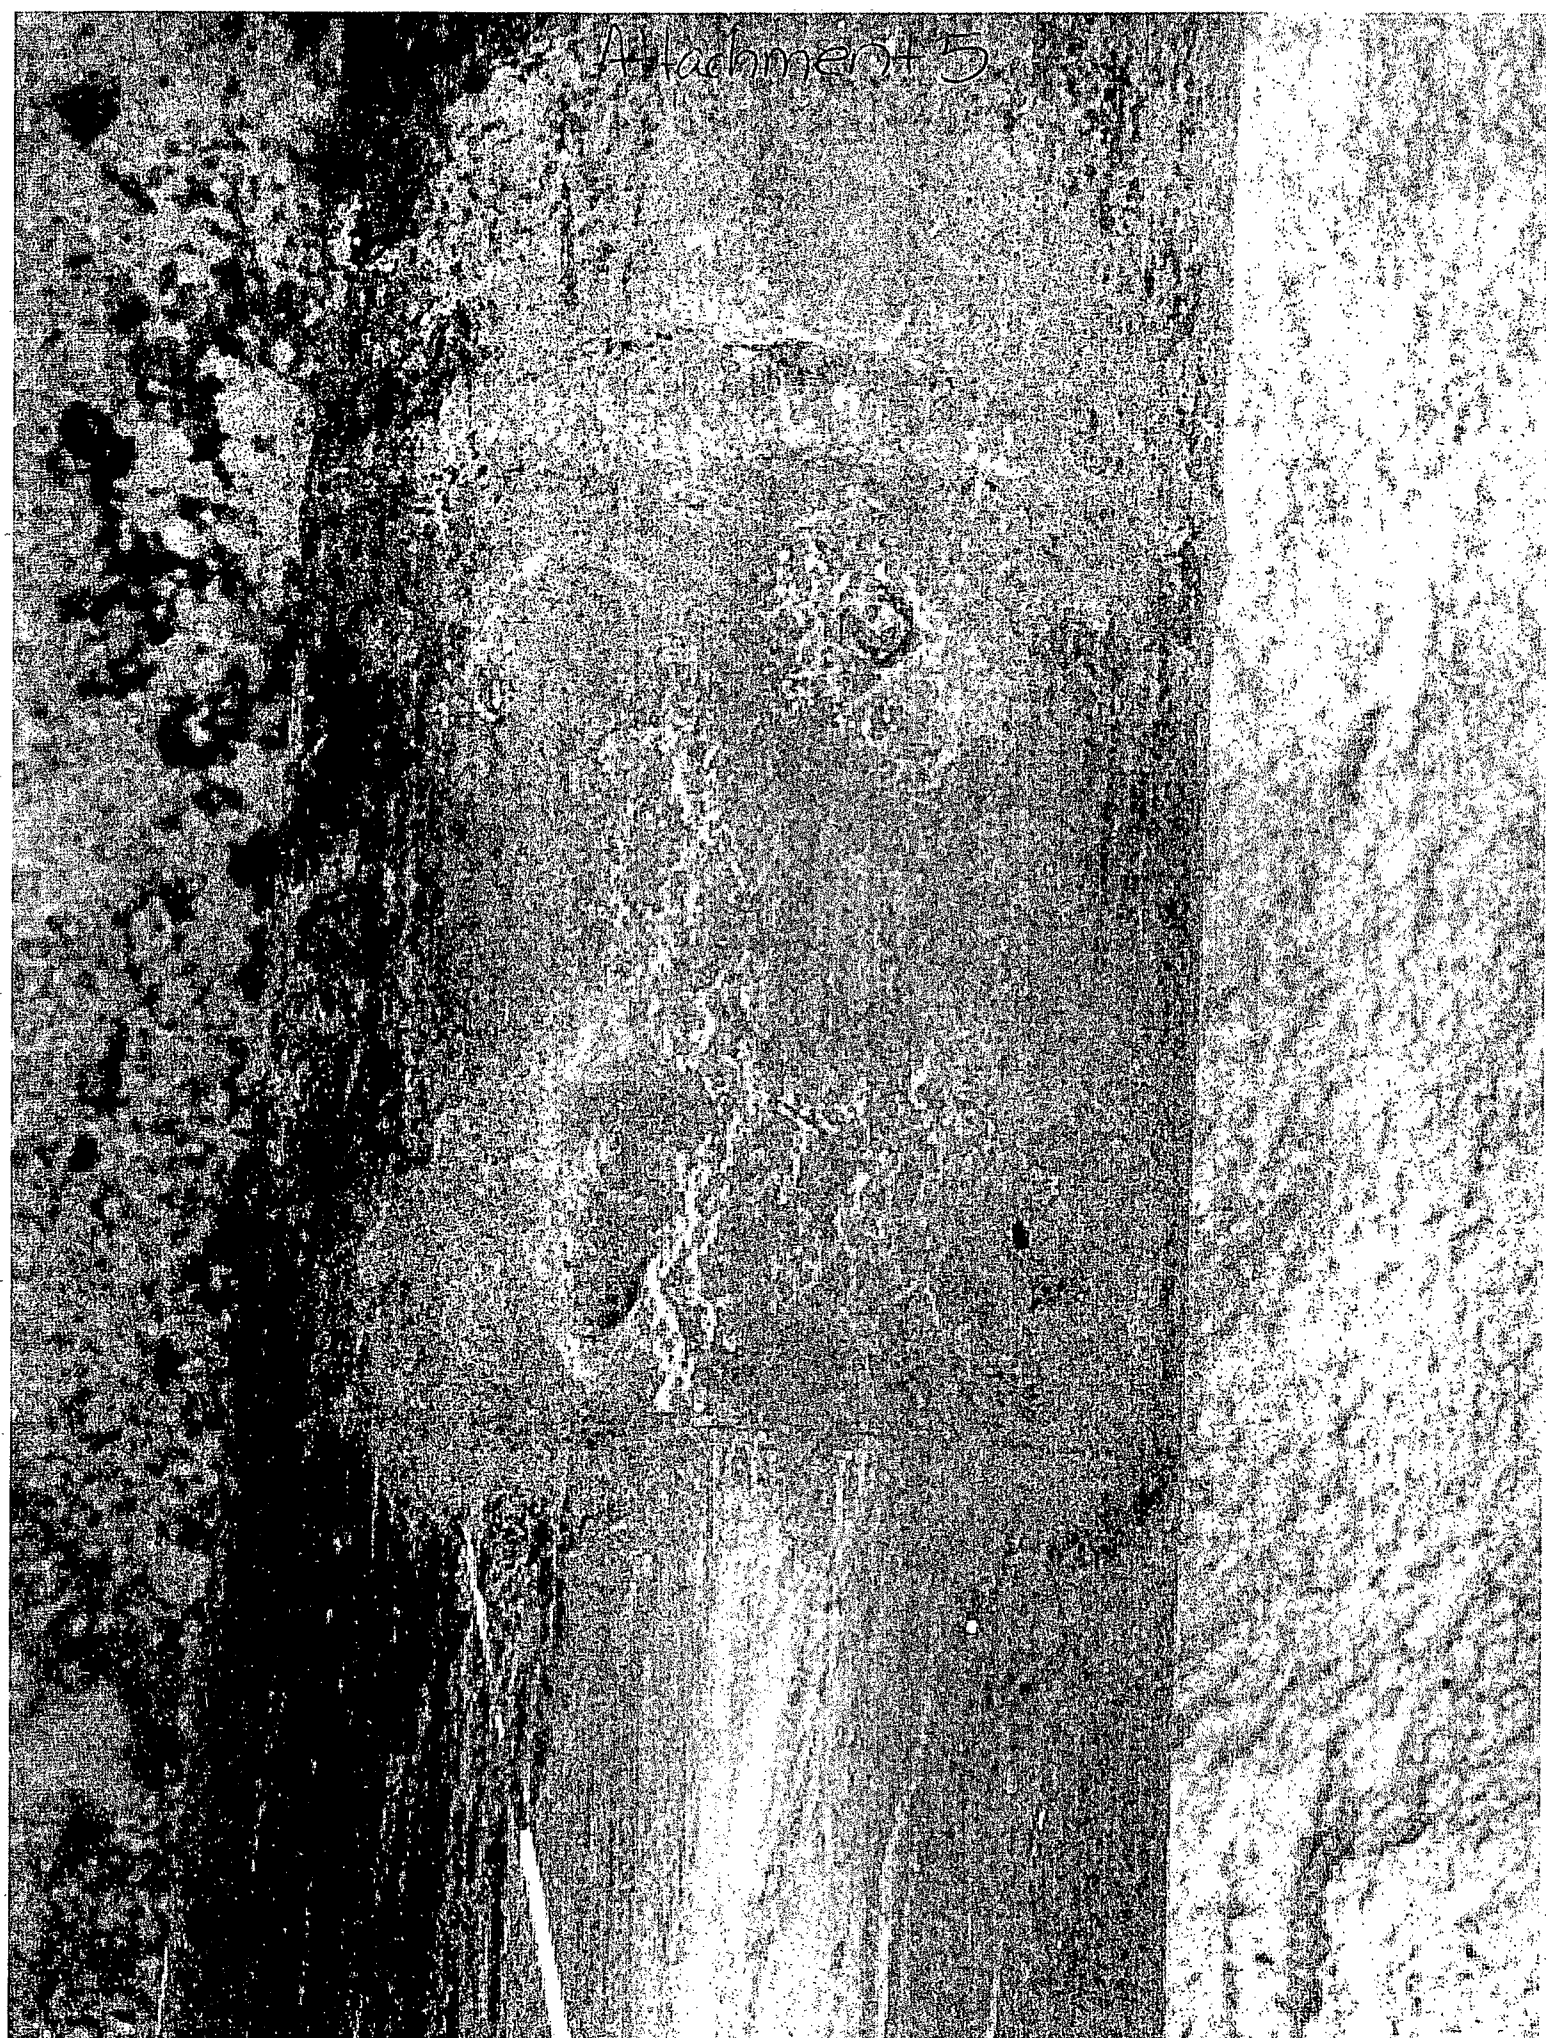
Attachment 5

10. On Friday July 17, the section of piping determined to have the second leak was exposed. Another through-wall OD originating pit was found, with two other significant pits close by. All of these were found in the base metal. Maintenance is in the process of clamping this hole and performing a pressure test to insure this is the last leak location. (see Attachment 5)

11. On Saturday July 18, repair at second leak location was completed. Pressure test was performed and found acceptable.
12. On Monday July 20, second pressure test on line was performed and found acceptable. Soil that contains diesel fuel continues to be removed.
