UNITED STATES  
NUCLEAR REGULATORY COMMISSION

Subject: COOPER NUCLEAR STATION - NRC INTEGRATED INSPECTION  
REPORT 05000298/2009003

Enclosure:  
NRC Inspection Report 05000298/2009003  
w/Attachment: Supplemental Information

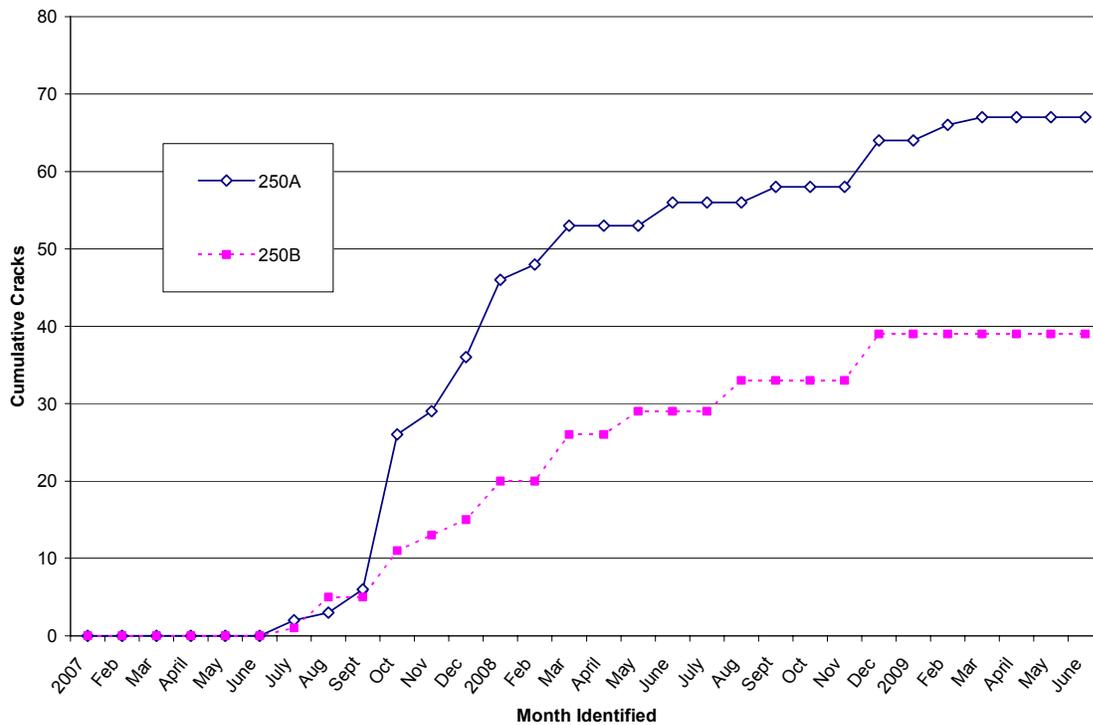
**Figure 1: 250 V Battery Cover Cracks: Cumulative Totals**

From a review of condition reports written during the previous 2 years, the inspectors determined that cell cover cracking had affected 67 cells in 250 Vdc Battery A, 38 cells in 250 Vdc Battery B, 6 cells in 125 Vdc Battery A, and 14 cells in 125 Vdc Battery B (against a total of 120 cells in each 250 Vdc battery and 60 total cells in each 125 Vdc battery). Figures 1 and 2 depict the historical trend of identified battery cell cracks.

The licensee determined that the battery cell cover cracks do not threaten the safety function of the battery. However, 250 Vdc Batteries A and B have exhibited signs of corrosion on the battery racks and grounding cables. Condition Report CR-CNS-2008-06519 identified the battery cell cover leakage as the source of this corrosion. Continued corrosion of the battery racks will likely degrade the structural strength of the battery racks and threaten their safety function. The inspectors noted that 250 Vdc Battery B is scheduled for replacement during Refueling Outage 25 and 250 Vdc Battery A during Refueling Outage 26. Additionally, the inspectors noted a degrading trend on 125 Vdc Battery B, and that no plans existed to replace this battery. Following discussion of this adverse trend with inspectors, licensee staff concurred that a degrading trend existed and will consider replacement of this battery.
