NL-09-1145

Edwin I. Hatch Nuclear Plant-Unit 2 Inservice Inspection Program <u>Owner's Activity Report for Outage 2R20</u>

FORM OAR-1	OWNER'S	ACTIVITY	REPORT
------------	----------------	----------	--------

Stru	ctural Integ	grity Associates,	, Inc.	File No.: 0900257.3	01	
CA	LCULATI	ON PACKAGE	Ξ	Project No.: 0900257 Quality Program: 🛛 Nuclear 🗌 Commercial		
PROJECT ? Hatch Unit 2		nlet Nozzle G-5 Nozz	le-to-Safe	End Weld Flaw Evalua	ation	
CONTRAC [®] Later	ΓΝΟ.:				.	
CLIENT: Southern Nuc	clear Operating		PLANT: Hatch Unit	1 2		
CALCULATION TITLE: Flaw Evaluation of the Hatch Unit 2 Recirculation Inlet Nozzle (N2) G-5 Nozzle-to-Safe End Weld Axi Indication						
Document Revision	Affected Pages	Revision Description		Project Manager Approval Signature & Date	Preparer(s) & Checker(s) Signatures & Dat	
A	1 - 9	Initial Draft Issu	ie	M. L. Herrera 2/23/09	S. S. Tang 2/23/09 M. L. Herrera 2/23/09	
0	1 - 10	Initial Issue	1 1 1	Mun Zrzagn Kom M. L. Herrera 2/24/09	S. S. Tang 2/24/09	
					M. L. Herrera 2/24/09

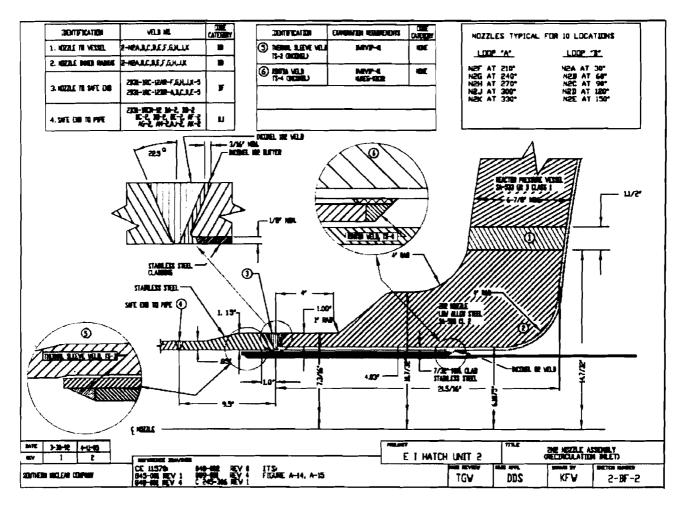
Figure 1: Recirculation Inlet Nozzle 2B31-1RC-12AR-G-5 Configuration

A flaw evaluation is performed to disposition an indication observed in the Hatch Unit 2 Recirculation Inlet Nozzle (N2) G-5 nozzle-to-safe end weld (2B31-1RC-12AR-G-5). The indication is axially oriented with a depth of 0.26 inches and a length of approximately 0.50 inches [1,2]. The indication based on inspection results is contained in the Alloy 182 weld. This weld is a dissimilar metal weld (Alloy 182) joining the stainless steel safe end and the low alloy steel (LAS) nozzle [2]. This location was stress mitigated using Induction Heating Stress Improvement (IHSI) [3].

The outside radius at the weld location is 7 3/16 inches (7.1875) Figure 1 [2]. The local wall thickness is 1.22 inches [1,2].

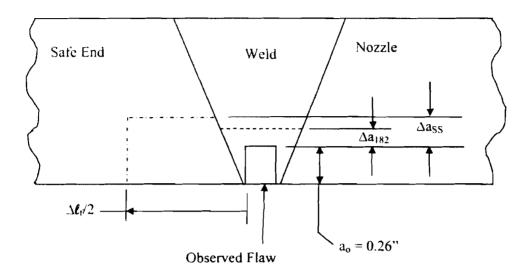
Figure 2: Predicted Crack Growth Configuration

A crack growth analysis is performed for the observed indication to obtain the crack growth due to stress corrosion and fatigue. Hatch Unit 2 is currently injecting Hydrogen at sufficient levels to fully protect this weld location. Since crack growth into the safe end or nozzle cannot be ruled out due to growth in the length direction, crack growth (depth direction) for Alloy 182, stainless steel and low alloy steel must be considered. The crack growth rate for LAS is bounded by that for Alloy 182, thus the flaw depth determined for Alloy 182 will be conservatively applied to the LAS. Figure 2 illustrates the postulated flaw configuration that considers lengthwise growth of the flaw.

Although the flaw is fully contained in the Alloy 182 material, this calculation also considers the potential for lengthwise growth into the stainless steel safe end and low alloy steel nozzle. Note that growth into the LAS will be small compared to that in the Alloy 182. Thus for purposes of this evaluation, the flaw depth predicted in the Alloy 182 will be used for the low alloy steel. Figure 2 illustrated the flaw configuration.

A flaw evaluation has been performed assuming that the flaw is an active stress corrosion flaw for an operating period of 2 years. Fatigue crack growth was also evaluated and was determined to be very small. Results of this evaluation demonstrate that growth of the observed flaw, will remain less than the allowable flaw size of 75% of the pipe wall. Therefore, the required safety factors will be maintained during operation with this flaw over the next operating cycle.
