## 6 Destructive Testing and Results

### 6.1 Cutting Plan

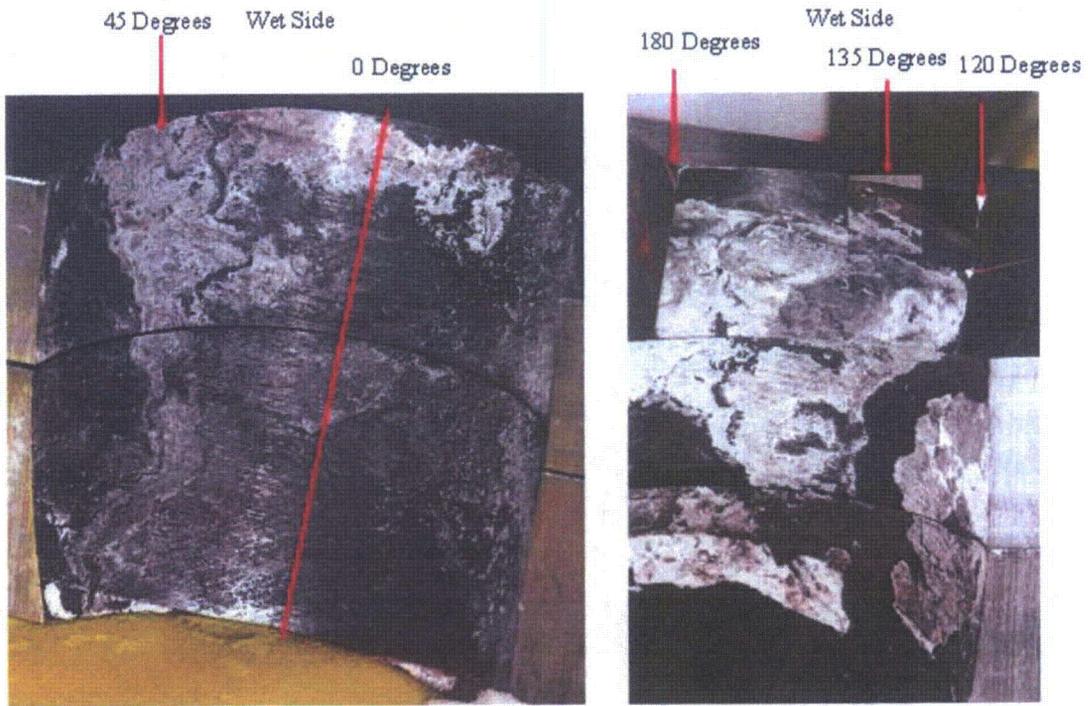
The annulus showed clear indications of water flow through the interference fit and the associated boric acid deposits left in the annulus. Two main indications of flow through the annulus were found—a small flow indication at 45 degrees and a very large indication with heavy boric acid deposits ranging from 120 to 190 degrees. A boric acid deposit found from 90 to 120 degrees also is shown in Figure 6.8. Two small flow indications were found close to 200 and 225 degrees. The two main flow indications and the indications near 200 and 225 degrees are shown in Figure 6.9.

**Figure 6.8 Two Main Flow Regions at 45 Degrees and 120 to 190 Degrees**

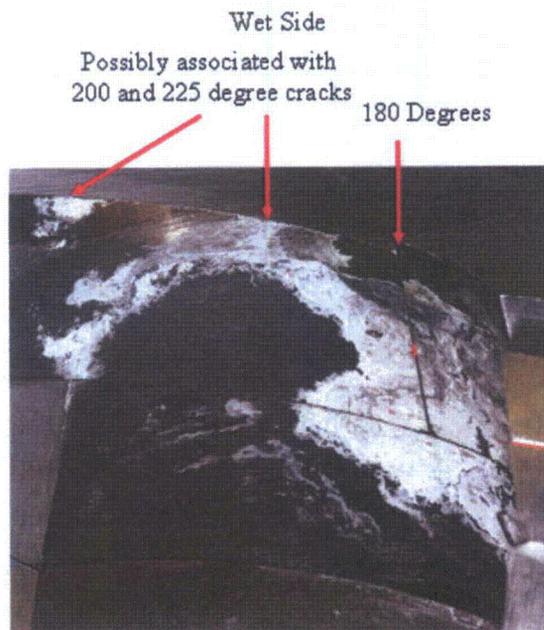
**Figure 6.9 Two Smaller Flow Regions at 45 Degrees and 120 to 190 Degrees**

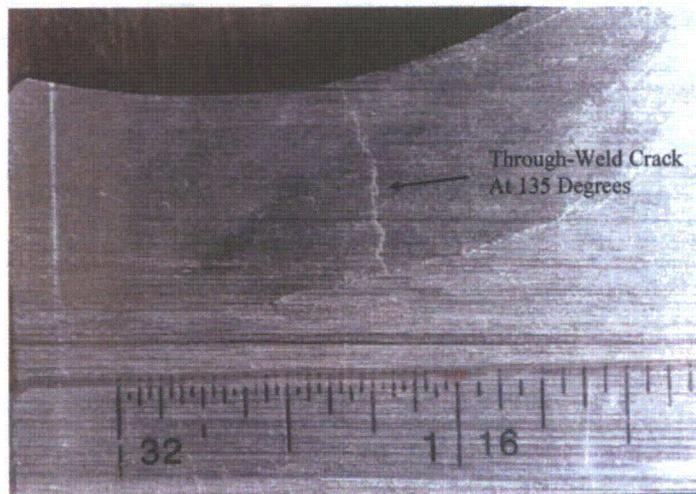
Careful ET examination and high-resolution photography did not find any evidence of through-weld cracking in Sections 1 and 3. A through-weld crack was immediately apparent, however, in the buttering of Section 2 at 135 degrees. This crack was clearly visible with the naked eye and was confirmed with ET and photography. This crack is shown in Figure 6.12. Because this crack was in a region shown to have crack-like indications and none of the other sections showed any indications of through-weld cracking, all attention was focused on Section 2 near this crack.

**Figure 6.12 Confirmed Through-Weld Crack Found Above the Triple Point in Section 2 at 135 Degrees**

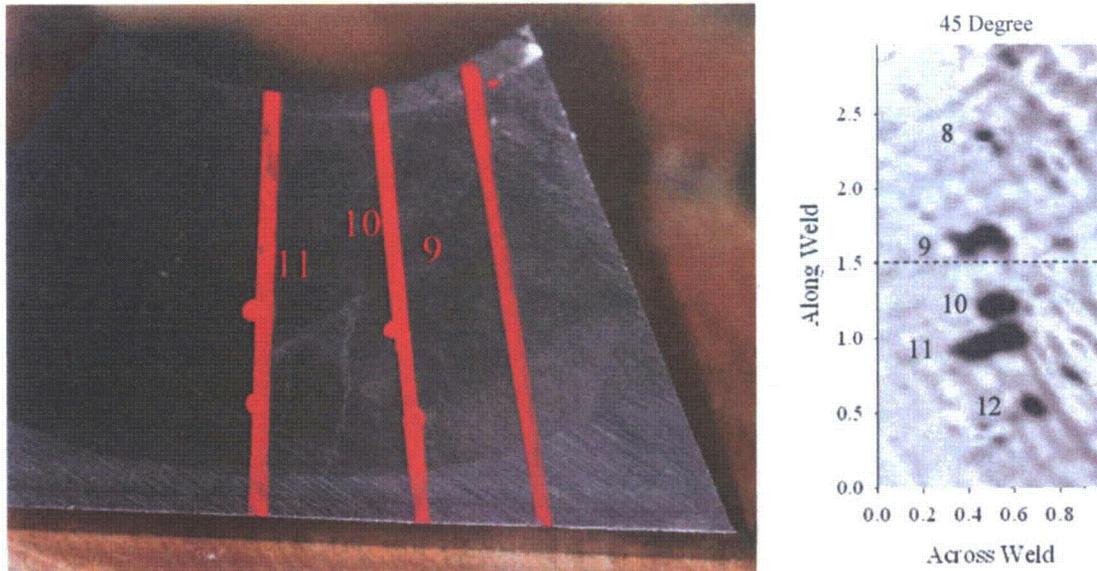
After the cutting, it was clear, based on the position and spacing of the cracks, which cracks were associated with which ET indications. Figure 6.14 shows the three cracks on the cut face 8 mm below the wetted surface. One interesting aspect of the cracks and the ET indications is how much longer the cracks are 8 mm into the weld than they were at the wetted surface. ET indication 9 is 8 mm long on the surface, and the visible crack length is 21-mm long at the cut surface. ET indication 10 is 6 mm long at the surface and is 25 mm long at the cut surface. Indication 11, which is 10 mm long at the wetted surface, is 15 mm long at the cut surface. The crack spacing is preserved; cracks 10 and 11 are 5 mm apart on both surfaces, and cracks 9 and 10 are 11 mm apart on the wetted surface and 10 mm apart on the cut surface. By contrast, ET indication 8 is 16 mm apart from ET indication 9. It is worth noting that ET indications 8 and 12 do not represent cracks that penetrated 8 mm into the weld.

**Figure 6.14 Eddy Current Testing Indications at 145, 155, and 160 Degrees Confirmed Using Destructive Examination**

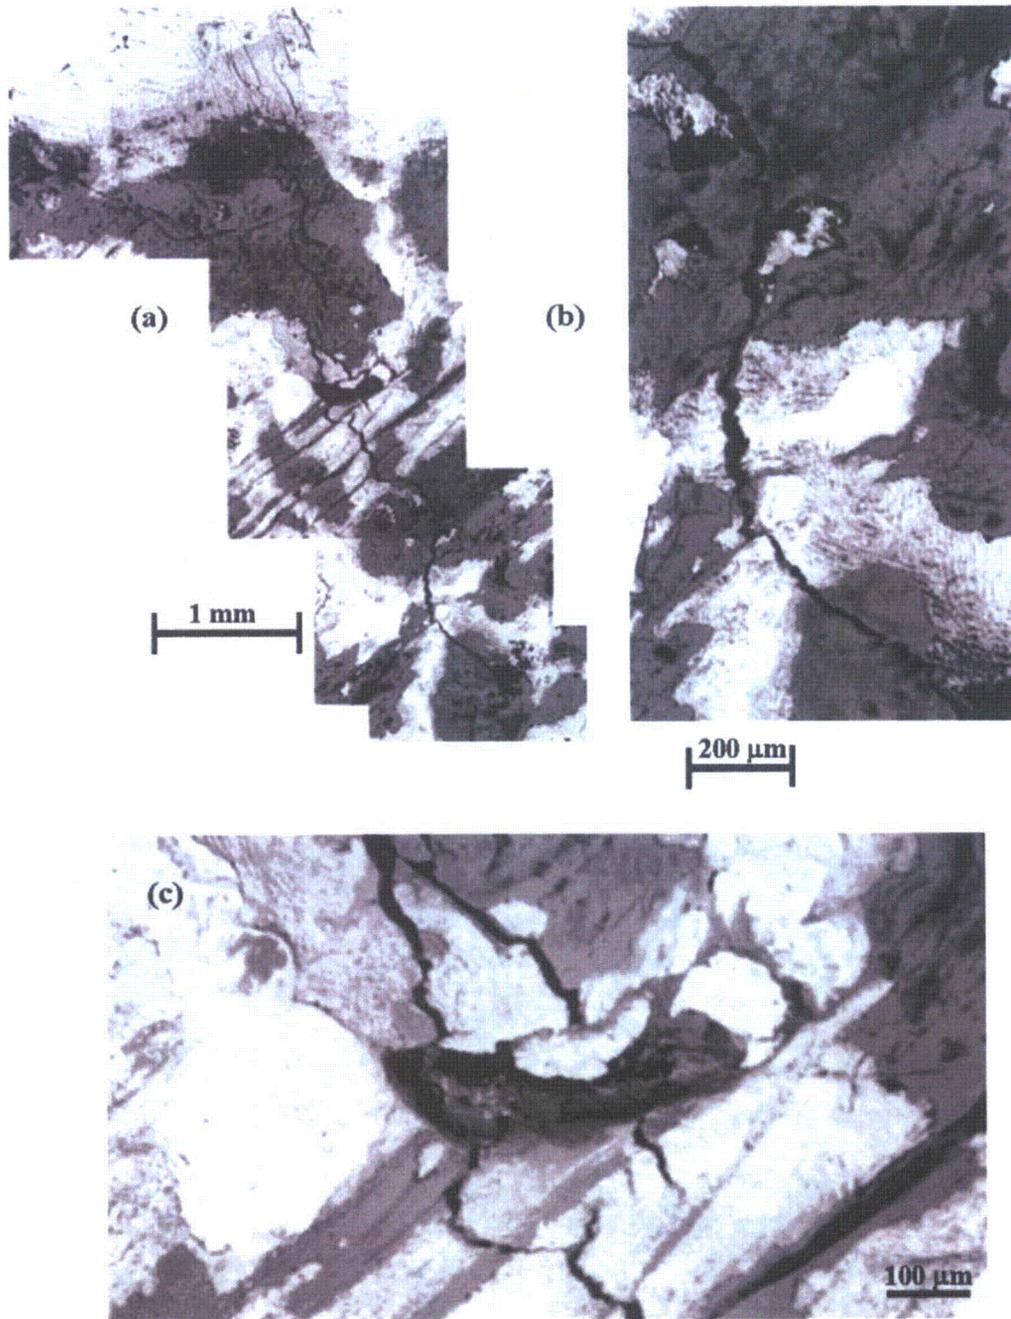
Before the three major pieces A, C, and E were sectioned, additional surface examinations were performed using scanning electron microscopy (SEM) to better document crack characteristics. The A surface exposed to PWR primary water was rough, and relatively thick oxide corrosion products remained in many locations. The SEM images revealed an obvious crack in the Alloy 182 weld metal, perhaps widest in the region near the transition from the butter passes to the J-groove weld metal. A full crack montage is shown in Figure 6.20(a), with a slightly higher-magnification image illustrating the crack morphology in Figure 6.20(b). It is not possible to accurately determine crack openings from these images, but widest locations were on the order of 30  $\mu\text{m}$  (0.0012 in.).

**Figure 6.20** Observed Crack on the PWR Water Surface of Piece A at Two Magnifications. The rough as-welded surface and relatively thick corrosion-product oxide in places (white contrast) made SEM imaging of fine secondary cracks difficult. However, the main crack is seen to extend ~6 mm (0.25 in.) on this surface. A moderate-size defect (pit) near the center of the main crack is shown in (a) and magnified in (c).

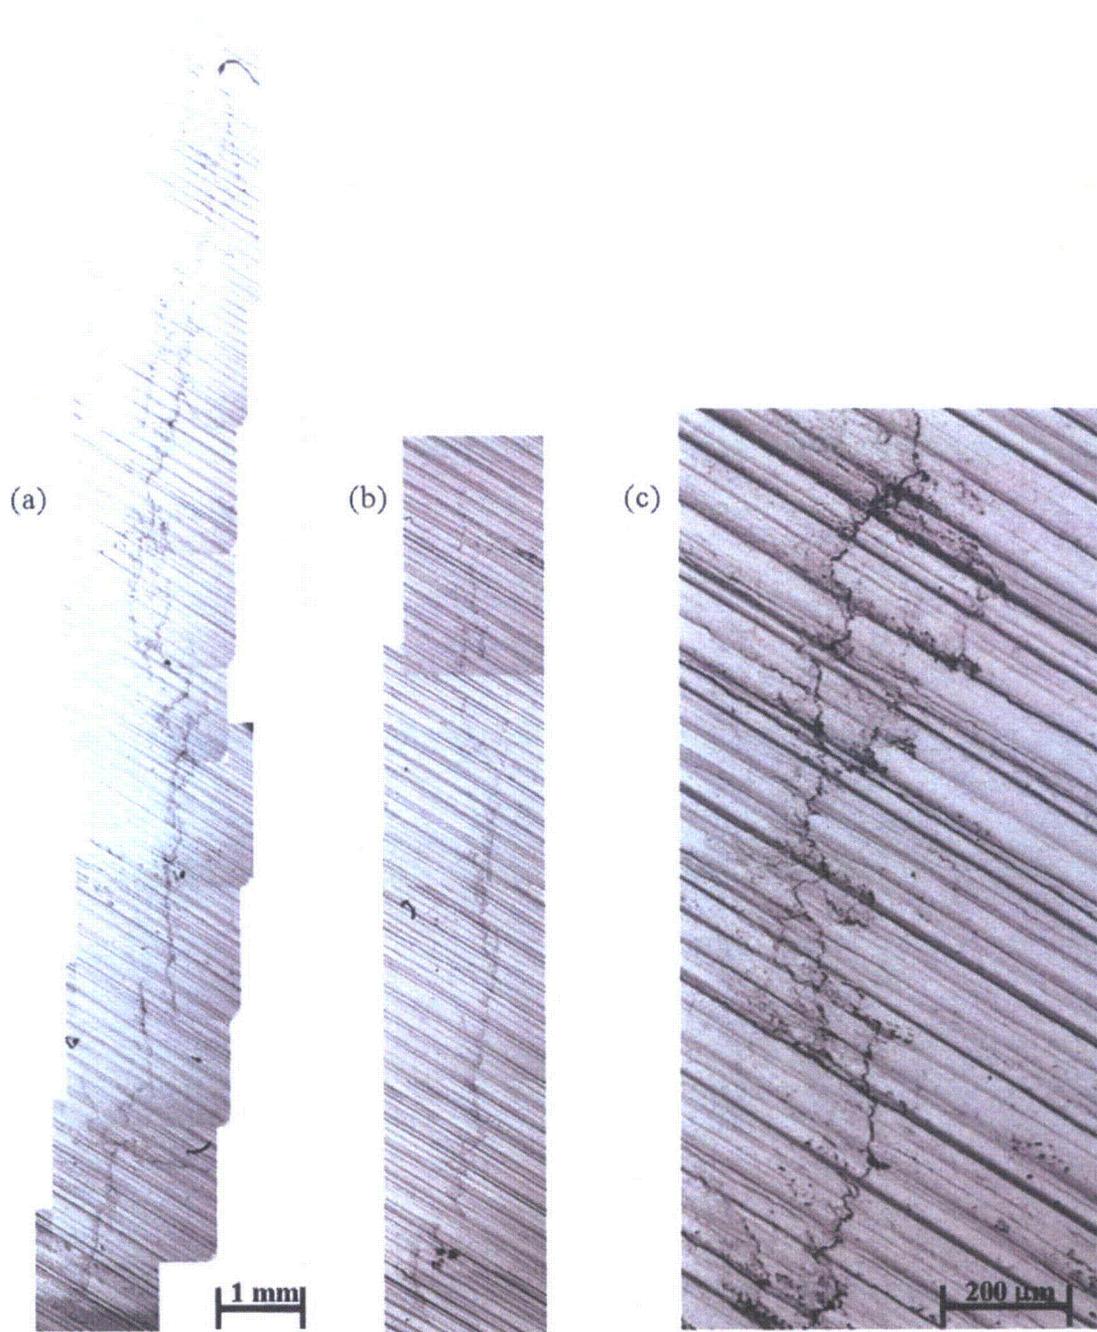
The top (inside) saw-cut surface from piece A enabled a much better observation of the full extent of the cracks. The SEM montages for the two primary cracks observed on this surface are shown in Figure 6.21(a) and (b). The main crack extends to the low-alloy steel interface and well into the Alloy 182 J-groove weld, while the secondary crack is near the edge of piece A and appears to have propagated into the adjacent piece B sample that was not examined. The higher-magnification SEM image in

Figure 6.21(c) documents the tortuous and branched crack path probably along interdendritic and grain boundaries. This will be examined in much more detail on the individual metallographic cross sections.

**Figure 6.21 Cracks on Piece A Top (inner) Saw-Cut Surface: (a) main crack, (b) secondary crack, and (c) higher magnification of typical crack morphology from (a)**

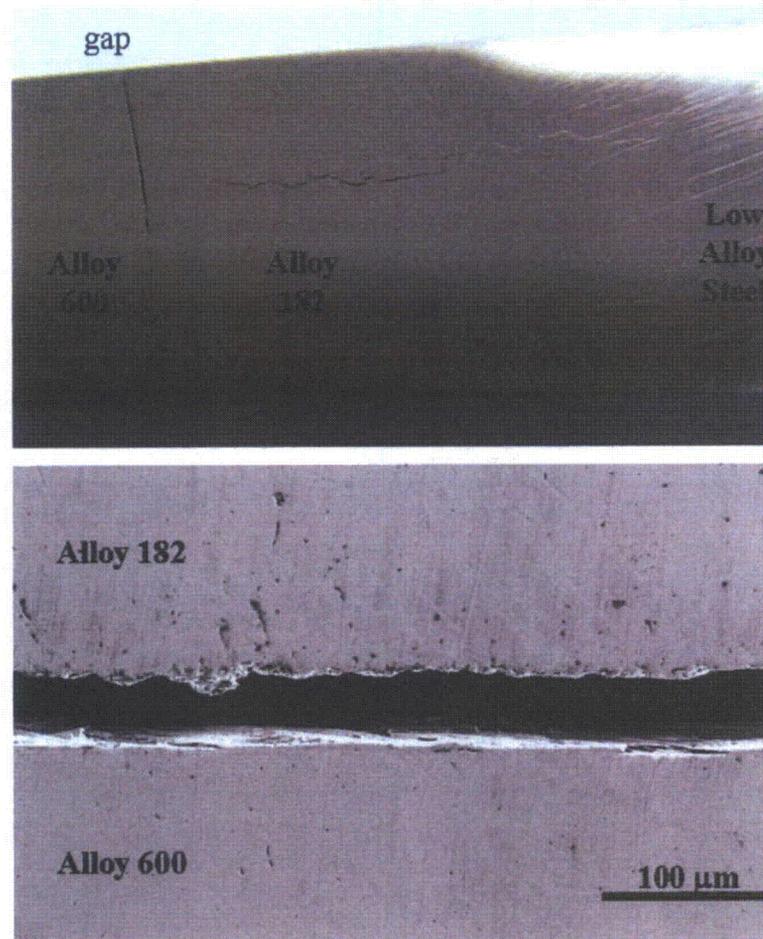
The surfaces of pieces C and E also were characterized with SEM before sectioning. The interference-fit gap was identified on the C top surface (facing E) both optically and by SEM, as illustrated in Figure 6.22. In addition to the bottom surface of piece E, the crack exit surface into the gap was examined. The Alloy 182 machined surface that made up the interference-fit gap with the Alloy 600 tube

**Figure 6.22 Interference-Fit Gap Between the Alloy 182 Butter Passes and the Alloy 600 Tube on Top Surface of Piece C (facing bottom surface of piece E)**

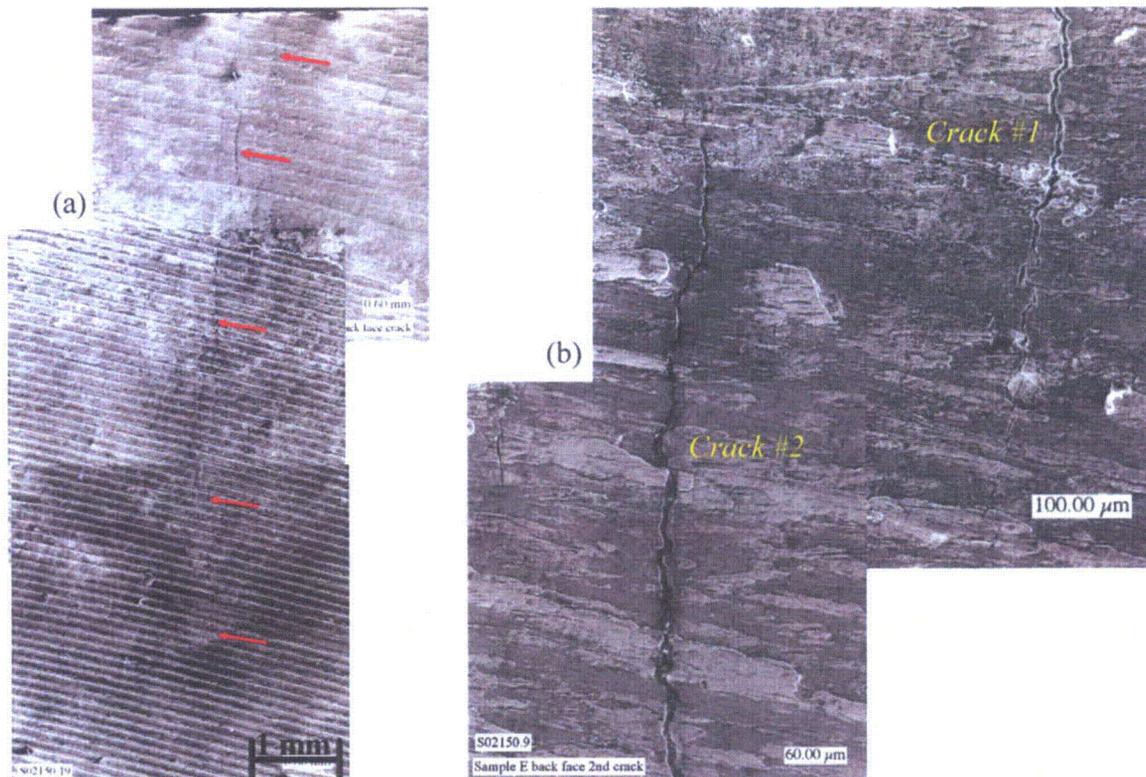
was found to have two relatively long cracks, as presented in Figure 6.23. When the two cracks were combined, a total crack length approaching ~7 mm (0.27 in.) was found on this exit surface, with the crack opening reaching ~10  $\mu\text{m}$  (0.0004 in.) in places. The cracks were filled with an unknown material, probably boric acid powder and corrosion-product oxide.

**Figure 6.23 Machined Surface and Exit Location for Through-Wall Cracks from Piece E Alloy 182 Weld Metal into Interference-Fit Gap Between Alloy 182 Butter and Alloy 600 Tube. Low-magnification SEM image (a) shows full length and two major cracks, while higher magnification (b) illustrates crack morphologies.**

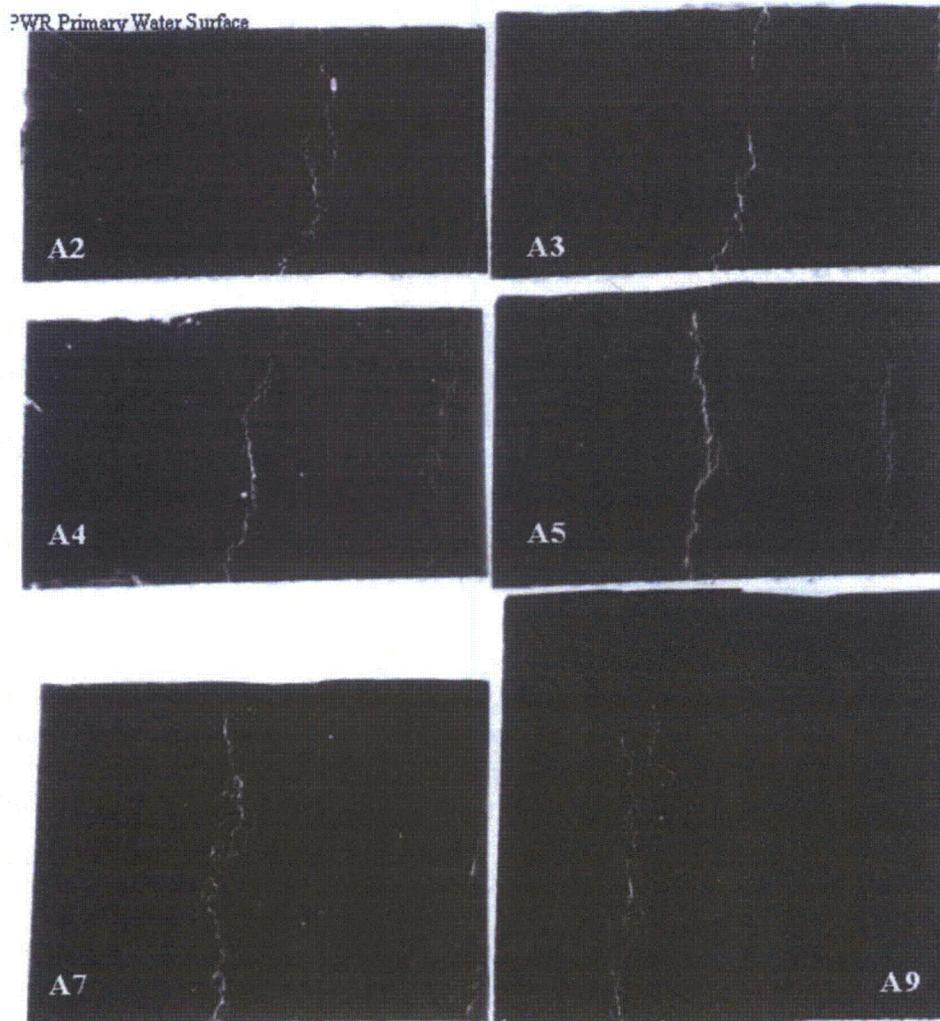
**Figure 6.24** Macro Cracks in Several Cross-Section Samples from Piece A Shown Through Photography. Note that PWR primary water surface is now on the top side of these images.

The macro images show extensive cracking through the Alloy 182 weld metal regions with possible initiation sites in cross section A3. A much more detailed evaluation of crack characteristics has been documented by recording systematic images mapping the full range of the cracks in each cross-section sample. Examples of these crack maps are shown for the A cross sections in Figures 6.25, 6.26, and 6.27. The secondary crack present in many of these cross sections also was mapped but will not be presented here. It is sufficient to note that this crack revealed a similar branched morphology.

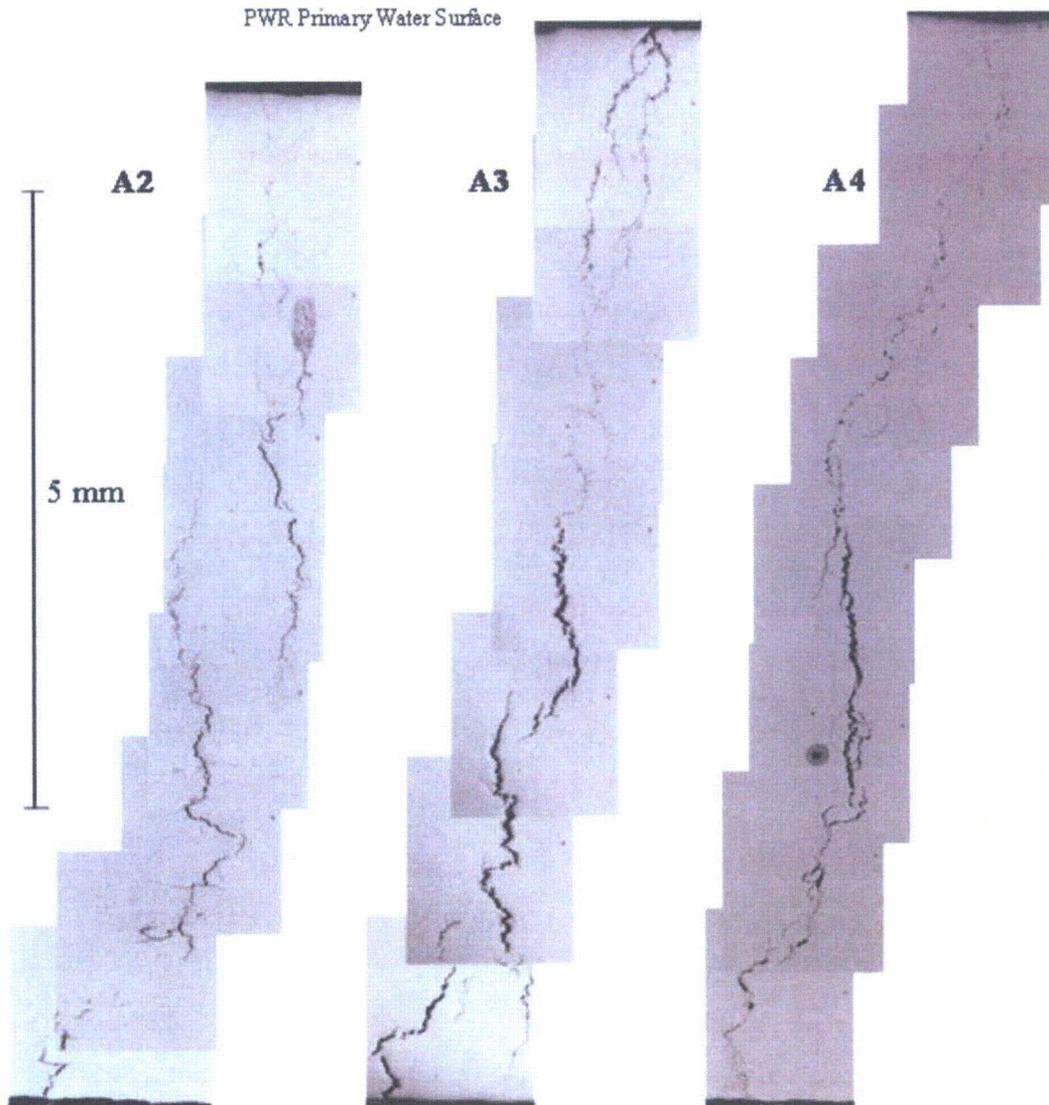
**Figure 6.25 Optical Micrographs for A2, A3, and A4 Cross-Section Samples Showing the Main Crack Essentially Running Through Entire Thickness of Each Sample**

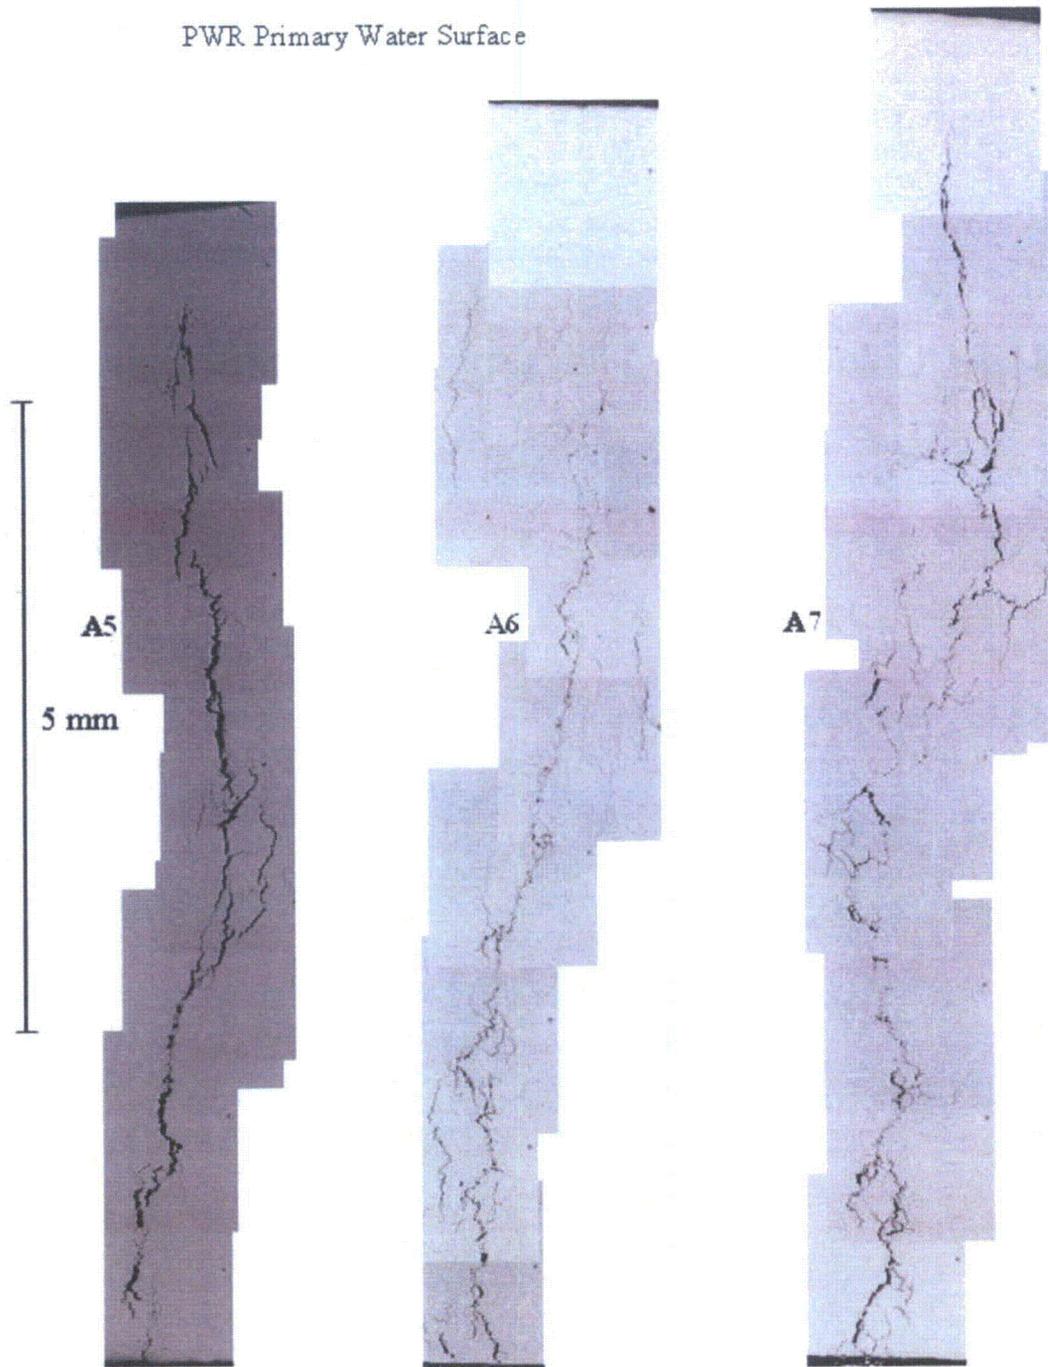
**Figure 6.26** Optical Micrographs for A5, A6, and A7 Cross-Section Samples Showing the Main Crack Appearing Below the PWR Primary Water Surface and Through Remaining Thickness of Each Sample

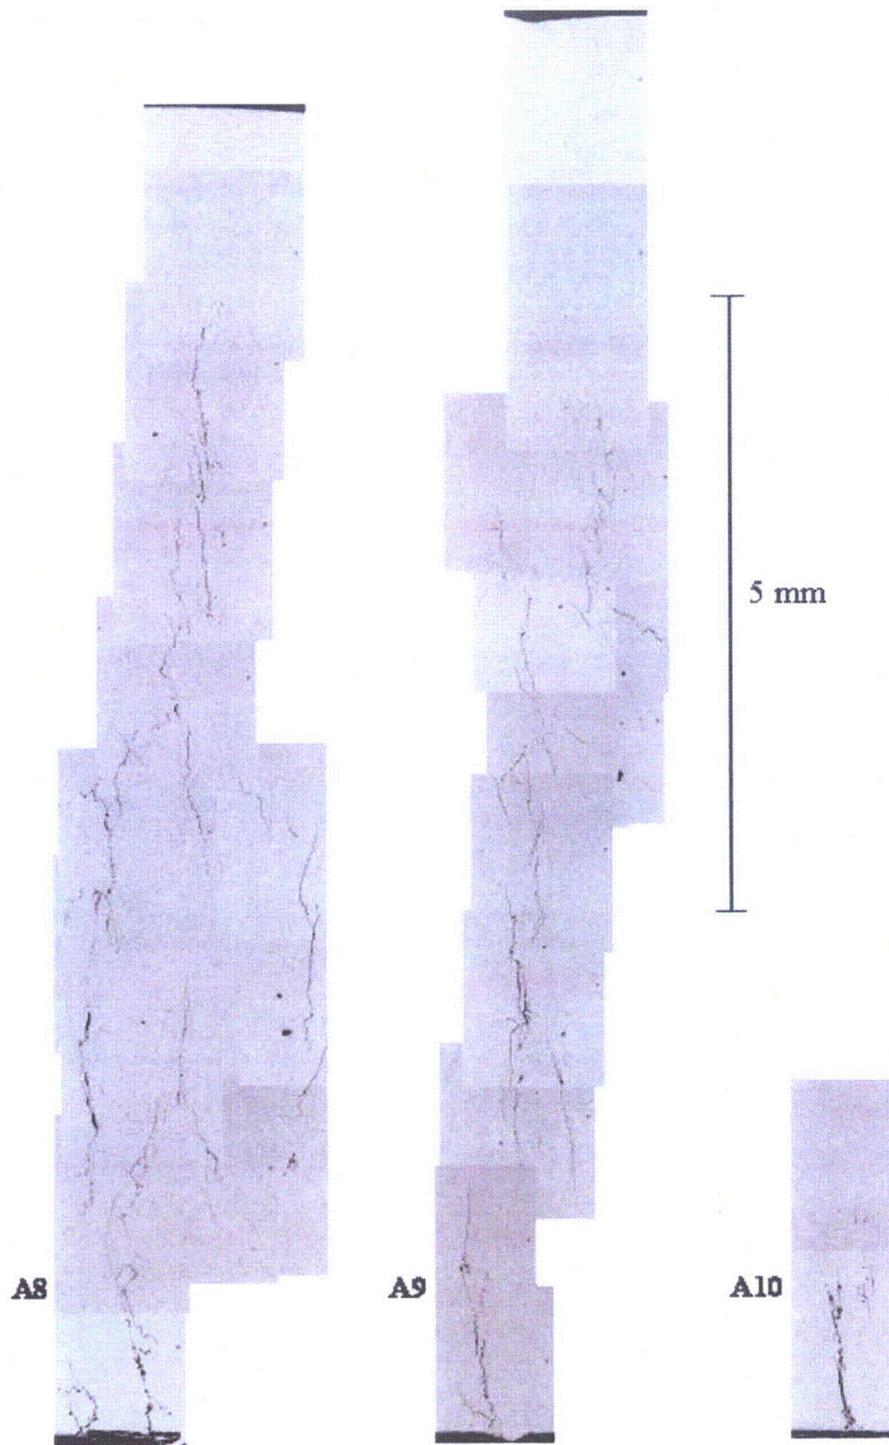
**Figure 6.27** Optical Micrographs for A8, A9, and A10 Cross-Section Samples Showing the Main Crack Appearing Farther Below the PWR Primary Water Surface as a Function of Distance from the Crack Initiation Sites in A3

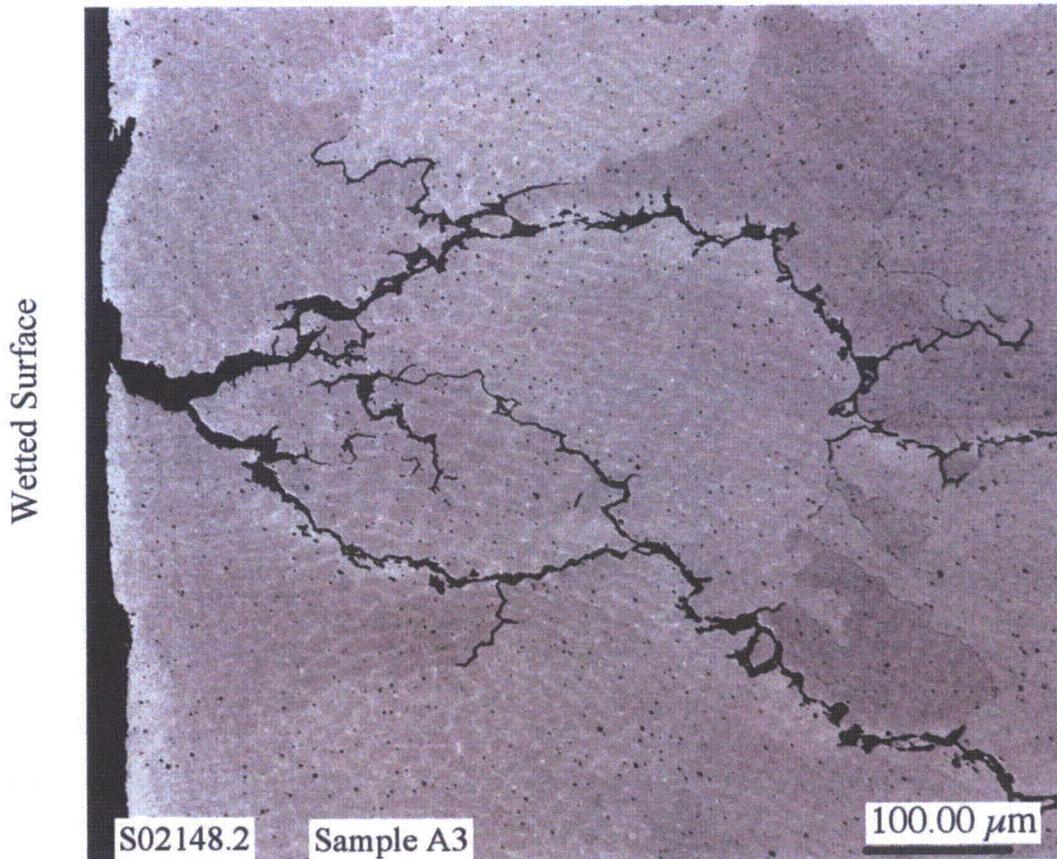
The apparent crack initiation site is near the A3 slice location, as illustrated in the optical micrograph for this cross section in Figure 6.27 and in a higher-magnification SEM image in Figure 6.28. The SEM micrograph suggests a region of damage at the surface near the crack opening. The width of the crack at the surface in the region is  $\sim 30 \mu\text{m}$  (0.0012 in.), consistent with the SEM examination of the cracks on the piece A primary-water surface presented in Figure 6.20. Crack morphology can be seen as heavily branched immediately below the surface and following convoluted interdendritic or grain boundaries for the most part. The SEM backscatter-electron (BSE) image provides both orientation (grain-to-grain) and compositional contrast. Both can be seen in Figure 6.28, with large grains several hundred micrometers in diameter and finer contrast within grains due to segregation (e.g., manganese and niobium) during final solidification. The heavily branched crack path continues throughout the Alloy 182 weld metal, as illustrated by the tight cracks shown in Figure 6.29. This area is from the mid-depth of the A3 cross section. Similar to the near-surface morphology, the main crack again has split into two separate cracks within this plane and has propagated along parallel interdendritic or grain boundaries. These images from the A3 cross section are representative of the general cracking morphology found within the Alloy 182 weld metal microstructures in nearly all metallographic sections examined.

**Figure 6.28** Location Where Crack Intersects the PWR Primary-Water Surface in Sample A3 and May Be Near the Initiation Site. Microstructural contrast within individual grains is due to solidification segregation in the Alloy 182 weld metal.

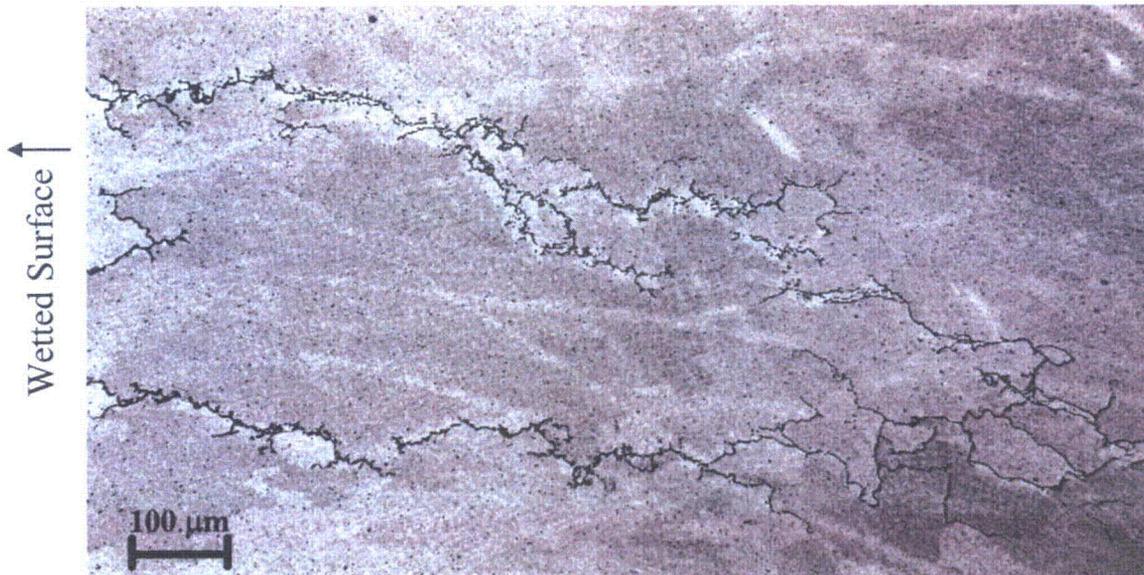
**Figure 6.29 Highly Branched Cracks Near Mid-Thickness in Cross-Section Sample A3**

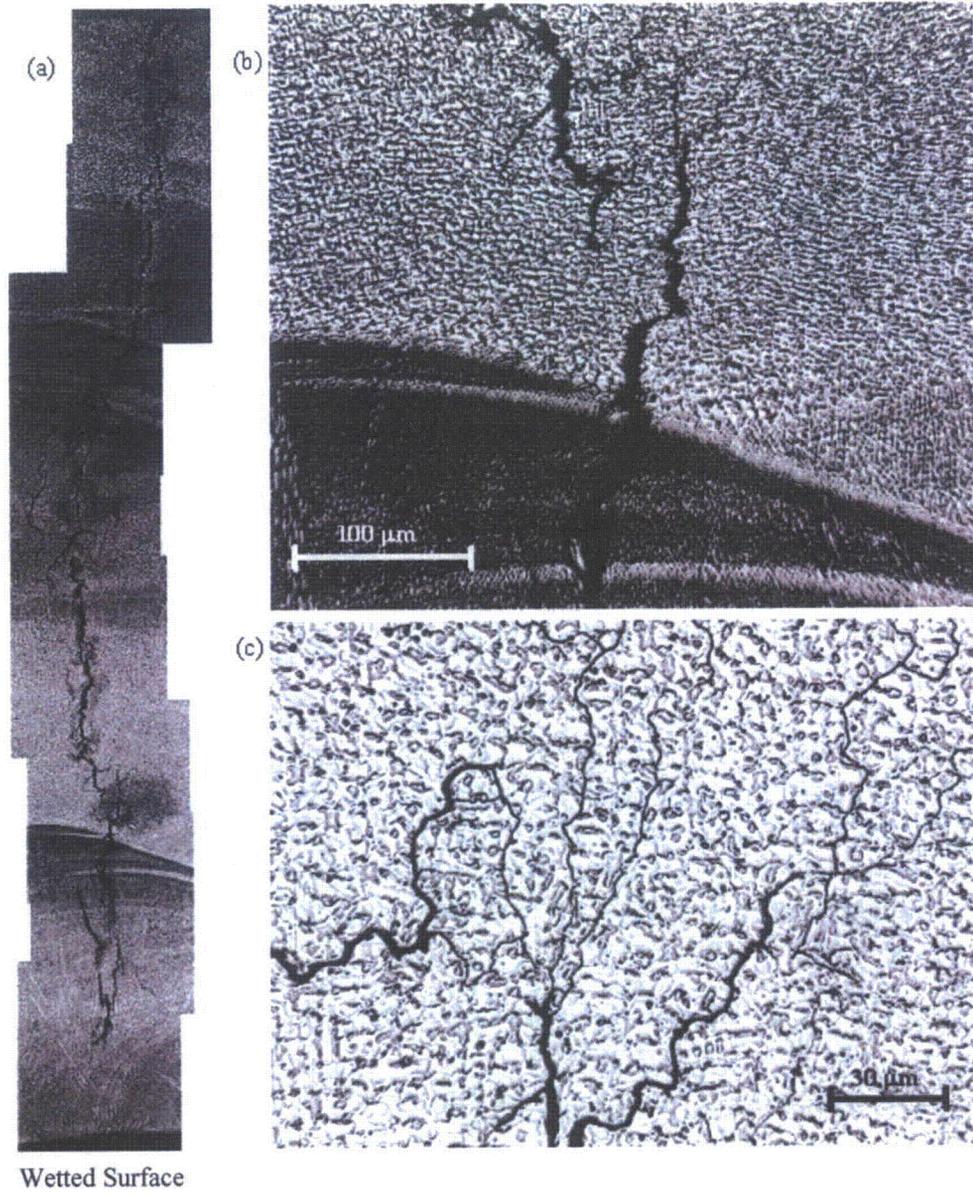
After optical and SEM images were recorded on as-polished samples, several samples were given a two-step nital/orthophosphoric etch to highlight weld-metal microstructures. Typical examples are shown in Figure 6.30 for sample A5. The full crack montage in Figure 6.30(a) illustrates that the crack propagates through several different passes of the J-groove weld within the thickness of piece A. In most cases, crack openings appeared to be wider as cracks approached weld pass boundaries (Figure 6.30(b)). This may reflect the higher stress required to transition to a new set of interdendritic or grain boundaries. Significantly different orientations of the dendritic microstructure can be seen between weld passes. The crack path clearly followed interdendritic or grain boundaries, as documented in Figure 6.30(c). Tight secondary cracks meander along, and end on, the convoluted weld metal boundaries.

**Figure 6.30 Etched Microstructures in A5 Cross-Section Sample: (a) montage showing full length of crack; (b) example of more open crack near/at weld pass interfaces; and (c) example of cracks following convoluted boundaries**

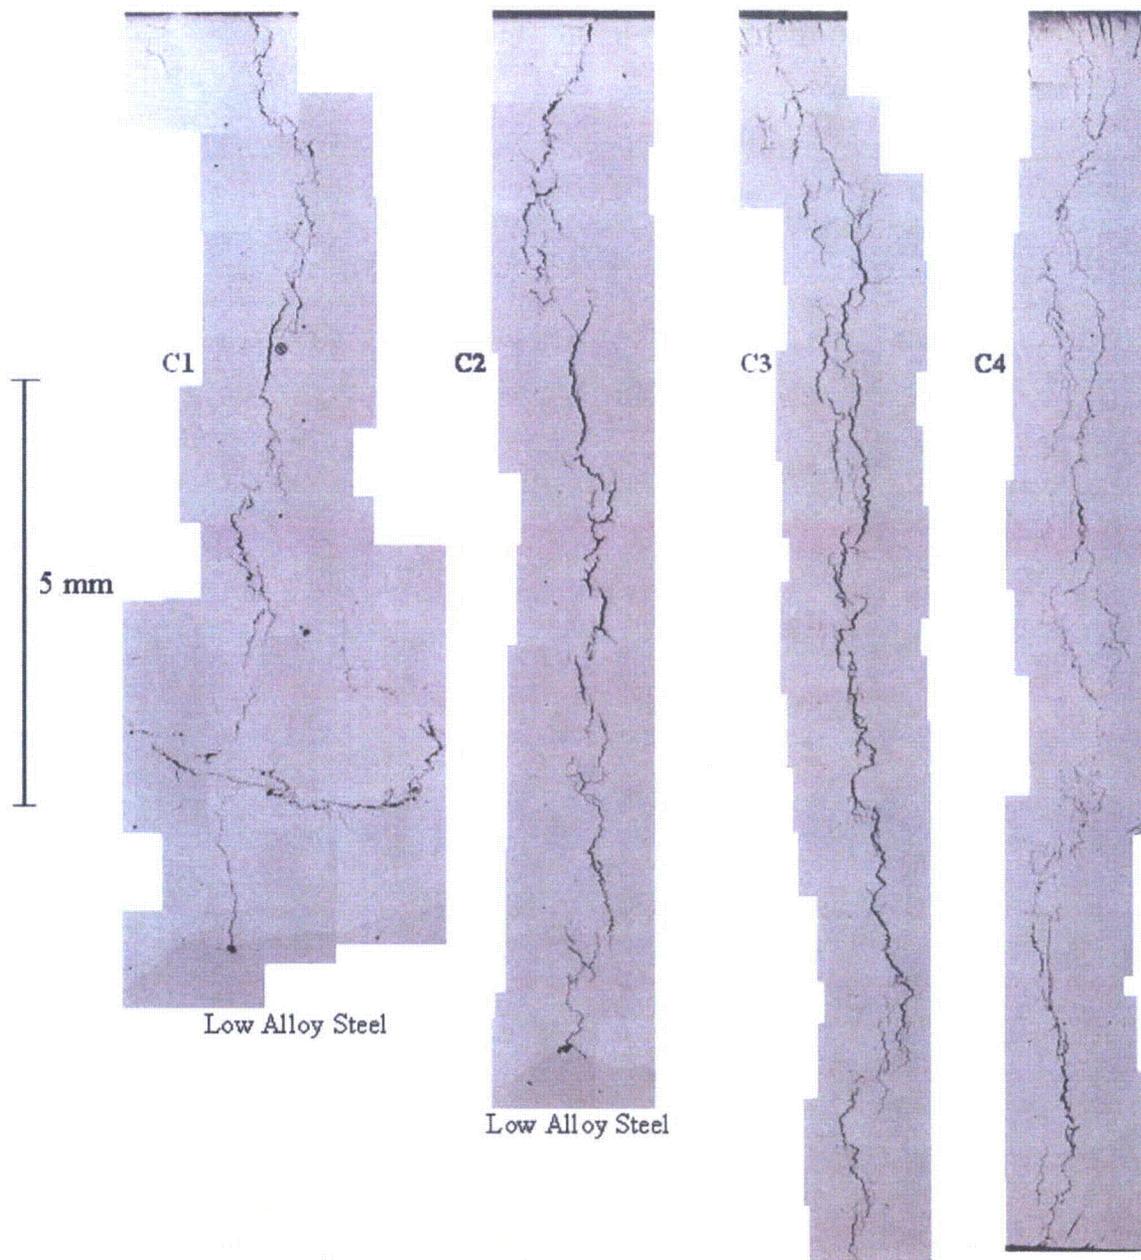
The approach for metallographic characterization of the A cross sections was repeated for the C and E cross sections. Cracking was found to extend from the low-alloy steel interface all the way into the Alloy 600 tubing in the C samples, as indicated by the earlier optical examinations (e.g., Figure 6.17) before sectioning. This observation is confirmed in Figures 6.31, 6.32, and 6.33, where crack montages are shown for cross-section slices C1–C4, C5–C7, and C8–C10, respectively. The cracks in sections C1 and C2 end at the low-alloy steel interface with the Alloy 182 butter passes. Scanning electron microscopy micrographs of this region are presented in Figure 6.34, documenting that no propagation occurred into the low-alloy steel. A small pit can be seen, but no significant corrosion of the low-alloy steel.

**Figure 6.31 C1, C2, C3, and C4 Cross-Section Samples Showing the Main Crack Running to the Low-Alloy Steel Boundary in C1 and C2, While C3 and C4 Show Crack Propagating Through Entire Thickness in Alloy 182 Weld Metal**

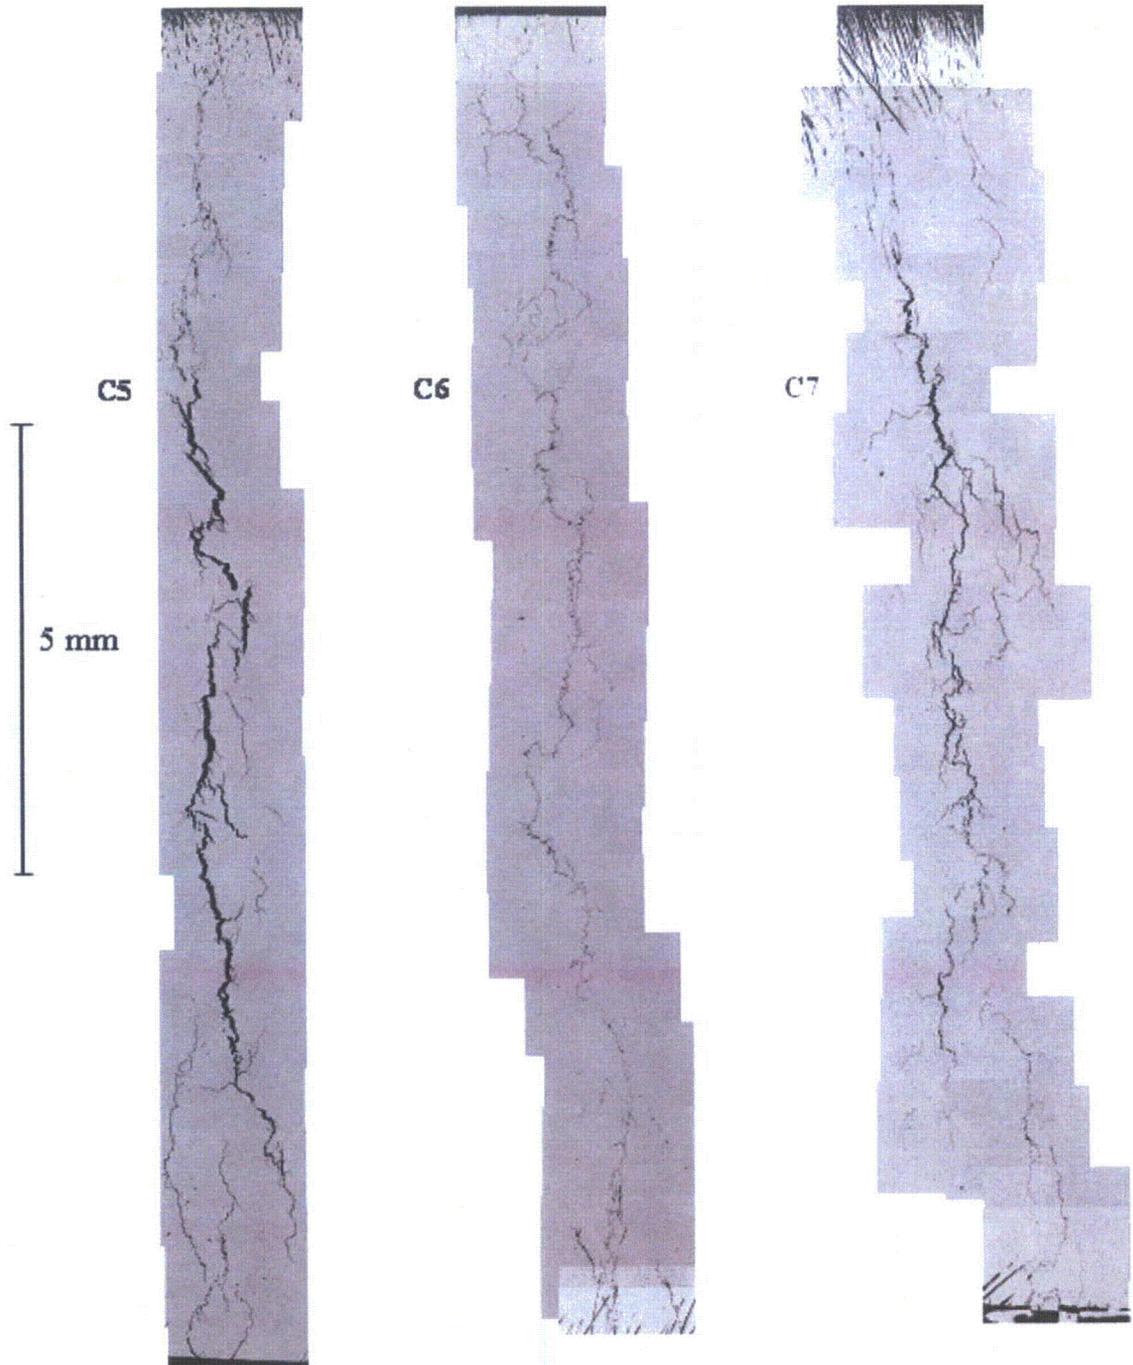
**Figure 6.32 C5, C6, and C7 Cross-Section Samples Showing the Main Crack Running Through Entire Thickness for These Locations**

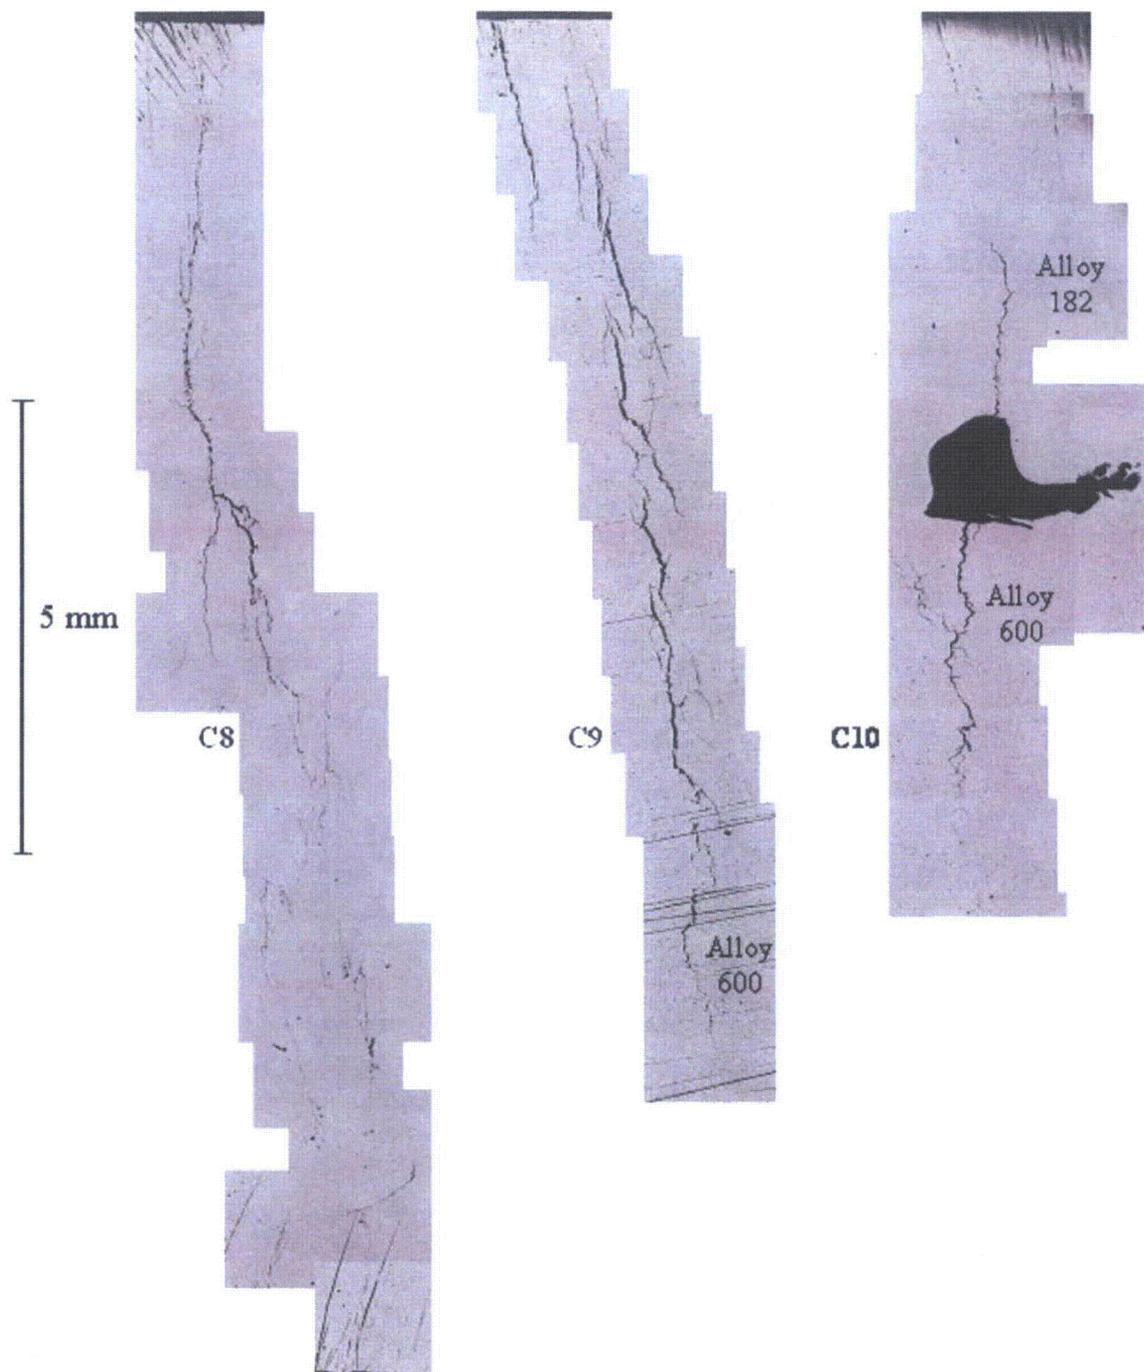
**Figure 6.33 C8, C9, and C10 Cross-Section Samples Showing the Main Crack Running Through the Alloy 182 J-Groove Weld into the Alloy 600 Tube. The large hole in the C10 cross section appears to be a weld defect at the alloy fusion line between the Alloy 600 tube and the Alloy 182 weld metal.**

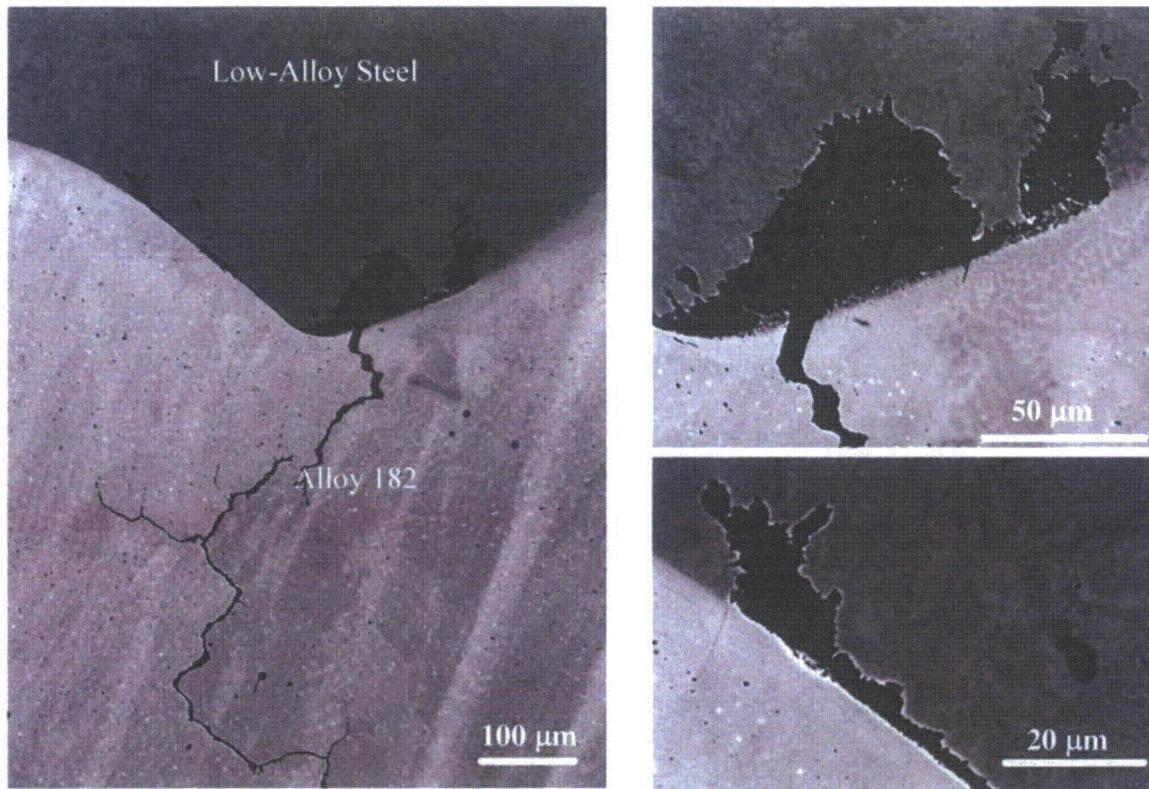
**Figure 6.34 Stress Corrosion Crack in Alloy 182 Butter Pass Ending at the Low-Alloy Steel Interface and Creating Small Corrosion Pits**
